FINAL REPORT

GTI Service Request No.: 525
GTI Project No.: 22480.1.54

Evaluation of Boretrace™

Report Issued: June 18, 2021

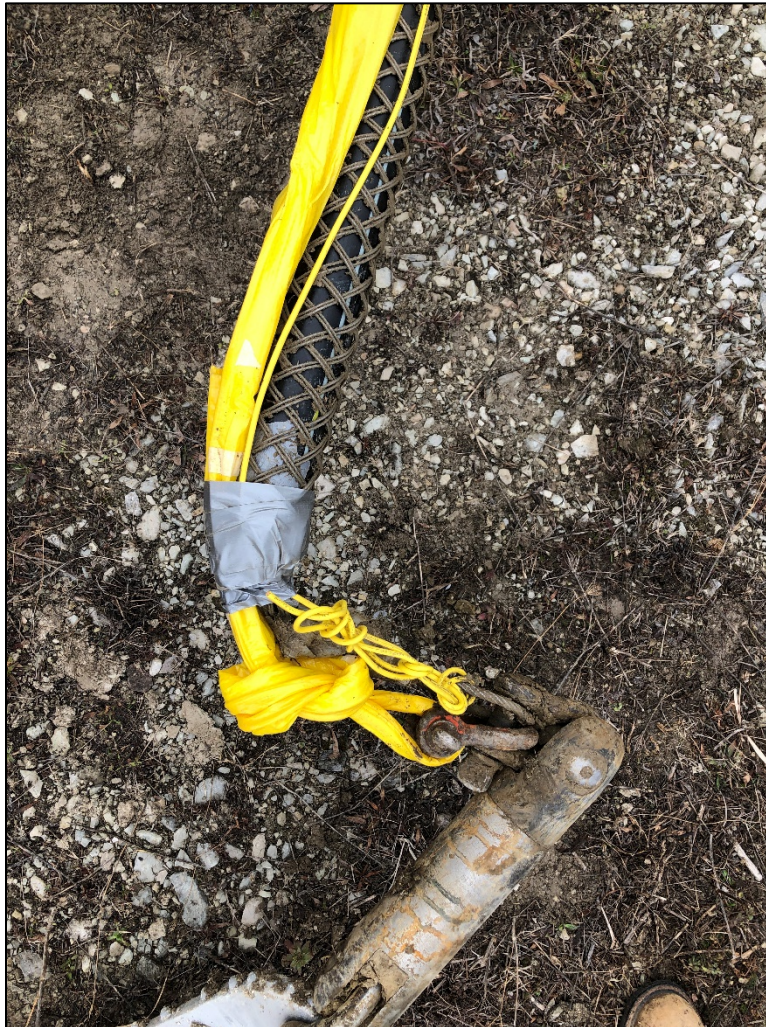
Figure 3. Installation attachment of tracer wire products

Both the 12 AWG tracer wire and Boretrace™ tracer wire were attached to the bore head as shown in Figure 3 below. Some abrasions were observed after removal from the bore

hole (Figure 6). However, no visible disconnections or catastrophic damage to either the traditional tracer wire or Boretrace™ product was visible. Upon laboratory inspection by DPS, some abrasions were observed on the Boretrace™ product and a single opening in the PE film exposed the tracer wire jacket, but the bare wire was not exposed. Tracer wire continuity was maintained, as described in **Marker System Evaluation**.

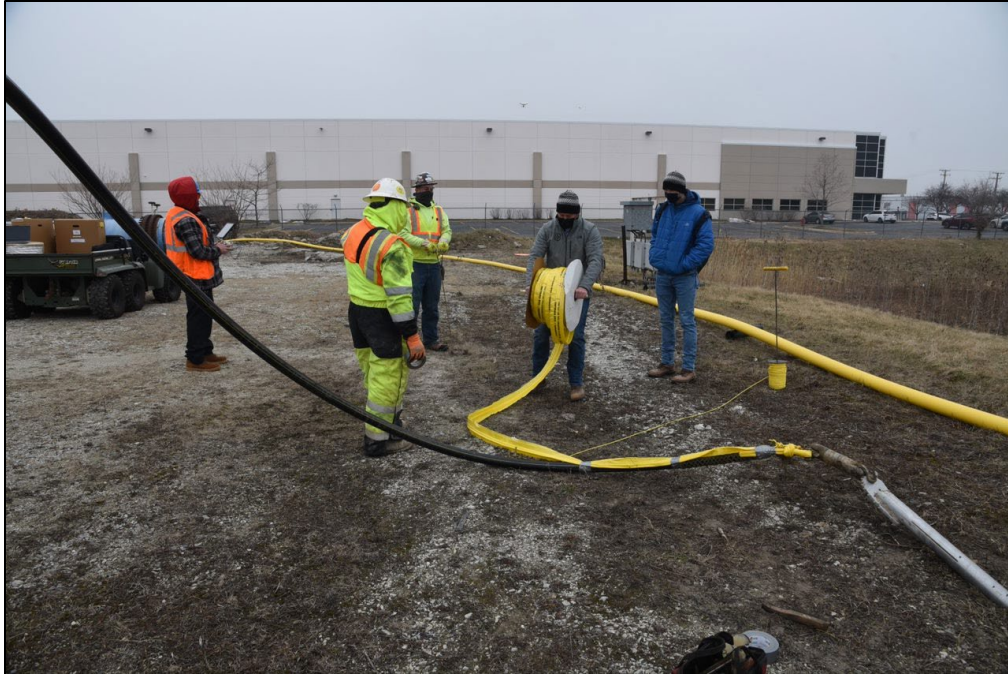
Figure 4. HDD Installation with Boretrace™ tracer wire

Boretrace™ was attached to a horizontal directional drill with 20,000 lb. of thrust and pull back capability per the attachment procedure shown in Figure 2. The HDD installation was carried out as a "dry pull", that is, no use of drilling mud, however some water was used to aid the installation. The pipe was pulled through clay soil, gravel and sand at ambient temperature and an estimated depth of 36 – 45 inches. An exemplar photograph of this installation is shown in Figure 5.
