# Facade Solutions

## Facades - Building - Thermal Inspection

North Façade, Windows, and Thermal

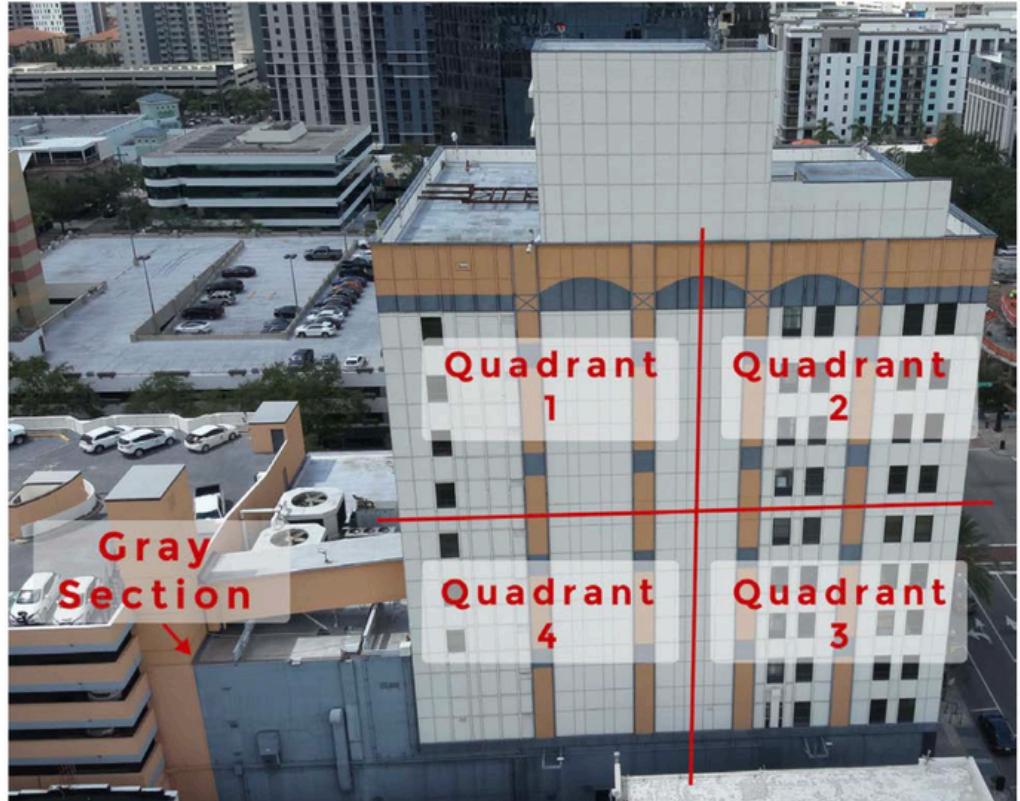
Location: North Façade, Quadrants 1–4

Comments: This image index shows the locations of the visually observed failures on the north facade.
