MRUT SIZING AXIAL: DEFECT DETECTION AND MEASUREMENT OF REMAINING WALL THICKNESS ON PIPES WITH GENERALIZED CORROSION

Arix Technologies sought to evaluate the MRUT SIZING application using VOLTA 2 for their inspection operations. To assess the application's performance, they provided a pipe sample containing conditions commonly encountered in the field, along with four artificial defects designed to challenge remaining wall thickness estimation. The Arix team aimed to confirm that Innerspec's solution could accurately detect and differentiate all four defects while providing a reliable estimate of the remaining wall.

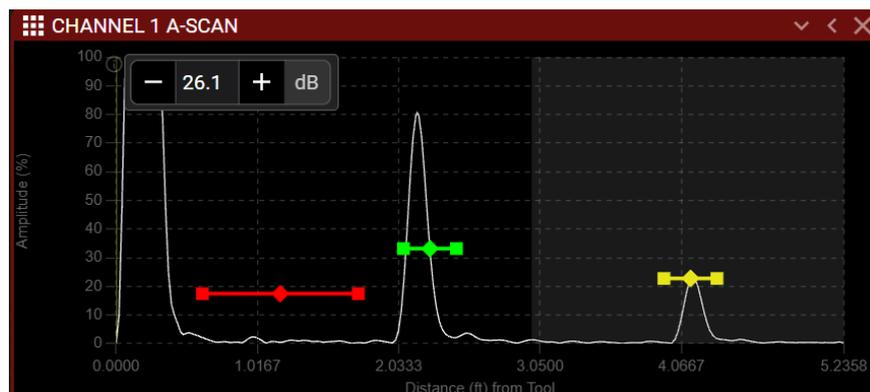
Figure 5. A-Scan Obtained from Calibrated System.

Channel 1 (amplitude), using SH0 wave mode, was able to identify an area where the wrap-around signals were strong, and reflections were at their lowest. The calibration process sets the gain so that the first wrap-around signal reaches 80% screen height. In this case, the calculated gain—which will serve as the baseline for the subsequent inspection scan—was set to 26.1 dB.

At the same 'clean' location, it was observed that the Channel 2 calibration (frequency sweep) had a negligible or non-existent response. Additionally, the baseline of the signal around the pipe was rough, resulting in a grainy B-Scan. This lack of frequency signal indicates that the SH1 wave mode cannot propagate around the pipe, which is a strong sign of internal corrosion. This is a known limitation of the
