# Brick Veneer Stabilization After Partial Façade Collapse

30 Kimberly Road | East Brunswick, New Jersey

Project No. 2400\_47

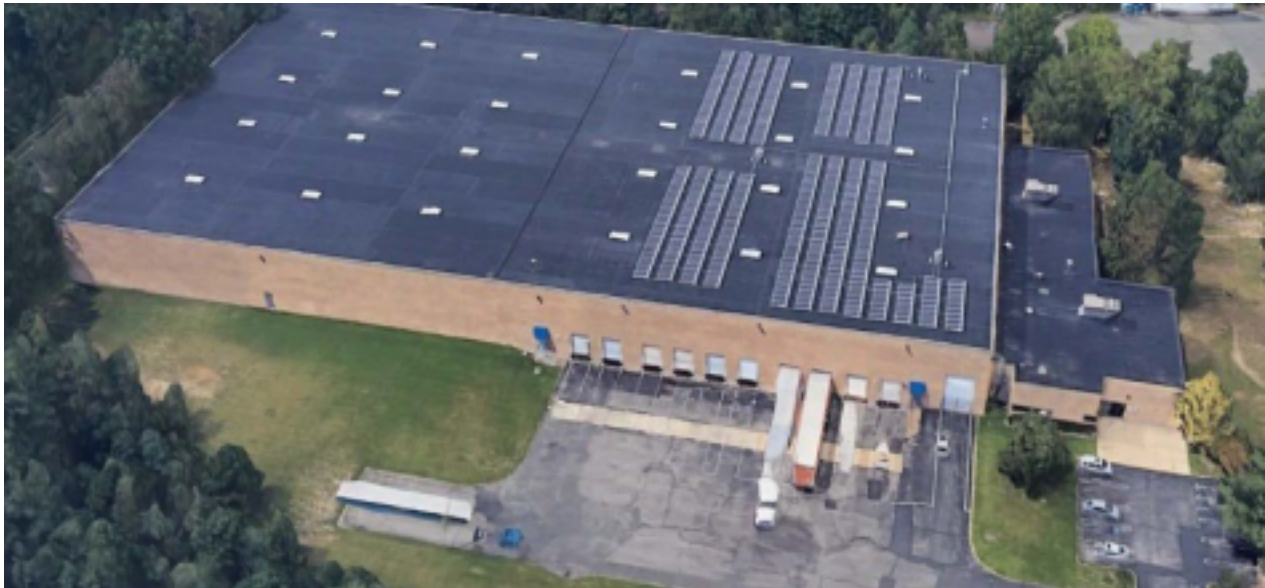
Aerial view of the approximately 430 ft x 240 ft warehouse and attached office. The failed area was located along the east wall.
