GT2026-176262

## DESTRUCTIVE AXIAL VIBRATIONS ON IGC THRUST COLLARS: RCA

Andrea Fusi<sup>1</sup>, Andrea Betti<sup>1</sup>, Giovanni Karahoxha<sup>1</sup>

<sup>1</sup>Compression Service Technology S.r.l., Florence, Italy

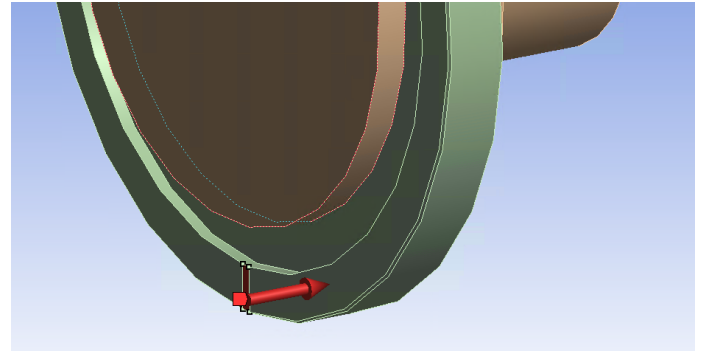
**FIGURE 12: APPLIED RING FORCE.**

A Finite Element Analysis (FEA) of the thrust ring, performed under static conditions and assuming a reduced contact area between the tapered raceways (due to ring deformation), showed acceptable stress levels. However, the axial deformation of the thrust ring under real operating conditions was found to be high enough to prevent the ideal alignment between the raceways leading to a loss of hydrodynamic support.

The FEA of the pinion was also used to evaluate the stiffness and deformation of the thrust collar. The axial thrust acting on the thrust ring was calculated to be 21 kN. This load was applied to a sector of the ring’s circular crown to simulate the Hertzian contact, while also accounting for the diametral interference range and the operating rotational speed (Fig. 12).
