Nantucket Regional Transit Authority 10-12 Washington Street

Existing Conditions assessment

Project number: 60767467

December 2025

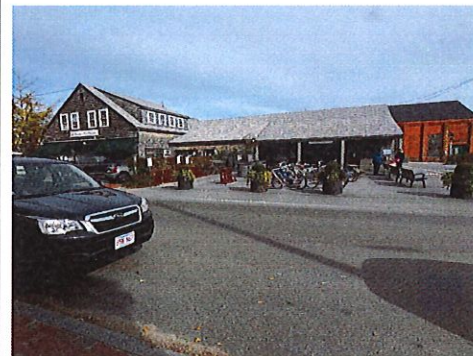
Exterior Façade – facing Washington Street

The finish on the exterior of the building is cedar shingles for much of the building with wood accent trim. There is one wall of wooden cladding under the canopy. The overall condition is good, with only a few areas of concern. There is a patch under the front canopy as well as a patch near the hose bib that should be repaired.

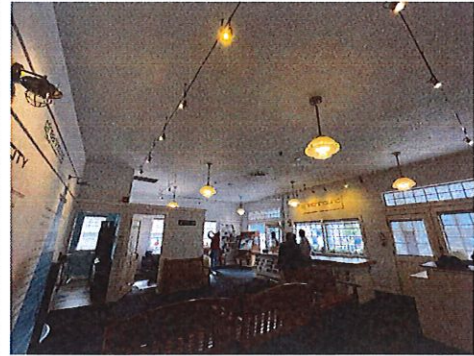
Interior Finishes – Lobby

The NRTA lobby has commercial grade carpeting tiles that are in fair condition with many stains and raised seams. The seams between tiles could be a maintenance concern.

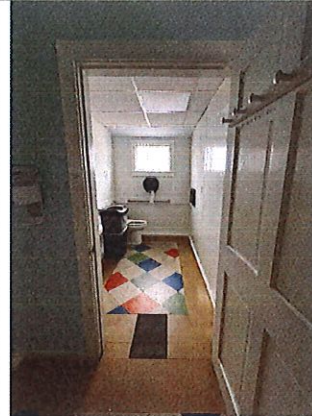
Interior Finishes – Toilet Room

The three toilet rooms have 2x2 acoustic ceiling tile system, for access to infrastructure for the toilet rooms that is run above the ceiling. The condition of the ACT is fair.

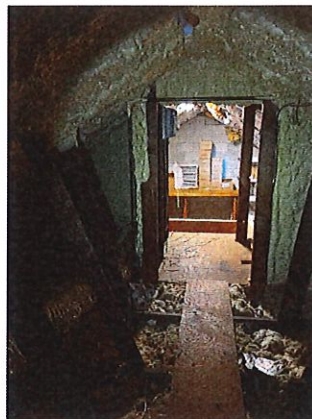
Attic

There is an attic space throughout 10 Washington Street, which is access via a wood stair, located within the Food Pantry area. The stairs are missing code required handrails though.

The attic space has some areas with plywood substrate (over the food pantry), and exposed ceiling framing over the NRTA space.

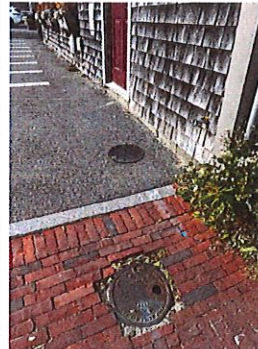
Domestic Water Service

The building has one electric domestic water heater. The water heater was not accessible, but the size of the enclosure suggests it isn't larger than a 30-gallon water heater. Recommend further review of the water heater to confirm age of equipment.

All visible water piping was copper with the exception of the pex water line for the irrigation system, located on the west elevation.

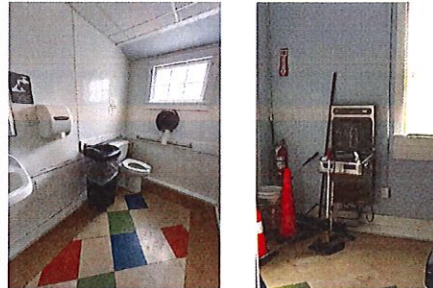
Plumbing Fixtures

The building's plumbing fixtures consist of three floor mounted tank type toilets, two wall hung lavatories, a shop sink, a single level drinking fountain with bottle filler, and one hose bib.

The plumbing fixtures were all in good condition at the time of the survey. They show typical and expected wear for the age of the plumbing fixtures, but useful life remains.

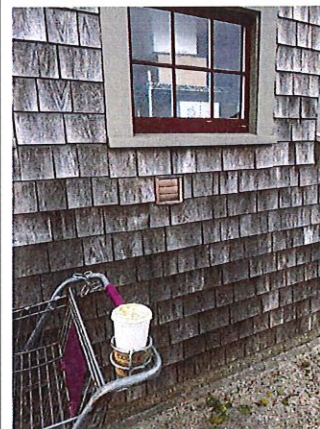
Toilet Room Exhaust Fan Louver

Three wall mounted inline exhaust fans have been found in the pantry. These fans serve public bathrooms. The status of these fans is not functional. These fans are vented to the exterior through a 4" wall vent. All ducting for these fans if flexible duct.

1. A new HVAC system is recommended to replace the existing HVAC systems and meet new space configuration and requirements. A heat pump multi-zone system can be used to have multiple control points based on the layout and occupancy of future space. This new system would eliminate the propane system including tanks and piping.
2. The area of operable openings needs to be checked to check if it provides the required natural ventilation (4% of floor area). There were no other sources of fresh air observed.
3. Further investigate exhaust fans and restore code required exhaust for the toilet rooms.

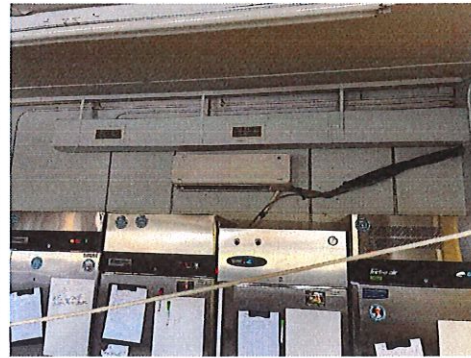
Mini-split system / heat pump

A wall mounted mini-split has been installed in food pantry area as a supplement unit, with the condensing unit located at the back roof. The split systems exceed the recommended life span expectancy.

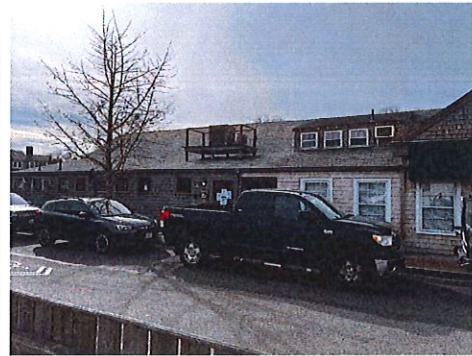
Roof Mounted Condensors

The current space is mainly served by a single zone gas-fired and DX cooling ducted split system. The indoor unit is horizontally installed in the attic. The condensing unit is located on a wooden platform on the back roof. The indoor unit (gas furnace and cooling coil) is not in very good shape. The cooling coil was manufactured in 2007 (around 19 years old); and has a four (4) ton cooling capacity. The DX air conditioning system works on R-22 refrigerant that has been discontinued long time ago and will not be easy to maintain. The ducts for this system utilize flexible duct that are typically only used for small ducts lengths, typically no longer than five feet per industry standard recommendations. The unit is controlled from a single programable thermostat located in the NRTA space.

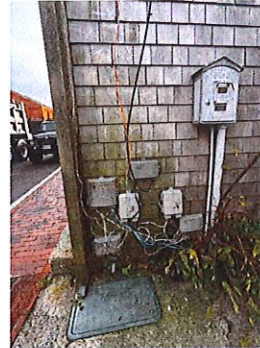
Fire Alarm Master Box

The original fire alarm system monitoring company was Intercity Alarms of South Yarmouth, Massachusetts, with operating instructions dated November 1, 1989, as evidenced by signage. Monitoring with Alarm New England was canceled in 2022, and if the system is currently unmonitored, this constitutes a fire code violation that could compromise the Certificate of Occupancy.

- Attain or perform full fire alarm system inspection and testing as required by code.
- Clear the alarm and trouble showing at the FACP.
- Confirm date and capacity of batteries, handwritten date of "8/17" was observed. Replace if expired.
- Restore monitoring service or confirm master box connection.
- Relocate / add notification devices per NFPA 72 spacing requirements.
- Add manual pull station devices per NFPA 72 requirements.
- Add carbon monoxide detectors where fuel-burning appliances exist.
- Two 120-gallon propane tanks are installed adjacent to combustible construction; per NFPA 58 and 527 CMR 1.00, the minimum required clearance is 10 feet for containers up to 500 gallons.

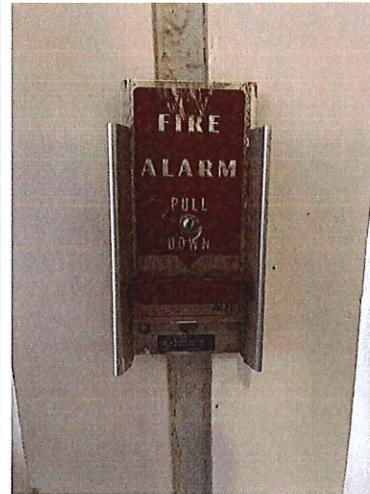
Fire Alarm Pull Switch

Detection devices, including heat and smoke detectors are installed in miscellaneous locations, and notification appliances such as horn/strobes are also installed in miscellaneous locations. However, overall notification coverage is inadequate per NFPA 72, with only one strobe observed in the lobby and one strobe at the second-level attic. Manual pull stations are located at the two primary exits within the NRTA space but lacking at the two other exits. Carbon monoxide detectors were not identified in the building, though they are required where fuel-burning equipment is present.

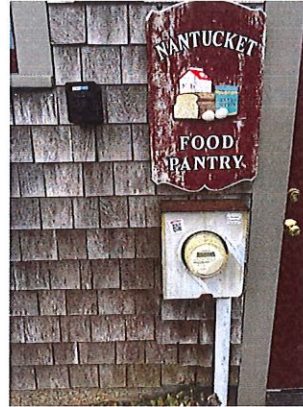
Electrical Service

The building's electrical service is 200A, 120/240 single phase with a single 42 circuit panelboard located within the Food Pantry Area. The panel is past its useful life, recommended that it be replaced.

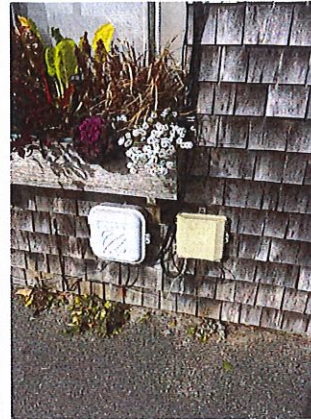
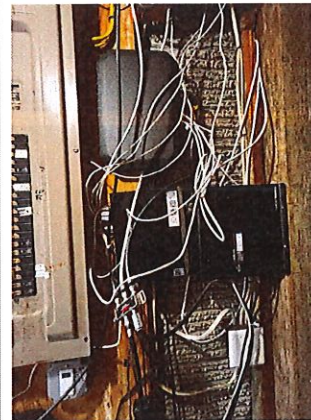
Telephone / Cable / Internet Service

The building has multiple cable and telephone services, with some appearing abandoned. Recommend demoing all abandoned services, in their entirety where possible, and repair finishes.
