**\*30691-4 OY3 #3 December 2023 / Building 2 / 1st Floor / 1st Floor Bldg 2.**

**\*30691-4 OY3 #3 December 2023 / Building 2 / 2nd Floor / 2nd Floor Bldg 2. (2nd Floor Bldg 2)**

## \*30691-4 OY3 #3 December 2023 / Building 2 / 3rd Floor / 3rd Floor Bldg 2

## \*30691-4 OY3 #3 December 2023 / Building 2 / 4th Floor Bldg 2 RFS (4th Floor Bldg 2 RFS layers)

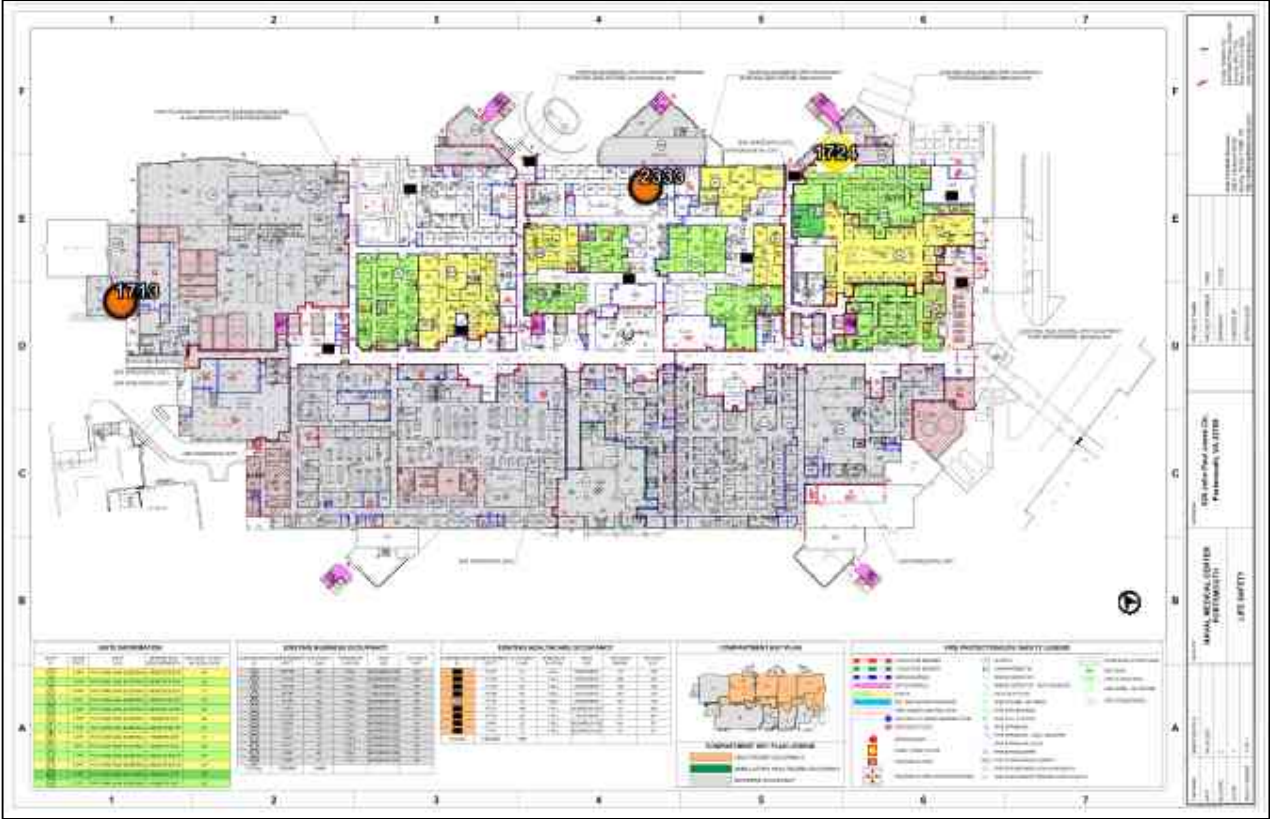
| Icon | Punch # | ID | Room Number | System | Inspection Type | Item | Type | Fire Rating | Wall Material | Action | Resource | Comments | Due | Type Comment | Created By | Priority |
|---|---|---|---|---|---|---|---|---|---|---|---|---|---|---|---|---|
| | 1713 | 885619 | | cja1080 | Repairs | TP-Wall | Metallic Pipe | 1 Hour Smoke Zone Barrier | Concrete | Repair | | | 12/14/23 | | MS | |
| Repair 12/14/23 12/23/23 NFPA 101 Section 8.5<br>Room Number 110103 12/14/23 12/23/23<br>Wall Direction 12/14/23 12/23/23 East<br>Lineal Feet 12/14/23 12/23/23<br>Repair 12/14/23 12/23/23 NFPA 101 Section 8.5 | | | | | | | | | | | | | | | | |

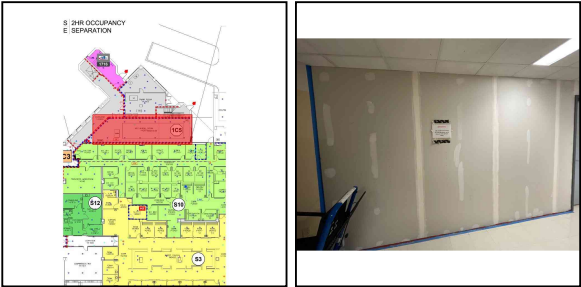
| Icon | Punch # | ID | Room Number | System | Inspection Type | Item | Type | Fire Rating | Wall Material | Action | Resource | Comments | Due | Type Comment | Created By | Priority |
|---|---|---|---|---|---|---|---|---|---|---|---|---|---|---|---|---|
| | 1724 | 885968 | | | Area | Area Survey | Construction Area | | | Note | | | 2/13/24 | | MS | |

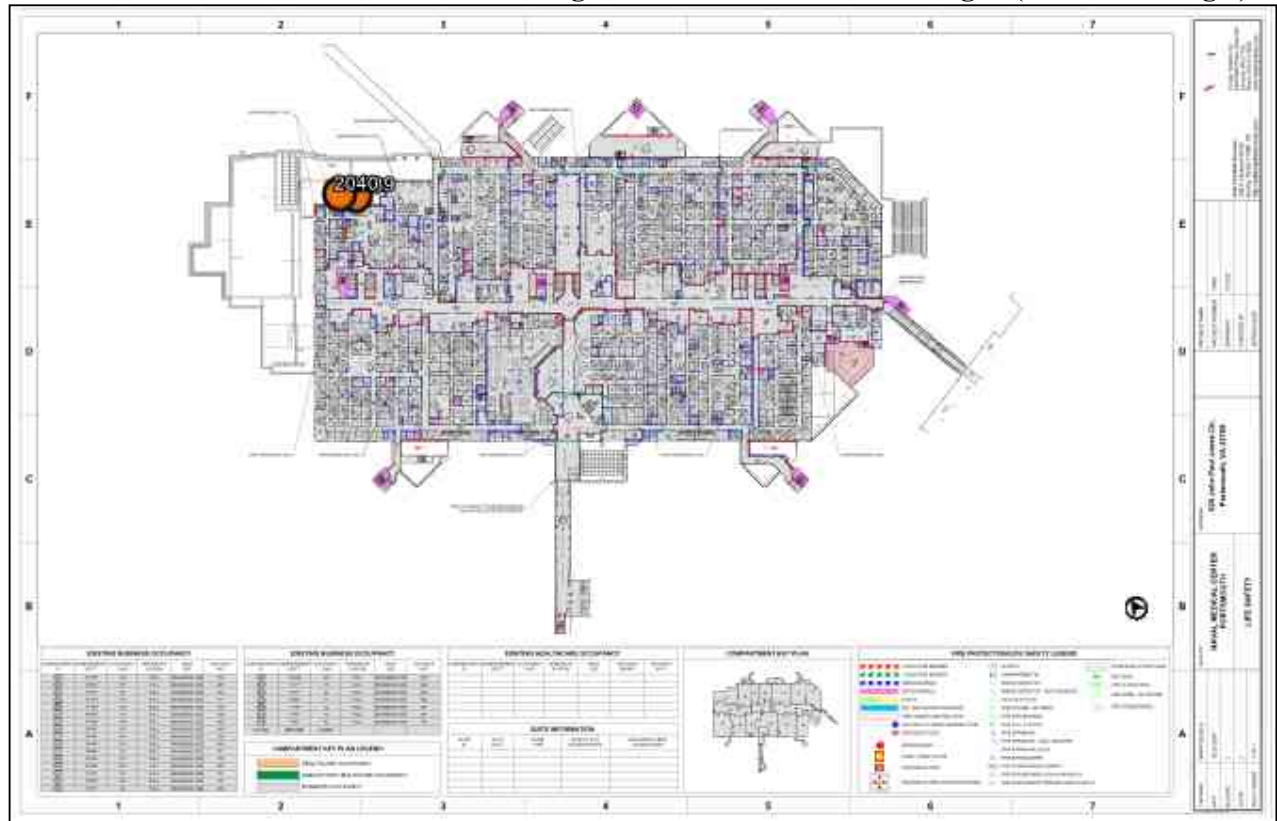
| Icon | Punch # | ID | Room Number | System | Inspection Type | Item | Type | Fire Rating | Wall Material | Action | Resource | Comments | Due | Type Comment | Created By | Priority |
|---|---|---|---|---|---|---|---|---|---|---|---|---|---|---|---|---|
| | 2039 | 885755 | | | Repairs | TP-Wall | Metallic Pipe | 1 Hour Smoke Zone Barrier | Gypsum | Repair | | | 12/17/23 | | MS | |
| Repair 12/17/23 12/23/23 NFPA 101 Section 8.5<br>Room Number 210321a 12/17/23 12/18/23<br>Wall Direction 12/17/23 12/23/23 West<br>Lineal Feet 12/17/23 12/23/23<br>Repair 12/17/23 12/23/23 NFPA 101 Section 8.5 | | | | | | | | | | | | | | | | |

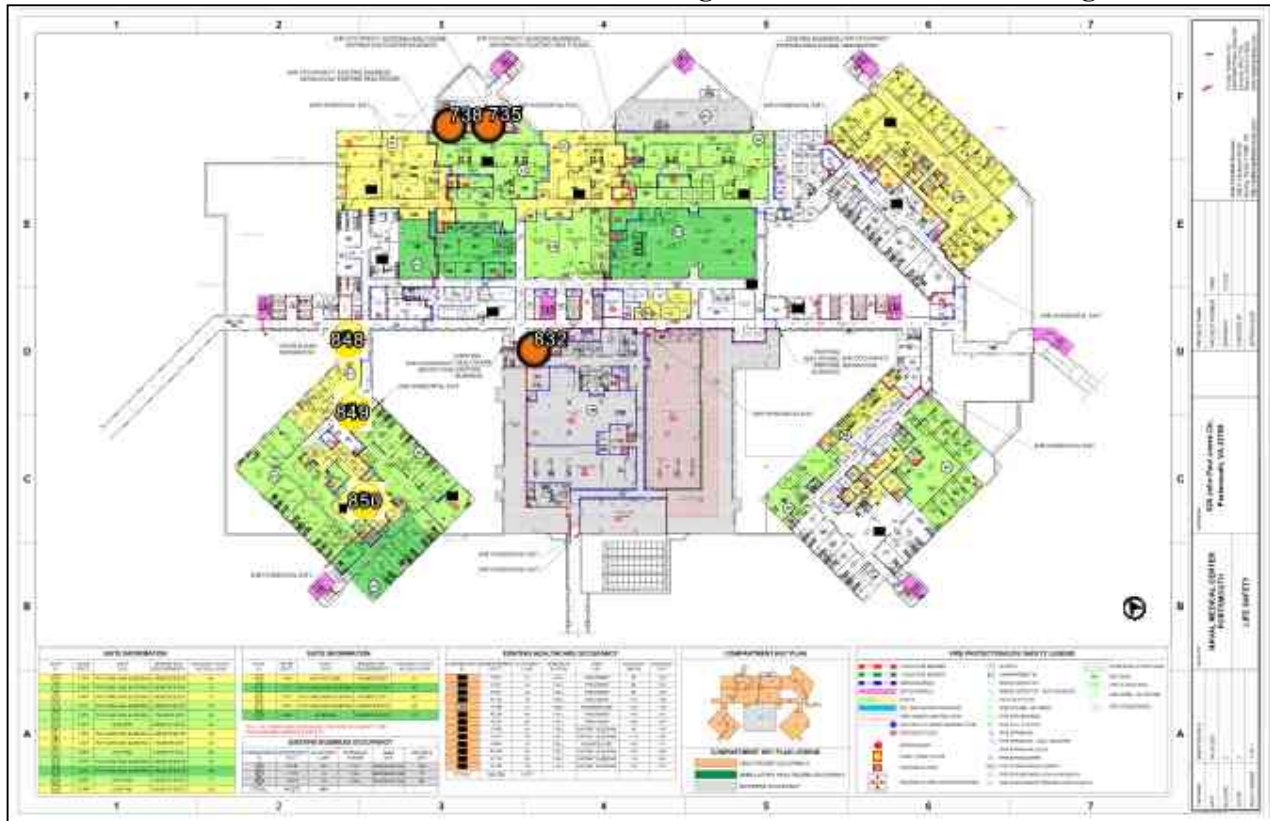
| Icon | Punch # | ID | Room Number | System | Inspection Type | Item | Type | Fire Rating | Wall Material | Action | Resource | Comments | Due | Type Comment | Created By | Priority |
|---|---|---|---|---|---|---|---|---|---|---|---|---|---|---|---|---|
| | 735 | 885627 | | caj1080 | Repairs | TP-Wall | Metallic Pipe | 1 Hour Smoke Zone Barrier | Concrete | Repair | | | 12/14/23 | | MS | |
| | Repair 12/14/23 12/23/23 NFPA 101 Section 8.5<br>Room Number st43n 12/14/23 12/23/23<br>Wall Direction 12/14/23 12/23/23 West<br>Lineal Feet 12/14/23 12/23/23<br>Repair 12/14/23 12/23/23 NFPA 101 Section 8.5 | | | | | | | | | | | | | | | |

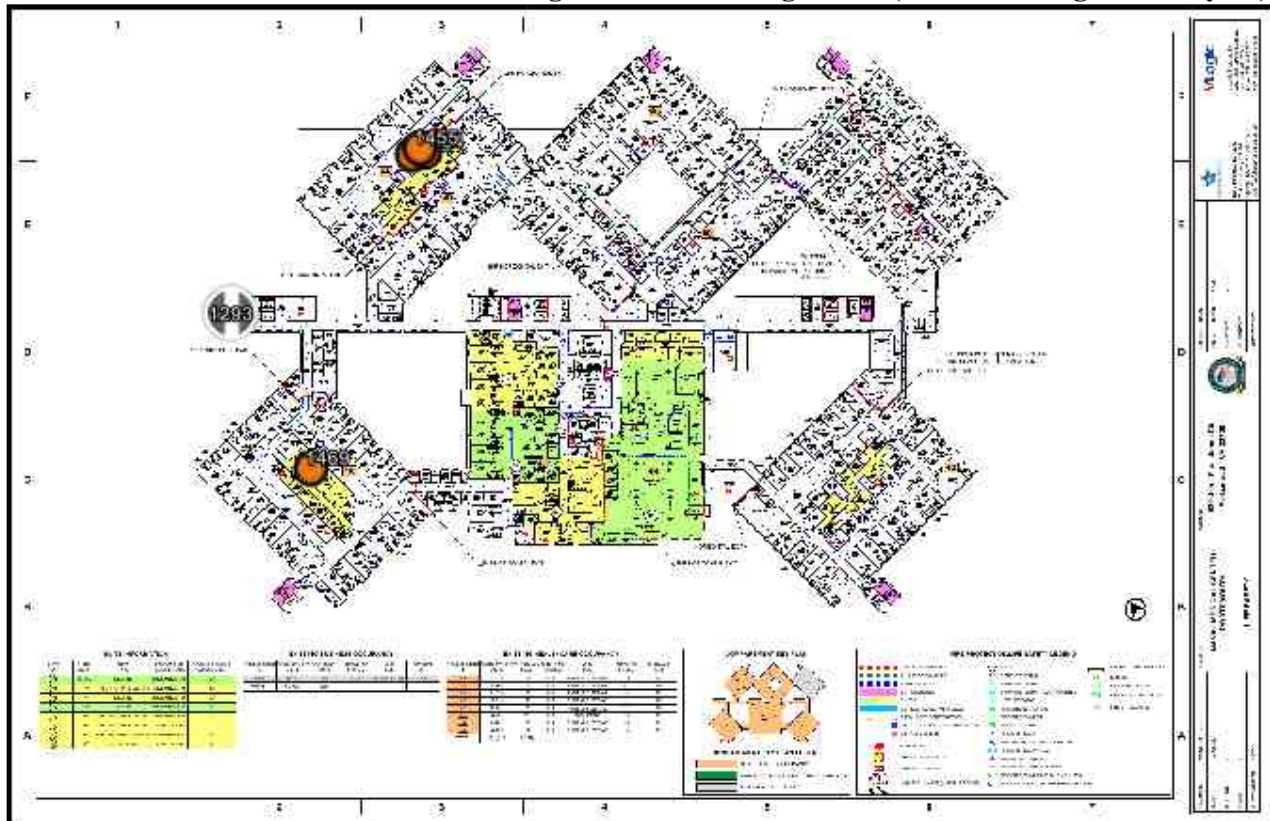
| Icon | Punch # | ID | Room Number | System | Inspection Type | Item | Type | Fire Rating | Wall Material | Action | Resource | Comments | Due | Type Comment | Created By | Priority |
|---|---|---|---|---|---|---|---|---|---|---|---|---|---|---|---|---|
| | 1293 | 885966 | | | Large Opening | Large Opening | Sections of walls missing | | Gypsum | Repair | | | 2/13/24 | | MS | |
| | Repair | 2/13/24 | | | NFPA 101 Section 8.5 | | | | | | | | | | | |

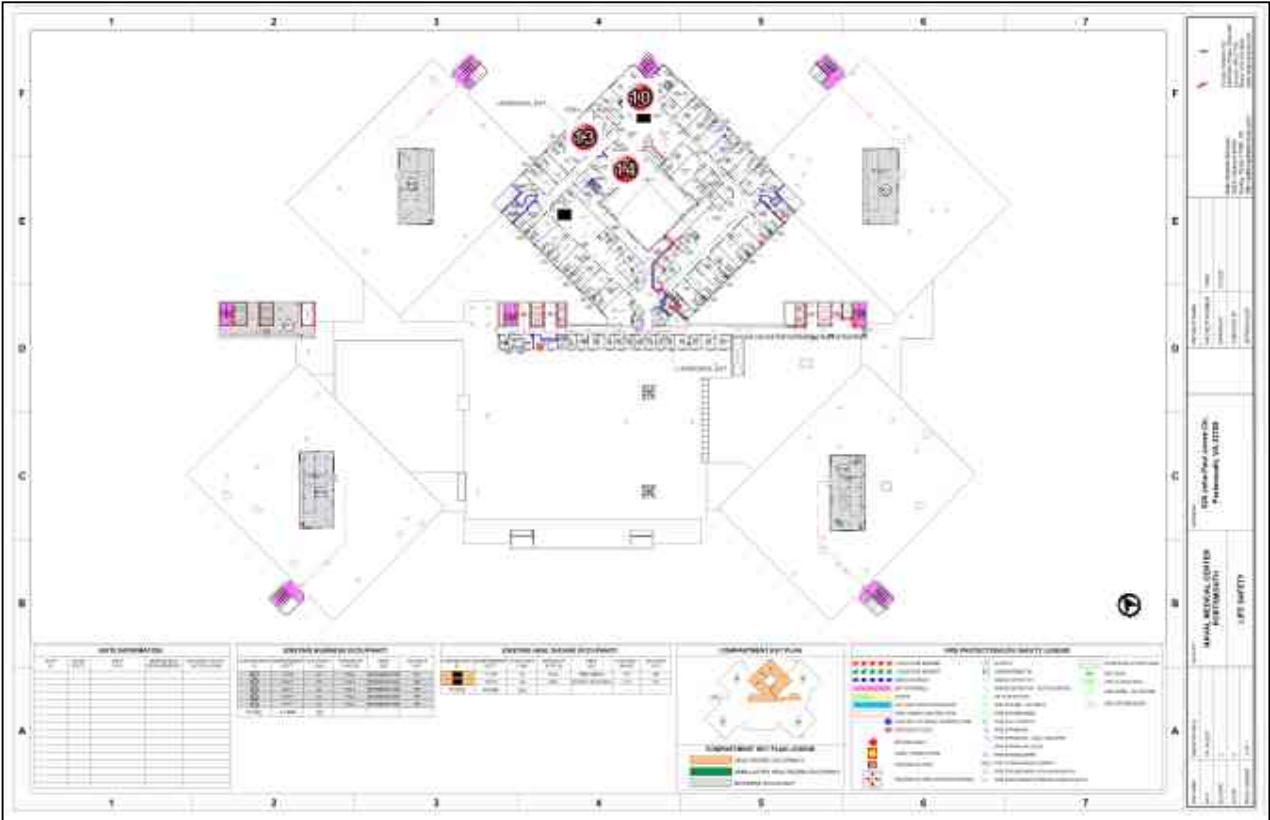
\*30691-4 OY3 #3 December 2023 / Building 2 / 5th Floor Bldg 2.

| Icon | Punch # | ID | Room Number | System | Inspection Type | Item | Type | Fire Rating | Wall Material | Action | Resource | Comments | Due | Type Comment | Created By | Priority |
|---|---|---|---|---|---|---|---|---|---|---|---|---|---|---|---|---|
| | 10 | 887507 | | | Area | Area Survey | Access Issue-Hard Lid Ceiling | | | Note | | | 2/20/24 | | JA | |
| | Note 2/20/24 2/20/24<br>Wall Direction 2/20/24<br>Room Number 531902 2/20/24 | | | | | | | | | | | | | | | |
