123 Example Address Avenue, Christchurch  
Building Report

22/04/2026

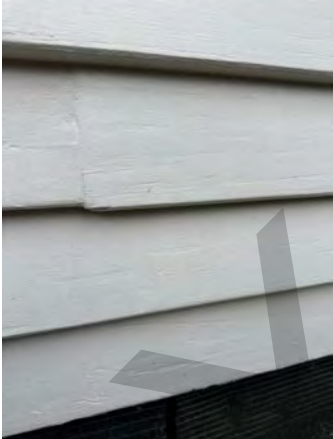
Split. Monitor this.

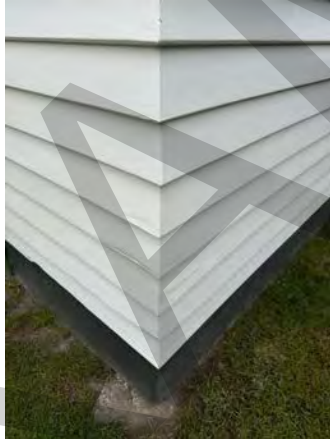
Close up example of typical weathering to boards throughout.

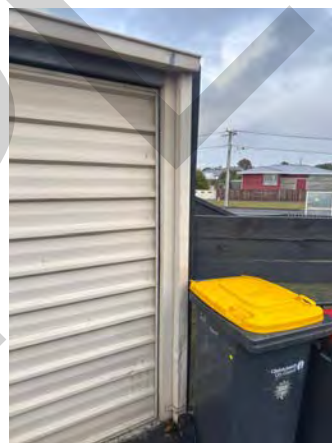
No garage door rebate or gutter. This makes the garage more susceptible to water tracking under the door.

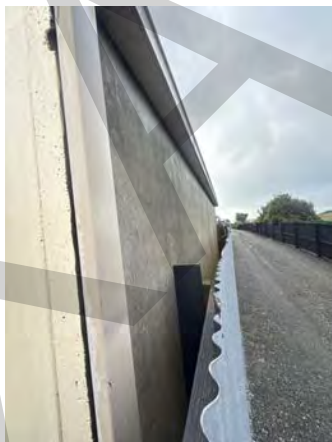
General denting to down pipe.

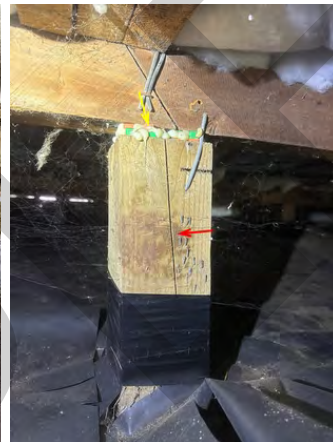
Split pile.

The original piles have been replaced throughout the sub floor with timber piles. Many of these have splits through them which is typical to occur to a certain extent; however many have severe splits or have been glued together. It is likely defective timber was used for some piles. These should be replaced or new piles fitted beside them. Some metal hardware strapping needs fitting or re-attaching noted in photos. We note that precast packers have been used to pack some piles. Best practice is to use H3.2 treated timber packers. Split or heavily notched bearers noted in photos should be professionally reinforced.

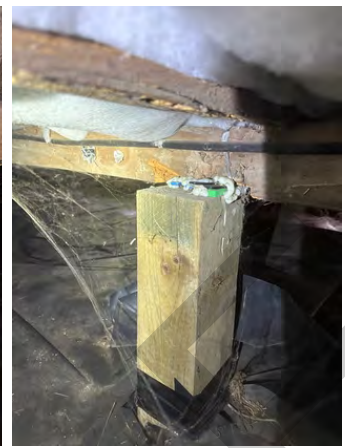
Bearers have been notched out quite far here.

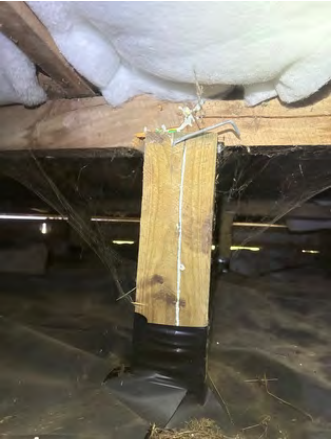
Pile not strapped in this side and not sitting properly under bearer.

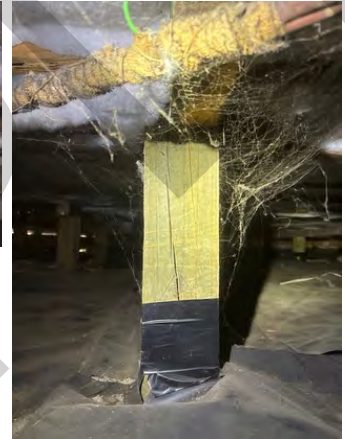
Reasonable split through to this bearer.

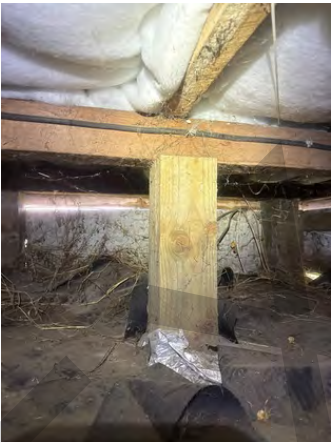
Monitor splitting on this pile.

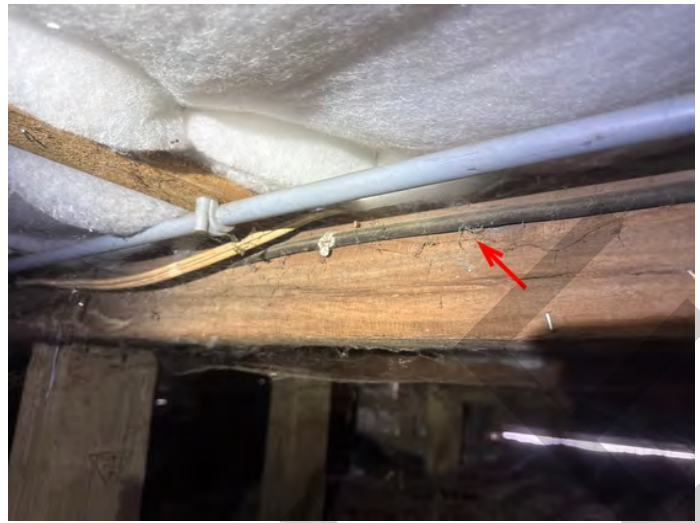
There is a combination of modern TPS and old wiring in the home; it is unknown if the old wiring is obsolete or not. Older wiring is prone to degrading and failure; a suitably qualified electrical specialist should confirm this.

Example - old non compliant power supply wiring.

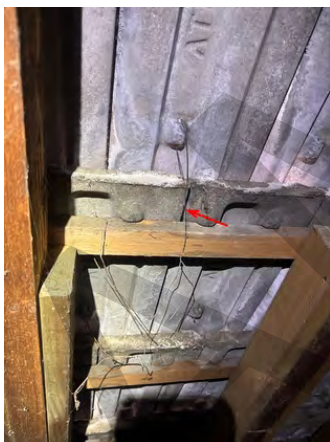
Vertical supports have been cut and reinforced.

All the roof rafters and verticals have been cut through throughout the roof for some reason, it is suspected that this house was relocated and this was carried out at that stage. These are structural elements that should not be cut through. These all appear to have been reinforced with additional timber however much of it is thin decking timber. Due to this being extensive, it is recommended that this be further inspected by a suitably qualified structural engineer to ensure that this is an acceptable solution. Many tile cladding metal ties have been detached and need re-attaching.

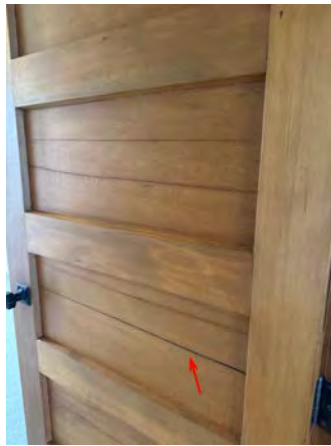
Some splitting to door panel. Striker plate has been notched out to a rough standard and the latch return on the handle is weak.
