# Plus Seven Inspect

## Plus Seven Inspection - SAMPLE REPORT

70345 Blue Ridge Mountain  
Tucson, Arizona, 85750

Inspection Type: Home Inspection

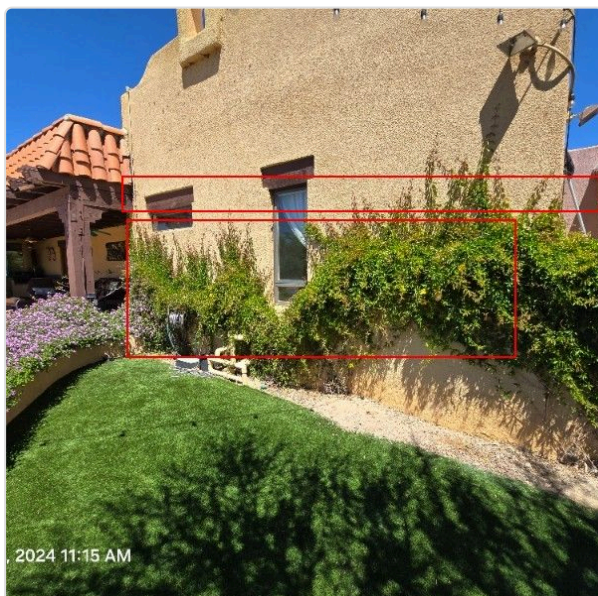
**Location:** NORTH SIDE OF STRUCTURE

## PRIOR STUCCO REPAIR NOTED

**Recommendation:** Contact the seller for more info

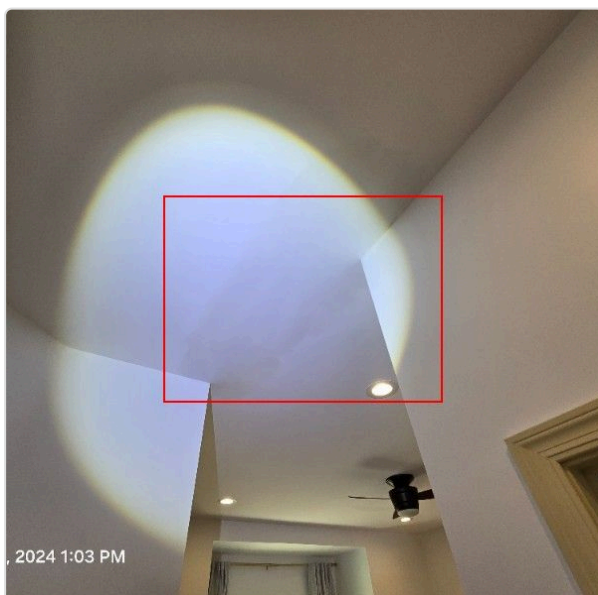
**Location:** GARAGE

## CEILINGINGS AND WALLS - WATER DAMAGE

**Recommendation:** Contact a qualified general contractor

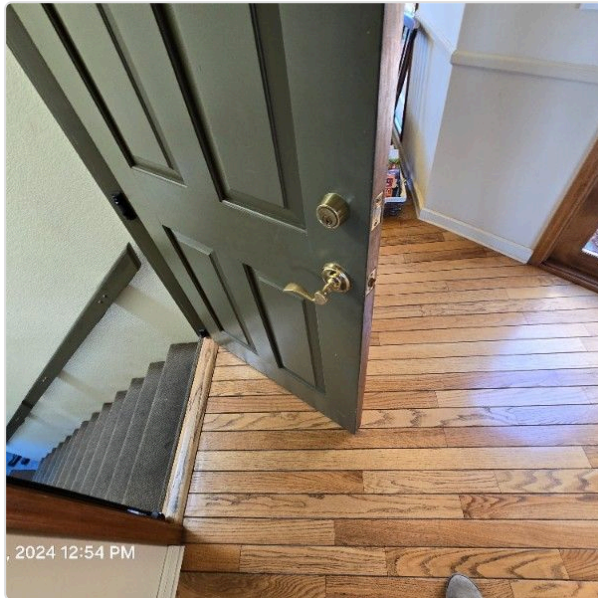
**Location:** SOUTHEAST SIDE OF STRUCTURE

## DOOR - SEALANT WEATHERING

**Recommendation:** Contact a qualified painting contractor.

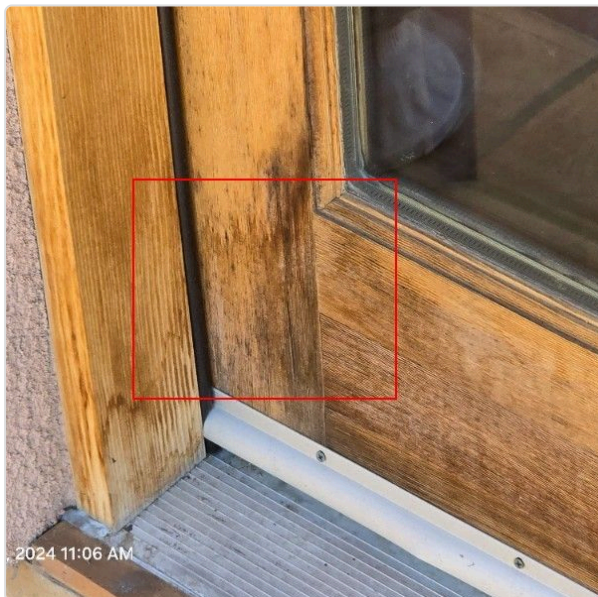
**Location:** SOUTH PATIO

## DOOR TO POOL - MISSING ALARMS / NO AUTO-CLOSE

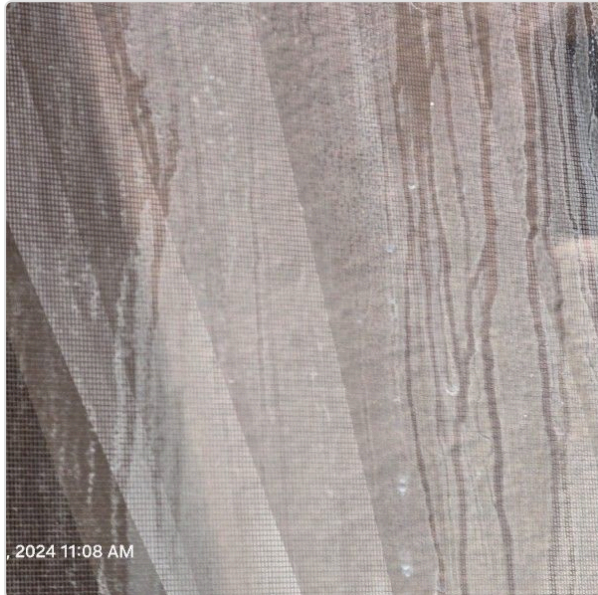
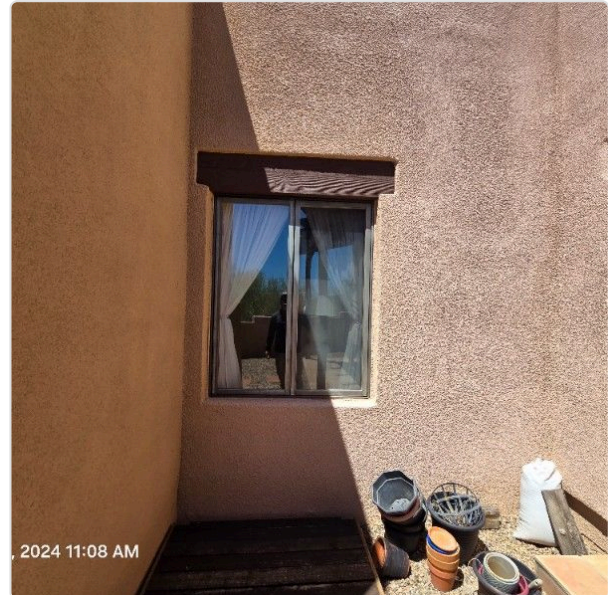
**Location:** NORTH BEDROOM

## WINDOW - WILL NOT OPEN

**Recommendation:** Contact a qualified general contractor.

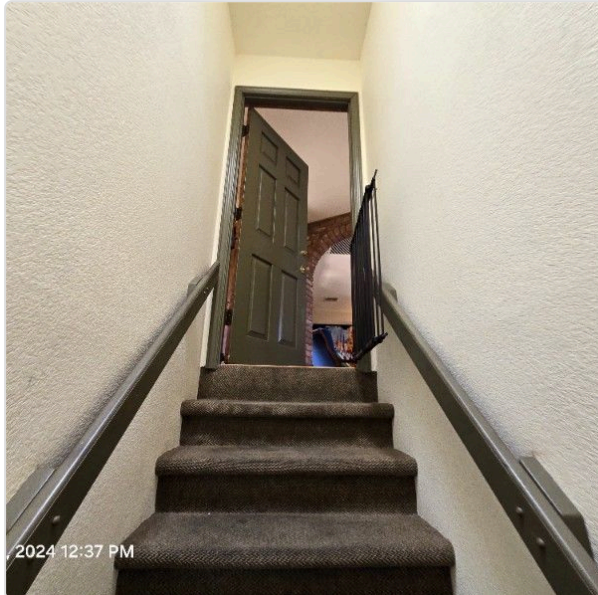
**Location:** GARAGE

## HANDRAIL - TOO LOW

**Recommendation:** Contact a qualified general contractor

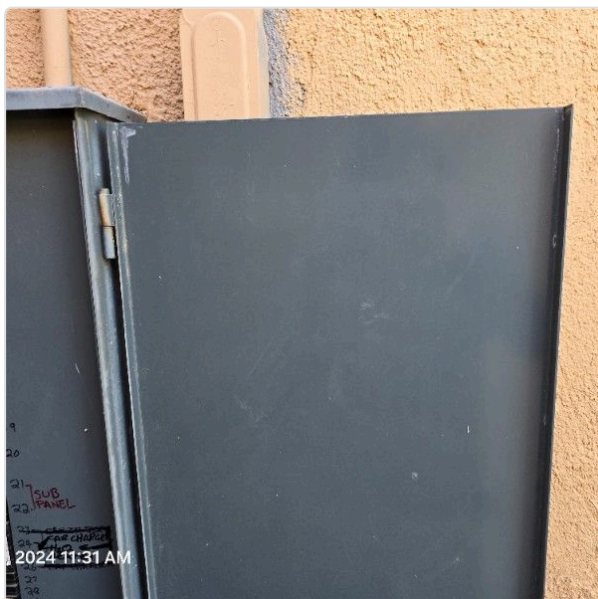
**Location:** MAIN PANEL - WEST SIDE OF STRUCTURE

## COVER - INCOMPLETE, INCORRECT, OR MISSING LEGEND

**Recommendation:** Contact a qualified electrical contractor

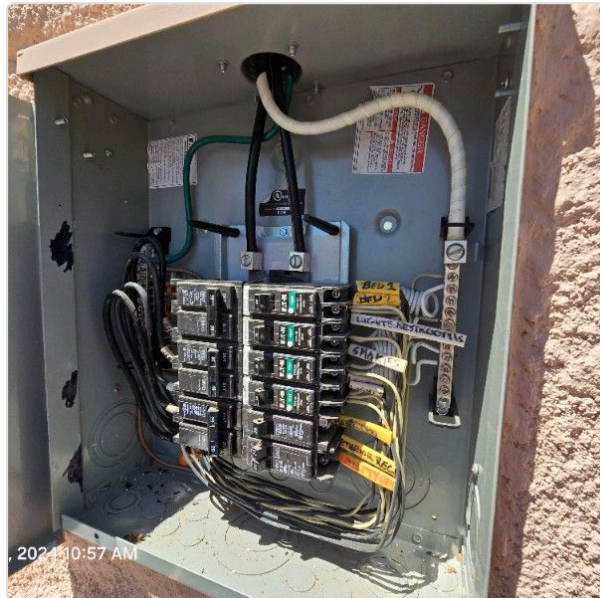
**Location:** EAST EXTERIOR - POOL PANEL

## UV DAMAGED WIRING

**Recommendation:** Contact a qualified electrical contractor.

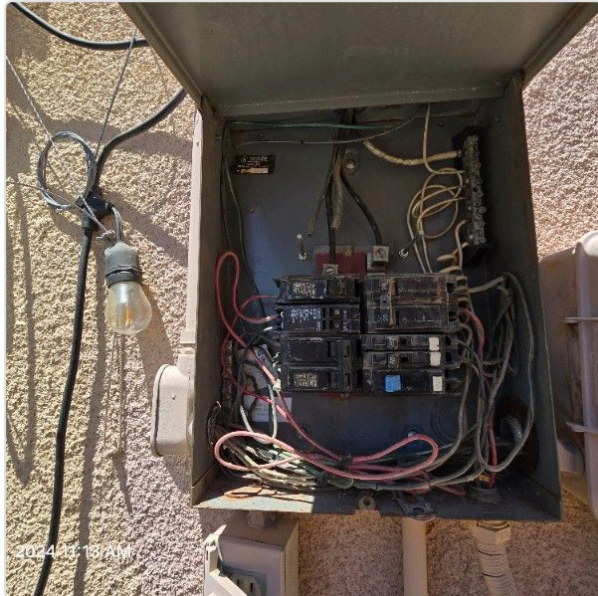
**Location:** EAST EXTERIOR - POOL PANEL

## PANEL - OPEN KNOCKOUTS

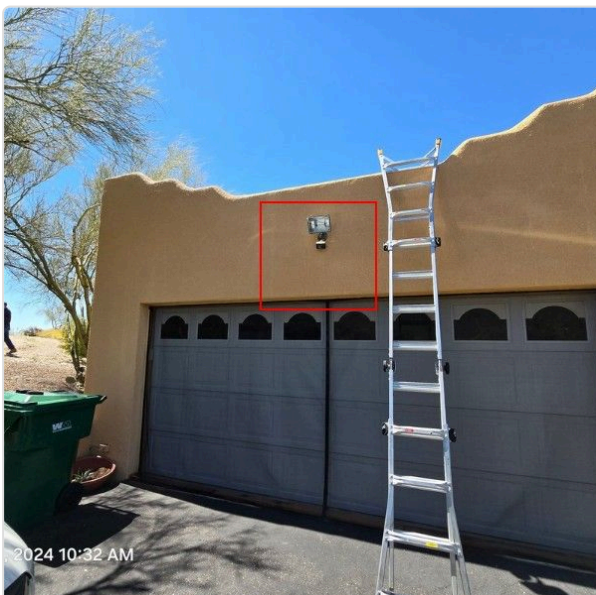
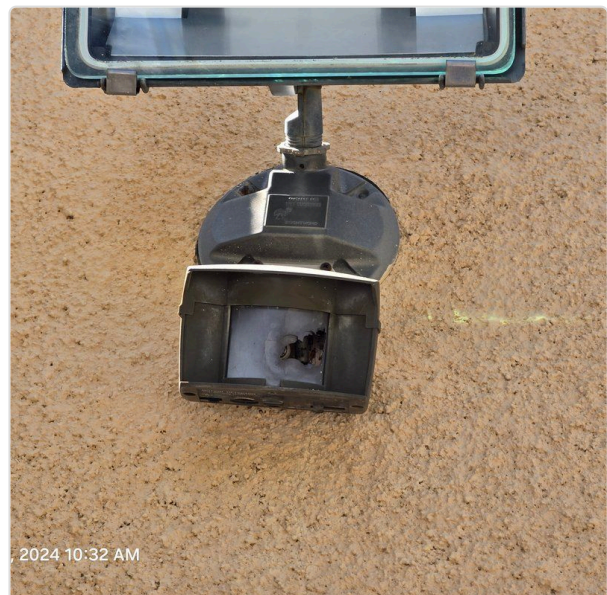
**Location:** GARAGE

## LIGHT(S) - NOT FUNCTIONAL / INOPERABLE

**Recommendation:** Contact a qualified electrical contractor.

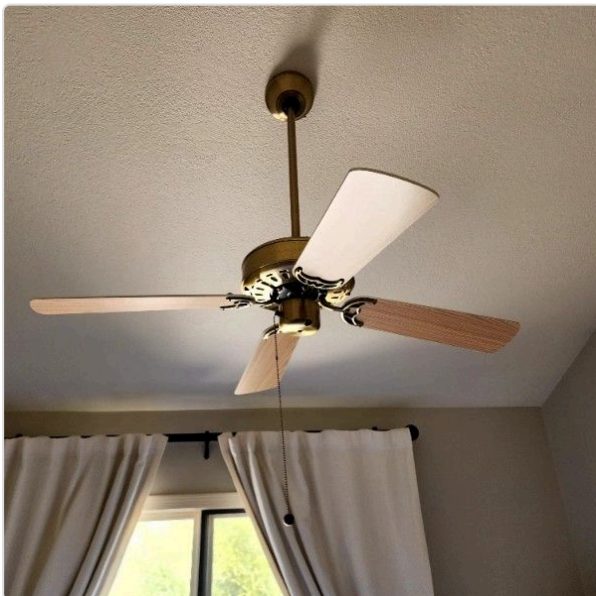
**Location:** LIVINGROOM DEN

## CEILING FAN - OUT OF BALANCE

**Recommendation:** Contact a handyman or DIY project

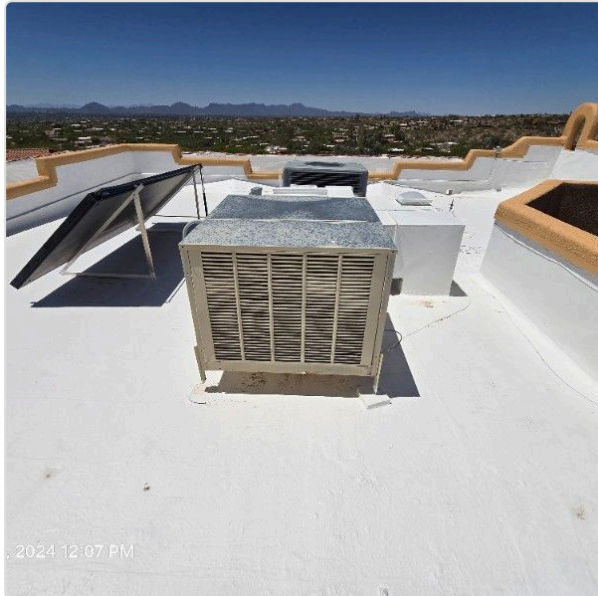
## EVAPORATIVE COOLER - MISSING SUPPORT

**Description:** Evaporative cooler support missing. Recommend installation of support or removal of evaporative cooler by a licensed roofing contractor to prevent water intrusion and deterioration of roof surface.

**Recommendation:** Recommend installation of support or removal of evaporative cooler by a licensed roofing contractor to prevent water intrusion and deterioration of roof surface.

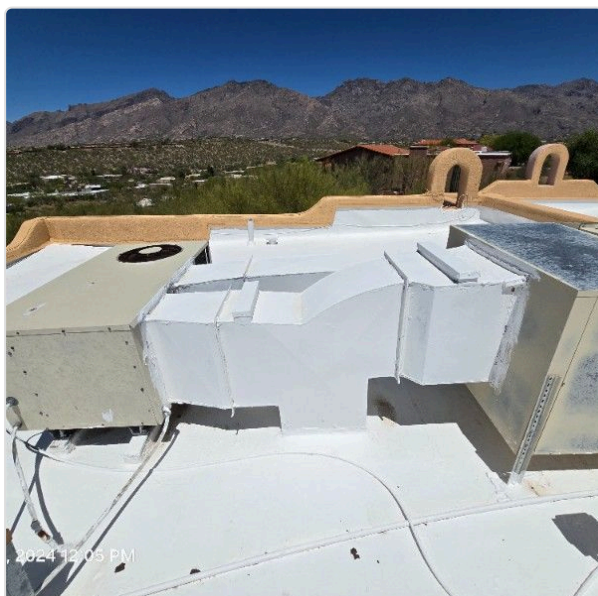
**Location:** ROOF

## DUCT - ROOF DUCTING REQUIRES FURTHER REVIEW

**Recommendation:** Recommend further evaluation by a licensed HVAC professional to confirm conditioned air is not escaping the system.

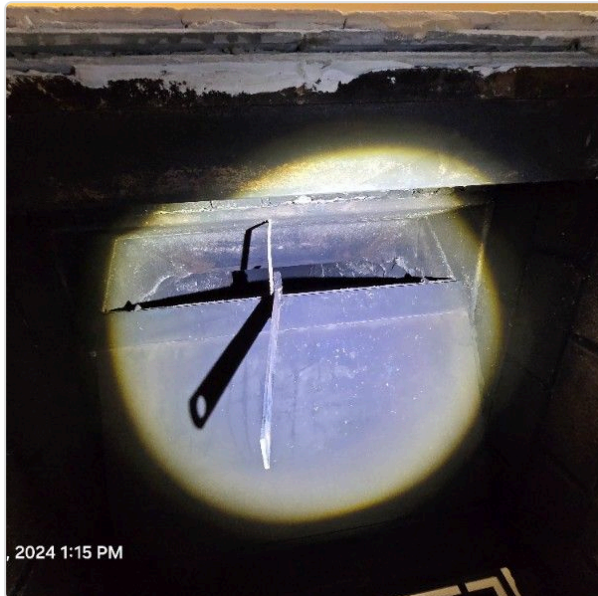
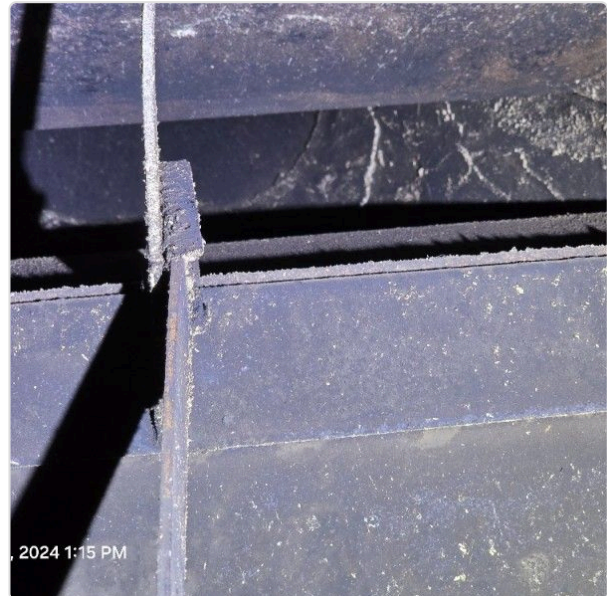
**Description:** Debris build up noted in the fire place and flue. Recommend a licensed contractor evaluate for removal/repair.

**Recommendation:** Contact a qualified chimney sweep.

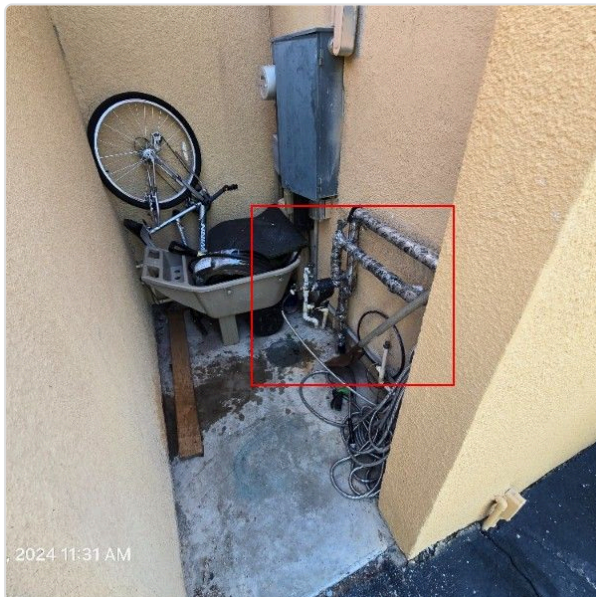
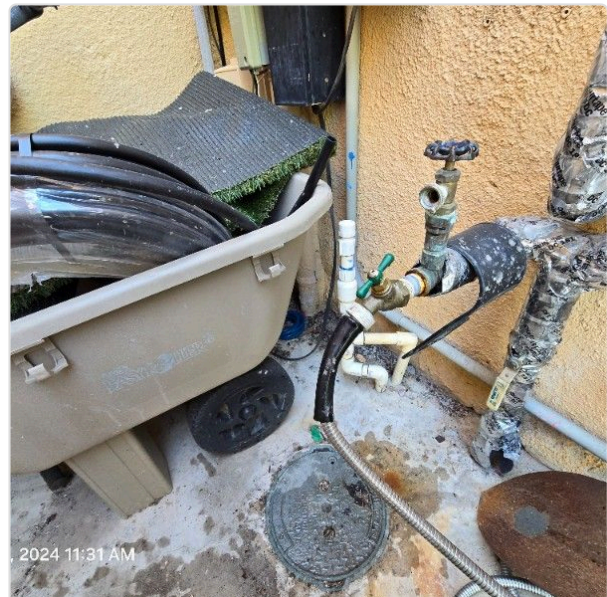
### WATER LINE - CORROSION

**Description:** Corrosion noted on an exterior plumbing lines or fittings. Corrosion may eventually compromise the plumbing and leak. Recommend a licensed contractor evaluate for repair.

**Recommendation:** Contact a qualified plumbing contractor.

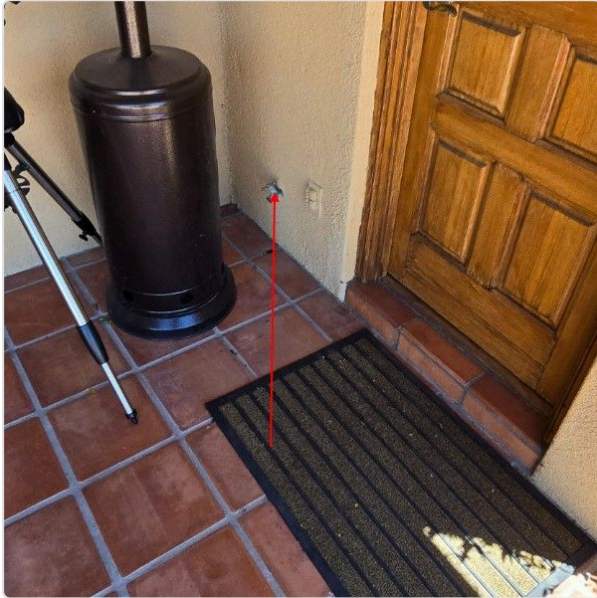
**Location:** SOUTH PATIO

## NO SERVICE

**Description:** No water service noted at one or more exterior faucets. Recommend a licensed contractor evaluate for repair.

**Recommendation:** Contact a qualified plumbing contractor

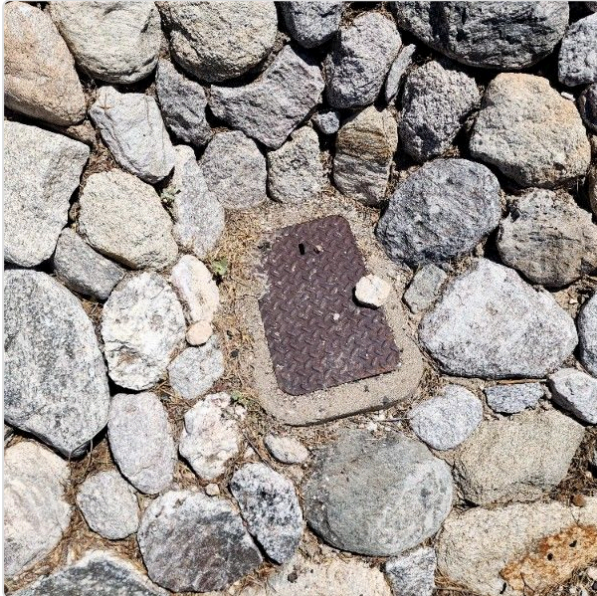
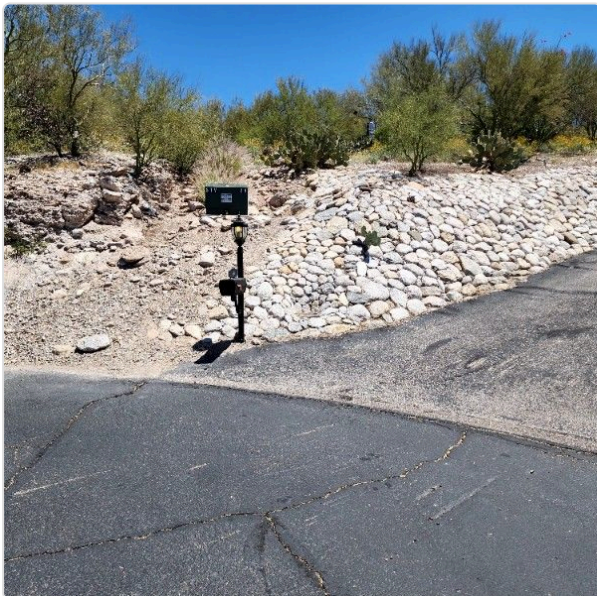
**Description:** The main water shutoff valve was buried and not accessible. Recommend removing dirt and exposing the valve to allow quick shutoff in the event of an emergency. Due to the inaccessibility of the water meter display, we are unable to observe the water meter to identify potential leaks that could not be discovered from visual inspection. Recommend excavation of the water meter and observation of the display to confirm integrity of property's water supply lines.

**Recommendation:** Contact a handyman or DIY project

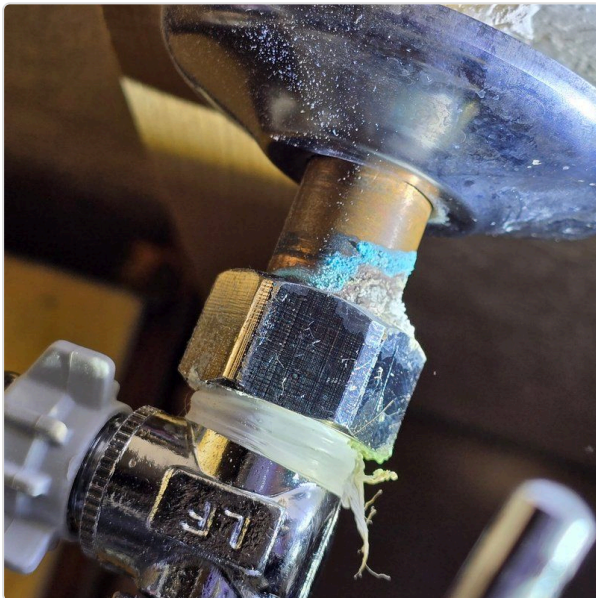
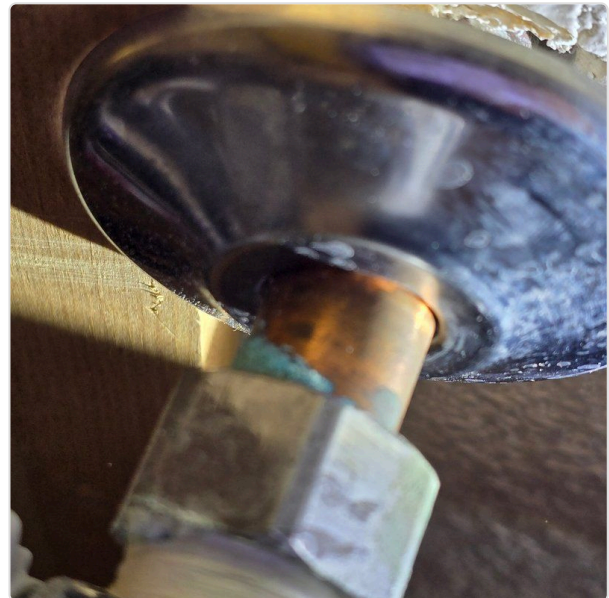
### Corroded and Leaking Angle Stops in Hall Bathroom

**Description:** Angle stops in the hall bathroom exhibit signs of corrosion and leakage. There are indications of a leak behind the fixture, and corrosion is present on the upper parts. Similar components throughout the house may be affected.

**Recommendation:** Evaluate all angle stops in the house for condition and replace as necessary to prevent leaks and further corrosion.

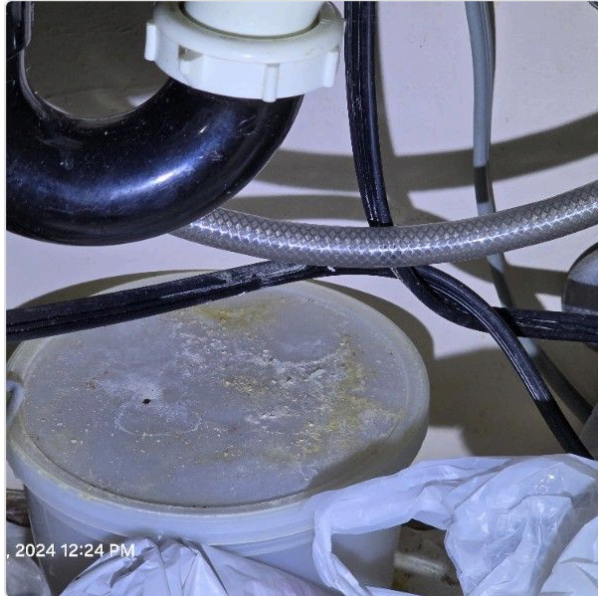
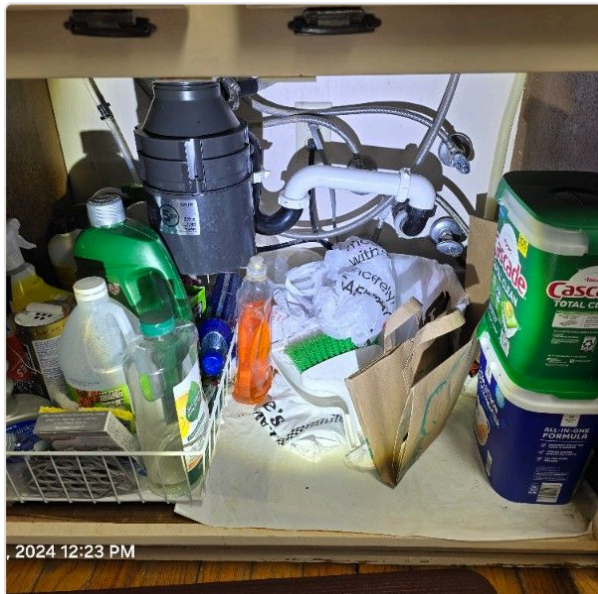
**Location:** KITCHEN

## PLUMBING - INDICATIONS OF PREVIOUS LEAK

**Description:** There are indications of a previous leak. No active leaking was noted at the time of the inspection.

**Recommendation:** Contact a qualified plumbing contractor

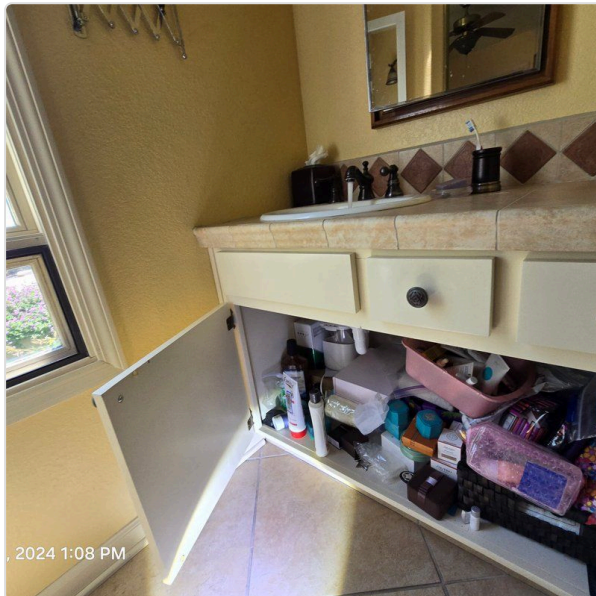
**Location:** His-and-Hers Bathroom

## Significant Buildup on Angle Stop

**Description:** There is significant buildup observed on the angle stop in the his-and-hers bathroom, which may affect water flow or valve operation.

**Recommendation:** Recommend cleaning and inspection of the angle stop to assess for corrosion or blockage and replacement if necessary to ensure proper function.

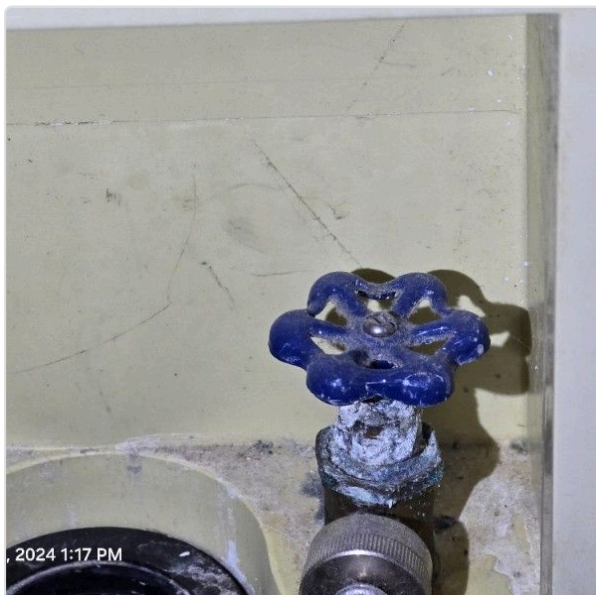
**Location:** LAUNDRY

## PLUMBING - CORROSION/BUILDUP

**Description:** Parts of the plumbing fittings have evidence of corrosion or build-up. Recommend correction to prevent future water leaks. Handle on hot water supply damaged.

**Recommendation:** Contact a qualified plumbing contractor.

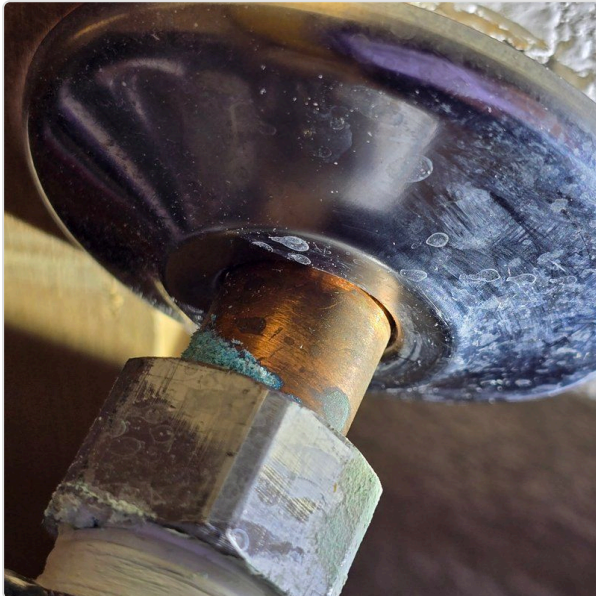
**Location:** Hall Bathroom

## Corroded and Leaking Angle Stops in Hall Bathroom

**Description:** Angle stops in the hall bathroom exhibit signs of leakage and corrosion. Similar components throughout the house may also be affected.

**Recommendation:** Evaluate all angle stops in the house for condition and replace as necessary to prevent leaks and further corrosion.

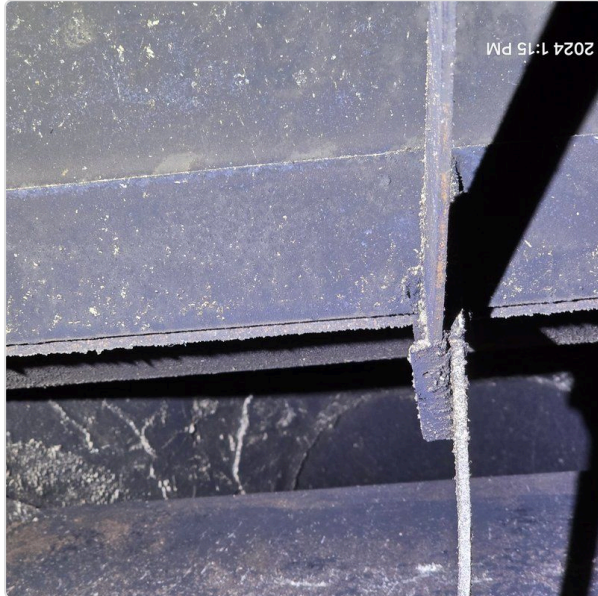
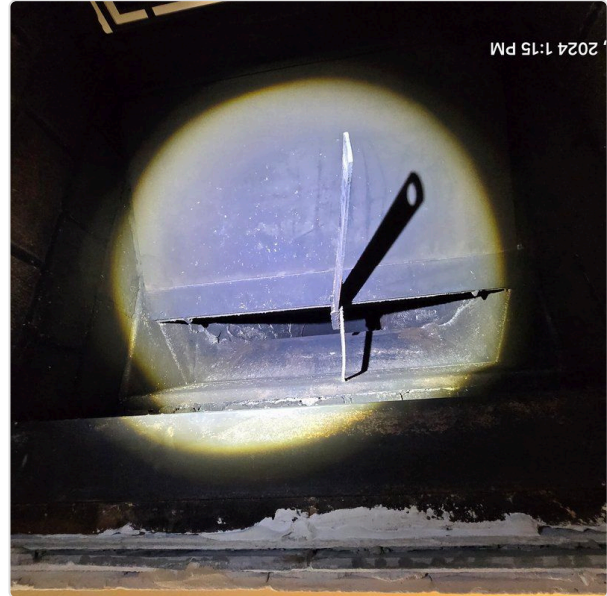
**Laundry Ventilation (Dryer Venting) Condition:** Observations noted on the condition of the laundry ventilation below. All other visible areas of the laundry ventilation appeared satisfactory and functional.

**Recommendation:** Inspect and service the laundry vent to restore proper function and ensure unobstructed airflow.

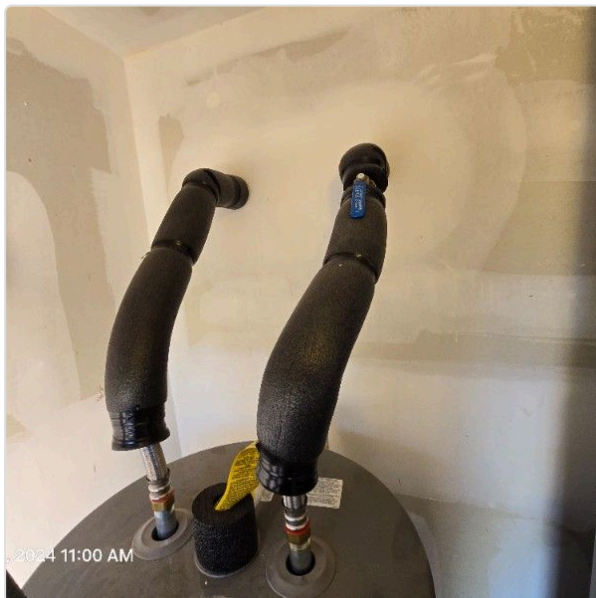
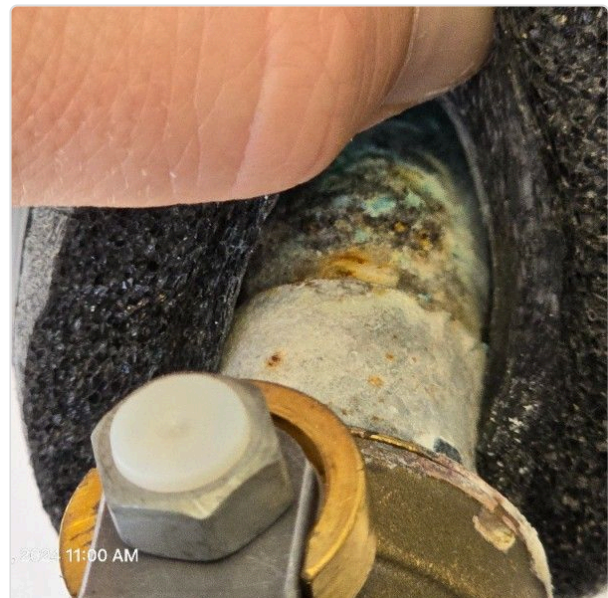
### WATER HEATER PLUMBING - CORROSION BUILD UP / POSSIBLE LEAK

**Description:** Corrosion build up noted along the water heater plumbing lines and/or fittings. Recommend a licensed contractor evaluate for repair/replacement.

**Recommendation:** Contact a qualified plumbing contractor.

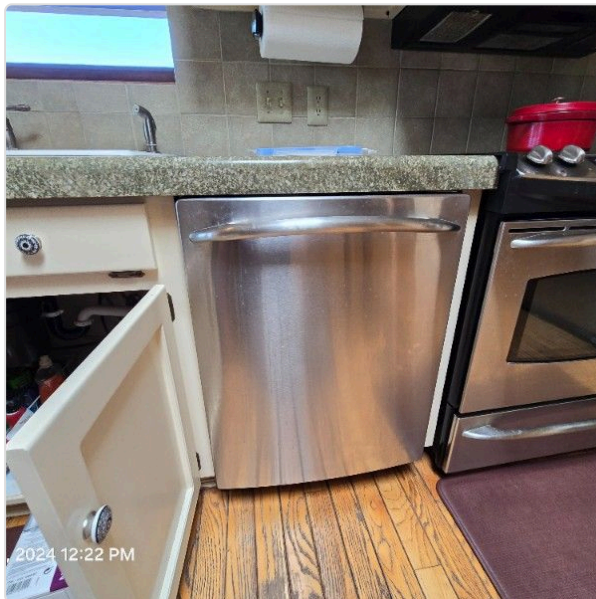
**Description:** The dishwasher is not mounted to the cabinets/counter tops. Recommend securely mounting the dishwasher so the unit does not move when the door is being operated.

**Recommendation:** Contact a qualified handyman.

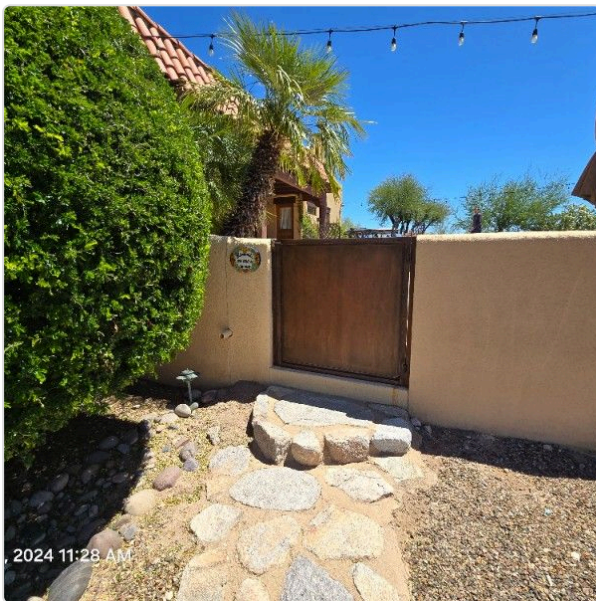
**Description:** The fence and gate around the pool may not meet the safety requirements for the local jurisdiction. Recommend further review to determine if fence and gate are compliant

**Recommendation:** Contact a qualified fencing contractor
