## PROJECT PROFILE

# WL 16

### CATTLE DAMAGED SITE

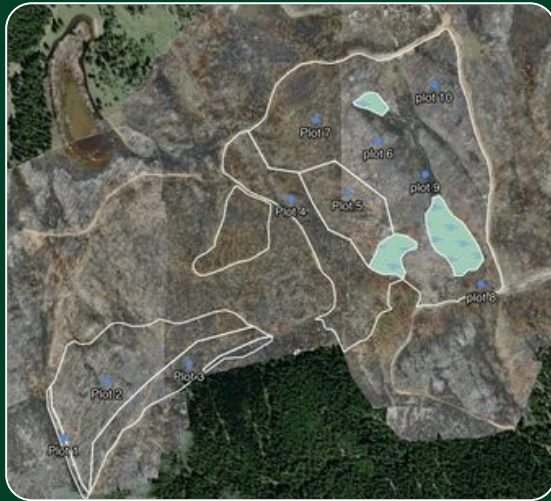
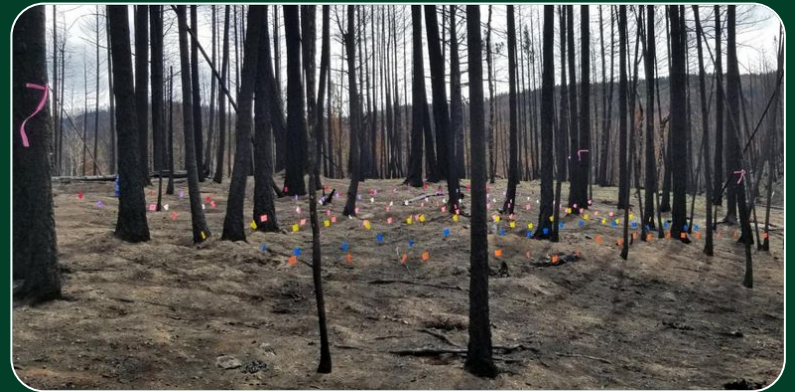
*Permanent (flagged) plot distribution across the block.      Flagged pod rows across the burned, south-facing block.*

In the first year, seven plots of flagged rows were distributed across WL1601 with pods planted directly adjacent to flags. These permanent plots allowed us to assess early germination rates in a south-facing block, as well as test the performance of embedded vs dropped pods and the relative success of the planted species. We used a sampling density of roughly 1 plot / 3 hectares for this site.
