## Baseline Assessment – Stream Attributes

**Reach S-H25 (Timber Mat Crossing)**

**Spread I**

**Franklin County, Virginia**

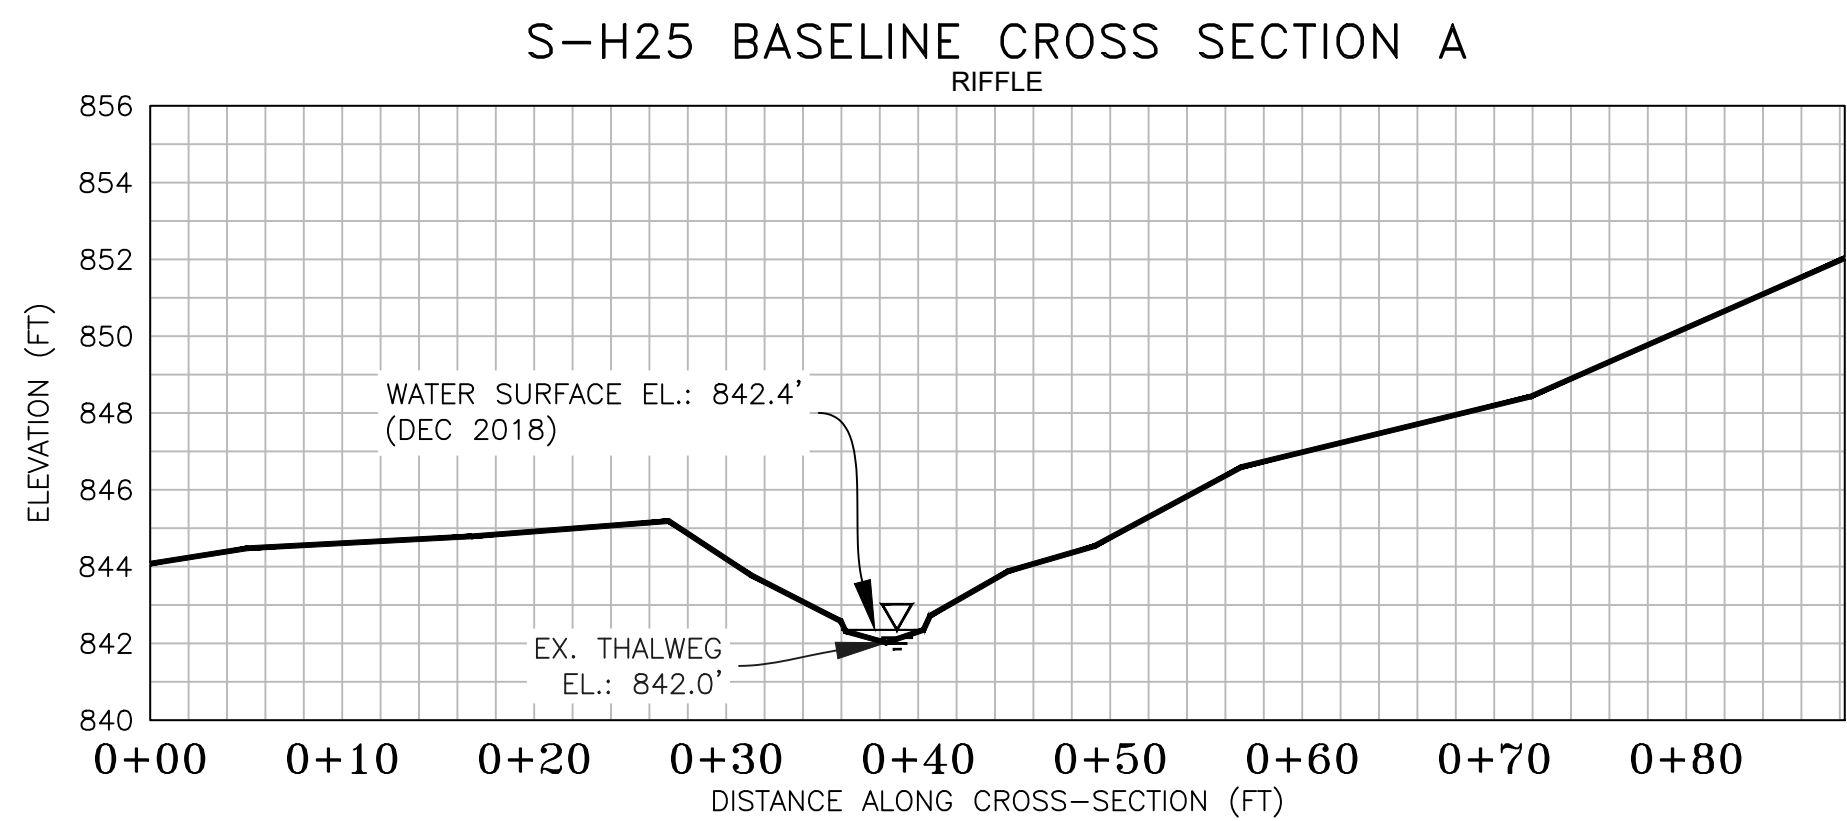
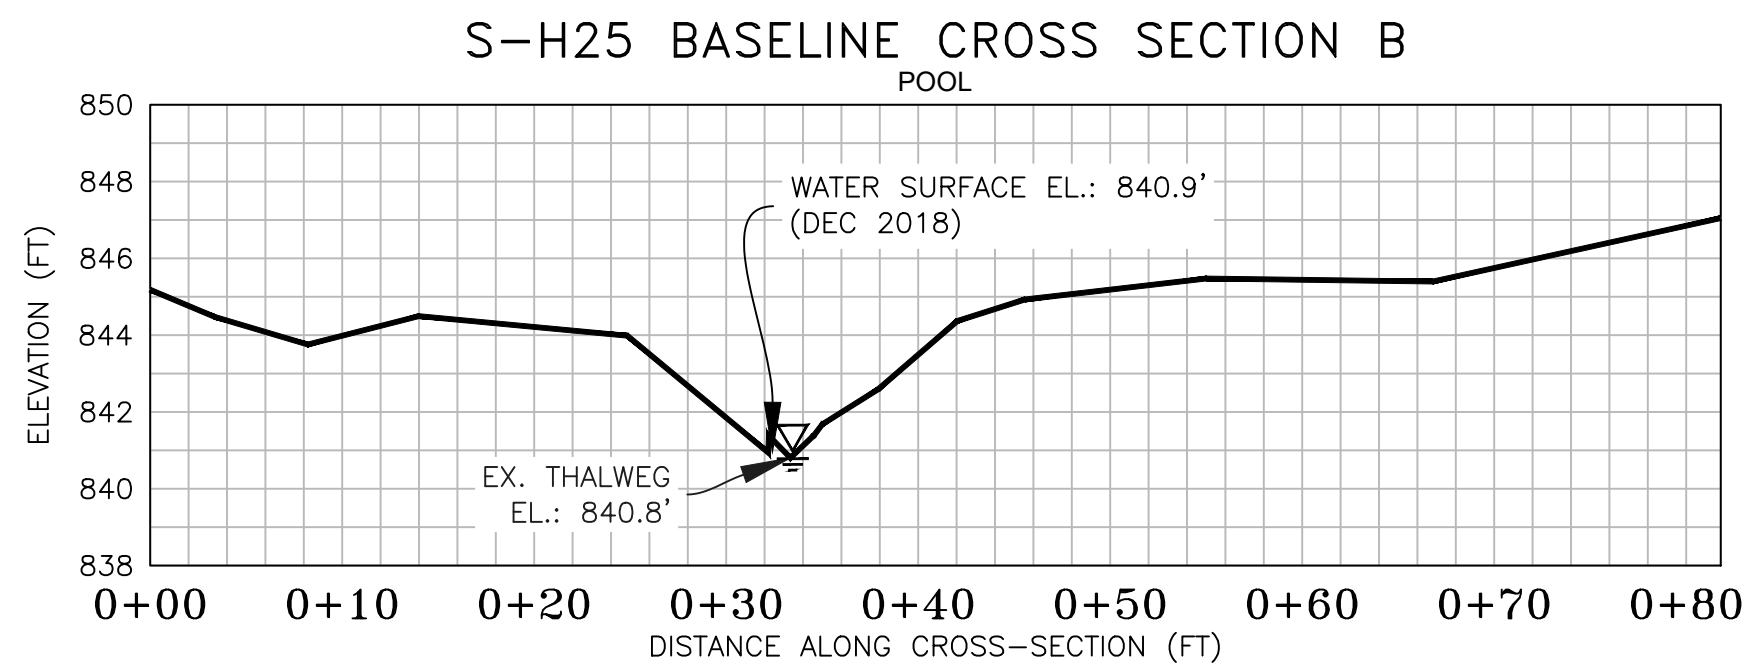
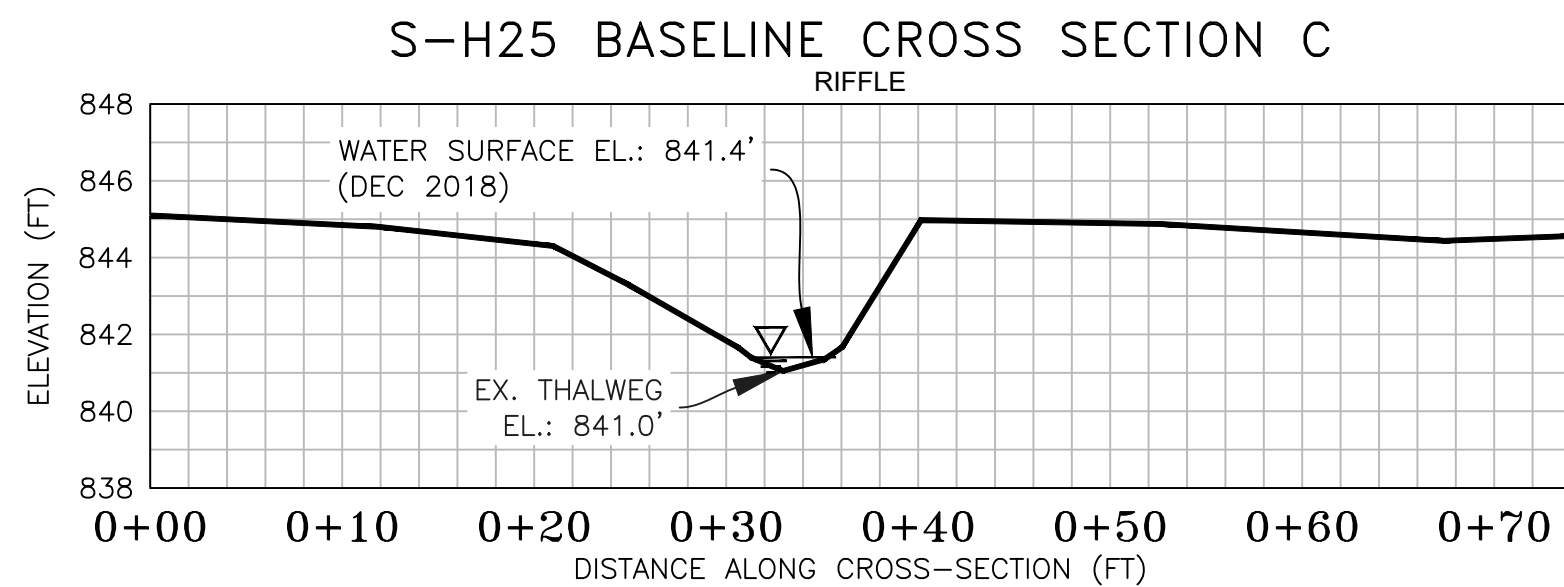
1. This map has been oriented to NAD 1983 UTM Zone 17N, and vertically to The North American Vertical Datum of 1988 (NAVD 88), using a Real Time Network (RTN) GPS. Field locations were completed on December 3, 2018.
2. Monumentation, including traverse stations and fly points, shown on this drawing should be used to orient any future boundary, topographic, or location survey.
3. Easement lines shown on plan view were provided by Mountain Valley Pipeline (MVP).
4. WSSI Contour Interval = 2.0'. Contours within the channel were interpolated using stream channel breaklines (i.e. top of slopes, toe of slopes, thalweg) and cross-sectional points. Contours outside the channel were interpolated using cross-sectional spot shots.
5. All section views shown are left to right facing downstream.
6. Cross-section B shot at location of pipe centerline (based on best professional judgement).
