Wetland Biological Conditions EA Report

| Project Name | H-600 Pipeline Spread E | A/E | 124300134 | Spread | H-600 Pipeline Spread E | |
| Wetland ID | W-M20 | Crossing Start Date | 10/4/2023 | Crossing Completion Date | 10/18/2023 | |

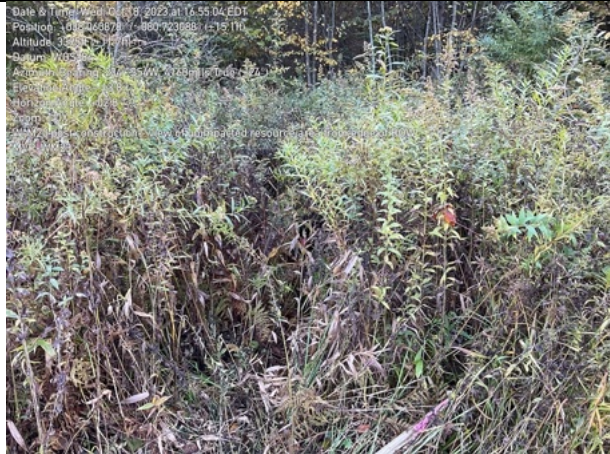
| <p>Pre-Construction Notes</p> <p>Pre-Construction Meeting - 9/18/2023</p> <p>17. Surface water, soil saturation and groundwater recharge observed in soil test pit (Photo 1).</p> <p>10/04/2023 - Contractor developed plans to minimize the impact to the permitted impact area of the wetland resource; however, due to its proximity to the centerline wetland topsoil was removed (Photo 2) Soil segregated and stored in upland area (Photo 3). Resource protected from on-going activities with the installation of P1 fencing (Photo 4).</p> <p>10/05/2023-10/17/2023 - Minimization measures were successfully implemented and other than topsoil removal, wetland resource was not disturbed (Photos 5 and 6). Trenching, hammering, bedding installation, pipe installation, welding, x-ray, sandblasting, coating, the construction of trench breakers, and the backfilling of the trench were all ongoing outside of aquatic resource during this timeframe.</p> <p>10/18/2023 - Wetland topsoil restoration (Photo 7). Survey of elevation and boundary was completed. Seed applied to resource (Photo 8). Silt sock installed around perimeter of the restored wetland resource.</p> <p>Post Construction Notes</p> <p>17. Water did not recharge in post construction test pit.</p> <p>18. Crossing and riparian areas have been recently restored. These areas will be monitored until 80% vegetative coverage has been achieved and areas that do not have 80% vegetative cover within 30 days will be reseeded.</p> <p>Trenching did not occur in resource so Condition Nos. 1, 4, 6, 9, and 10 do not apply.</p> | | | | | |

| <p>Date & Time: Mon 04/10/2023 at 09:59:27 EDT Position: +088.060928 W -060.723722 N (+18.3N) Altitude: 339.0 (+18 ft) Datum: WGS84 Azimuth Bearing: 003.0 (+0.0002 miles True) Elevation Angle: -15.7 Horizon Angle: -01.0 Zoom: 1.0 Pre-construction soil test pit and profile MVP-W-M20</p> | | <p>Date & Time: Mon 04/10/2023 at 10:01:10 EDT Position: +088.060928 W -060.723722 N (+18.3N) Altitude: 339.0 (+18 ft) Datum: WGS84 Azimuth Bearing: 003.0 (+0.0002 miles True) Elevation Angle: -15.7 Horizon Angle: -01.0 Zoom: 1.0 At edge of LOD, view of unimpacted resource area conditions during pre-construction assessment MVP-W-M20</p> | | <p>Date & Time: Wed 04/19/2023 at 16:55:04 EDT Position: +088.060928 W -060.723722 N (+18.3N) Altitude: 339.0 (+18 ft) Datum: WGS84 Azimuth Bearing: 003.0 (+0.0002 miles True) Elevation Angle: -15.7 Horizon Angle: -01.0 Zoom: 1.0 At edge of LOD, view of unimpacted resource area conditions during post-construction assessment MVP-W-M20</p> | |
