**Title: Impact testing a sample of stone cladding for Riverside Drive, Dundee**

**Certificate of Test Number: 30239**

This certificate of test describes impact tests carried out at the request of TI Tiles International on 16/17 March 2021 at VINCI Technology Centre, Leighton Buzzard.

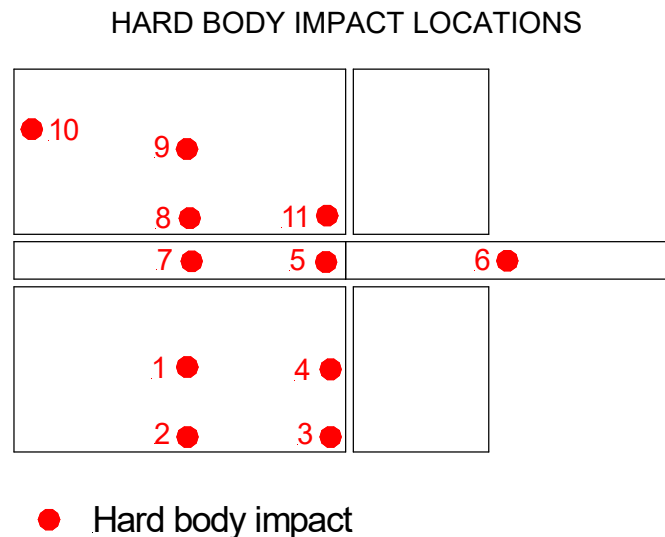
FIGURE 1

Location	Impact energy (Nm)	Observations	Classification
1	6	No damage	Class 1
2	6	Minor indent	Class 1
3	6	No damage	Class 1
4	6	No damage	Class 1
5	6	Minor indent	Class 1
6	6	Vertical crack – still secure	Class 3
7	10	Vertical crack – 41 g fragment	Low risk
8	10	No damage	Negligible risk
9	10	Minor indent	Negligible risk
10	10	No damage	Negligible risk
11	10	Corner fragment – 42 g	Low risk

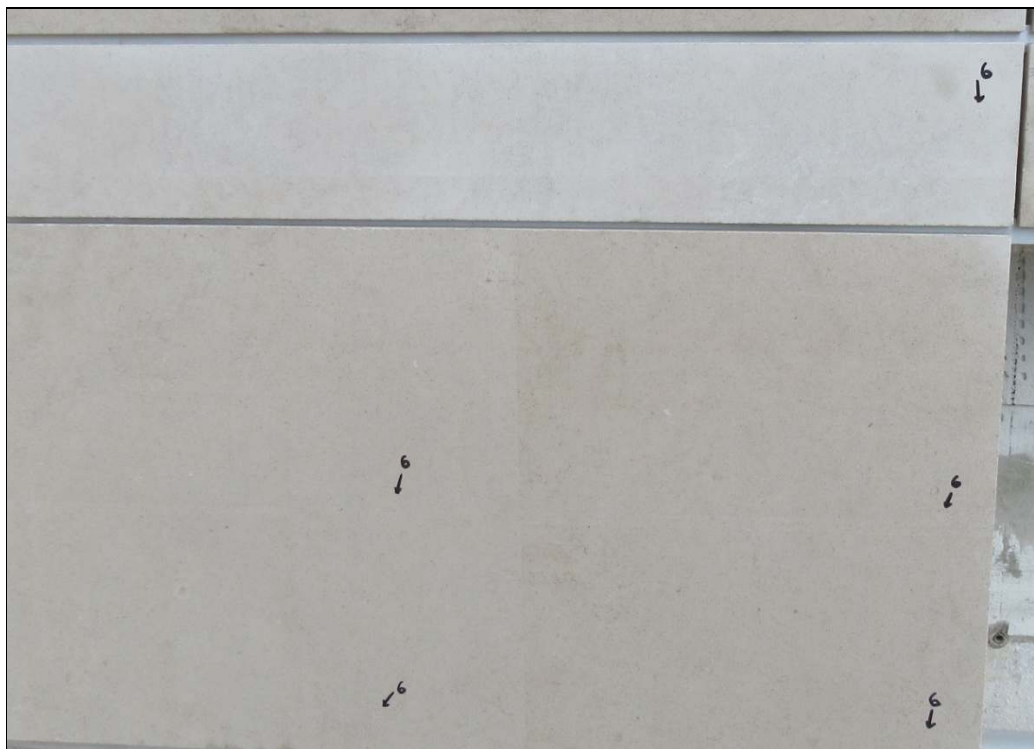
PHOTO 7213

HARD BODY SERVICEABILITY IMPACTS

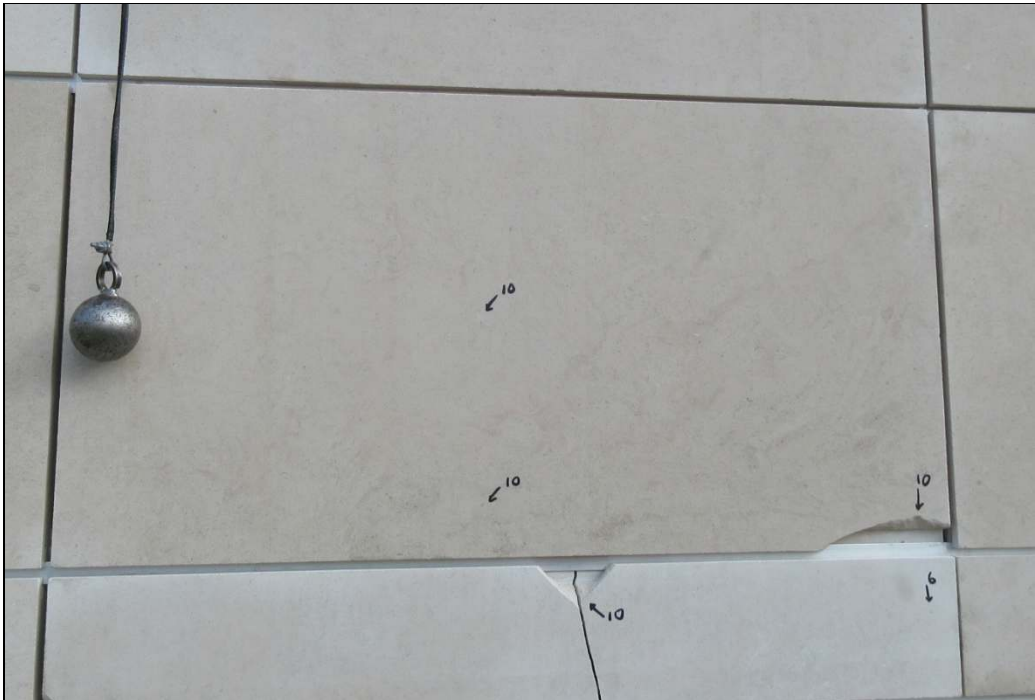
PHOTO 7223

HARD BODY SAFETY IMPACTS

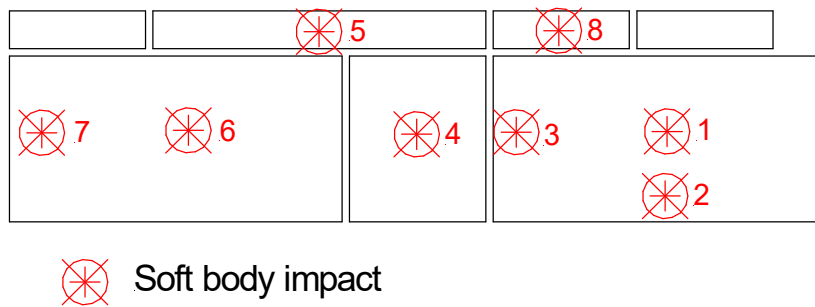
FIGURE 2

SOFT BODY IMPACT LOCATIONS

Location	Impact energy (Nm)	Observations	Classification
1	120 x 3	No damage observed	Class 1
2	120 x 3 350	No damage observed 48 g corner fragments	Class 1 Low risk
3	120 x 3	No damage observed	Class 1
4	120 x 3 350	No damage observed Edge fragments 62 g	Class 1 Moderate risk
5	120 x 3 350	No damage observed Vertical crack	Class 1 Low risk
6	350	No damage observed	Negligible risk
7	120 x 3 350	No damage observed 38 g corner fragments	Class 1 Low risk
8	350	No damage observed	Negligible risk
