August 30, 22

# Hayes Manor House

*Edenton, Chowan County North Carolina*

## Site Visit Report

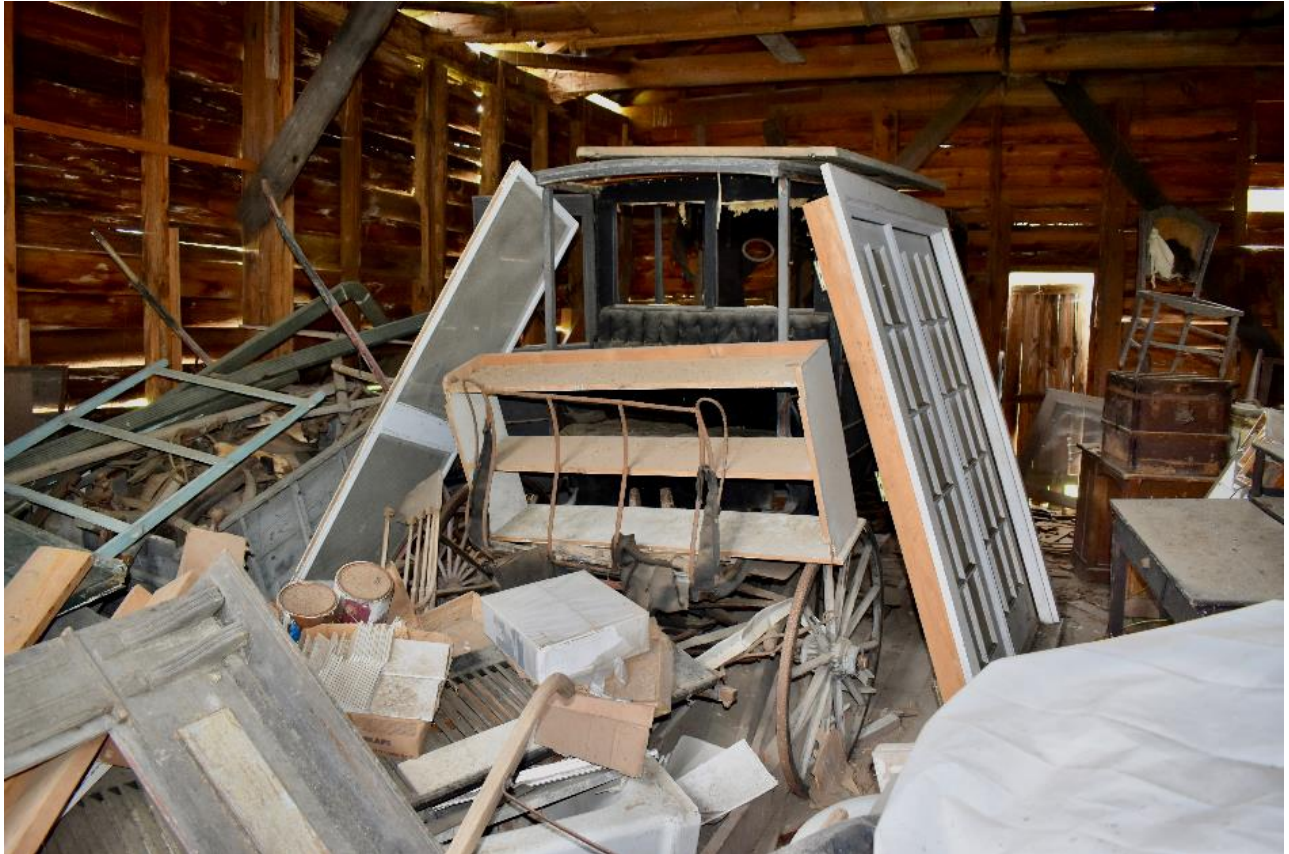
Fig. 32. Traveling Carriage

The roof has been leaking long enough in the area adjacent to the carriages to cause extensive decay to structural framing members. We recommend that the historic artifacts including the traveling carriages (fig. 32), farm wagons be moved to a secure storage location until the carriage house can be repaired. A restoration contractor/carpenter who has extensive experience with timber-frame buildings, of similar age, should be hired to perform repairs and/or stabilization work to secure this early nineteenth century building.

*1 Traveling Carriage, large & old (likely the one illustrated in Figs 32 & 33)*

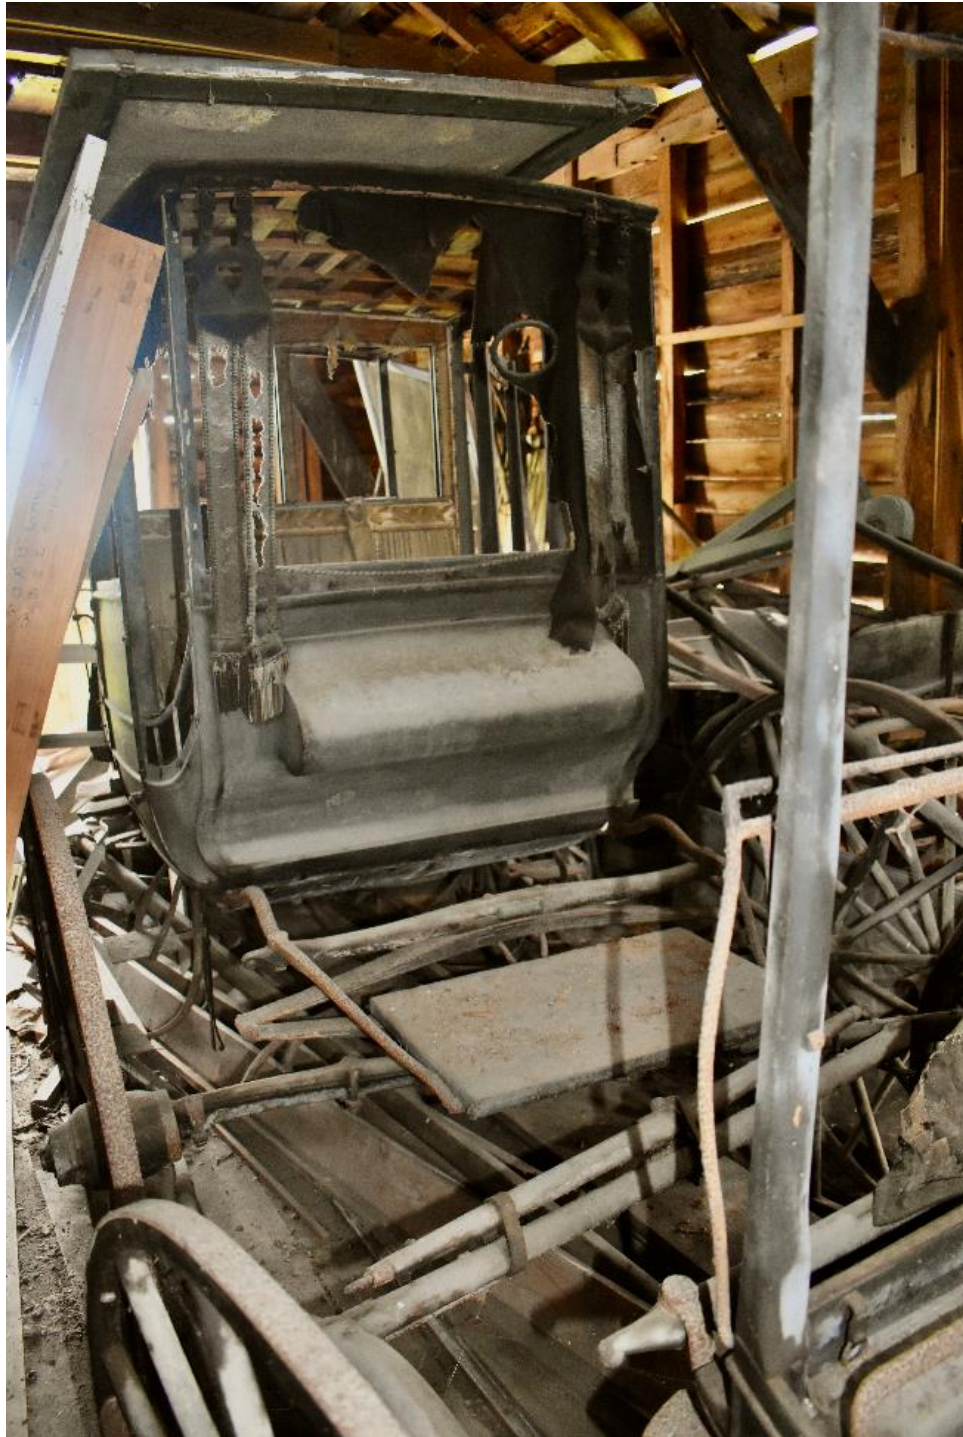
Fig. 33. Traveling Carriage

Listed in the Inventory for the “*Manor Farm-Hayes [ca. 1866]*” “*Riding & Pleasure Vehicles*” are two traveling carriages. The large carriage may be the one noted as “old” during the 1866 inventory (fig. 33)>
