ST PETER'S CHURCH, GRANDBOROUGH

## REPORT ON THE CLEANING AND CONSERVATION OF THE 1849 REREDOS

## Report on the Cleaning and Conservation of the 1849 Reredos

September 2025

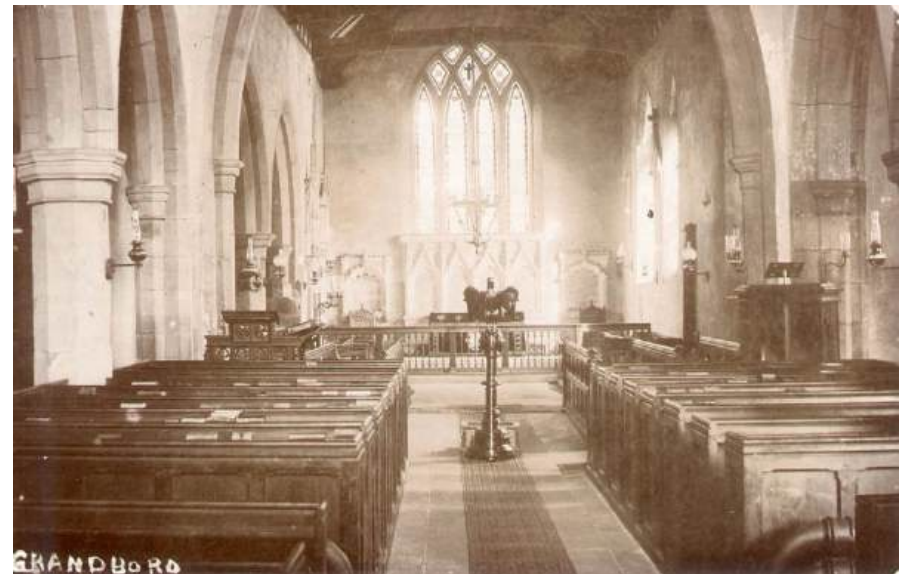
<sup>1</sup> Interior of St Peter's Church, Grandborough, looking east. 1910s Image Location: (Warwickshire County Record Office)

When first executed the Gothic Revival reredos would have provided an impressive focal point at the end of the chancel as seen in the black and white photograph<sup>1</sup> (*right*) taken c 1910. Located on the east wall and rather hidden behind a large later altar the reredos had become somewhat neglected. Sadly the paint layers had been damaged by humidity over time and both the texts and the surrounding stonework required cleaning, conservation repair and restoration of lost and damaged detail.

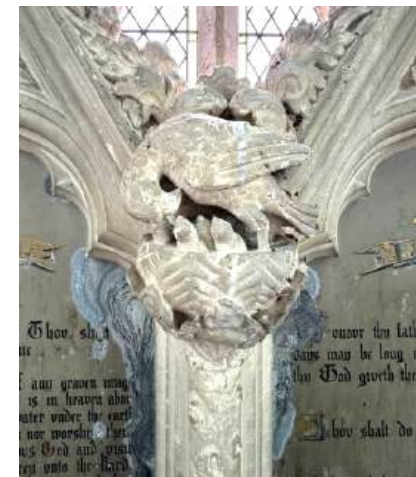
The reredos had suffered damage due to minor localised structural movement, there were cracks beneath both the northernmost and southernmost panels of the east window (see *photo upper right*), and an apparent forward movement at the top had resulted in cracking to the front of the uprights in places (see *photo below right*). The reason for the forward movement was thought to be corrosion of iron cramps within the structure. On dismantling the reredos the cramps became evident, with the expansion of the rusting iron exerting pressure on the stonework of the upper arcade.

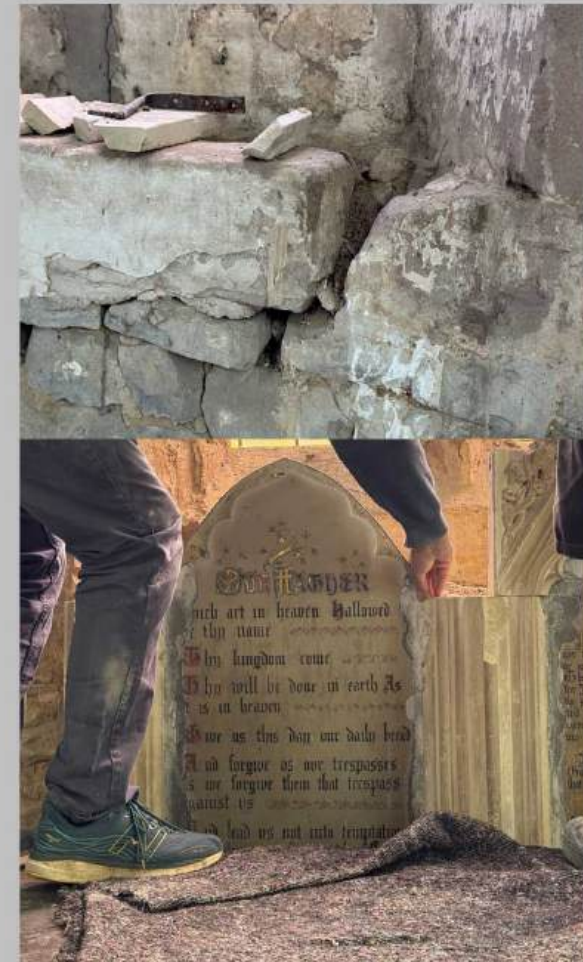
Plates 12-14 - St Peter's Church, Grandborough - 1849 Reredos

During the dismantling of the reredos the upper arches are removed and carefully steam cleaned using a Derator steam generator, the painted panels are gently lifted out and the mullions removed to reveal the loose rubble wall construction behind

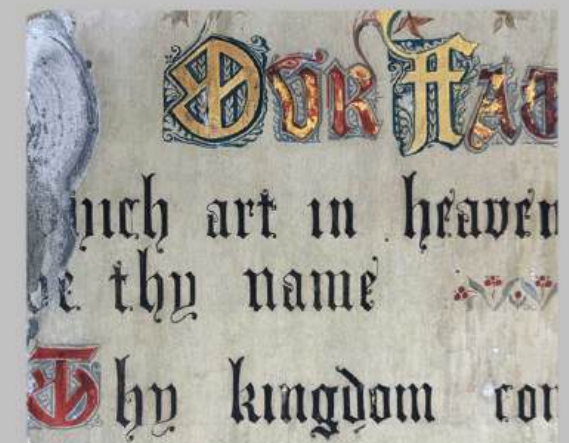
Plates 22-26 - St Peter's Church, Grandborough - 1849 Reredos

The Lord's Prayer during cleaning to remove ingrained dirt, which reveals deep staining and dark splash marks (centre above) within the background colour as a result of bat activity. Further cleaning tests indicate that retouching the background is the only viable option to disguise the dark splash marks (right)
