TECH TIP

PRODUCT: QUEST JUICE

SUBJECT: CABINET DRAIN TUBE MODIFICATION

DATE: AUGUST 2, 2004

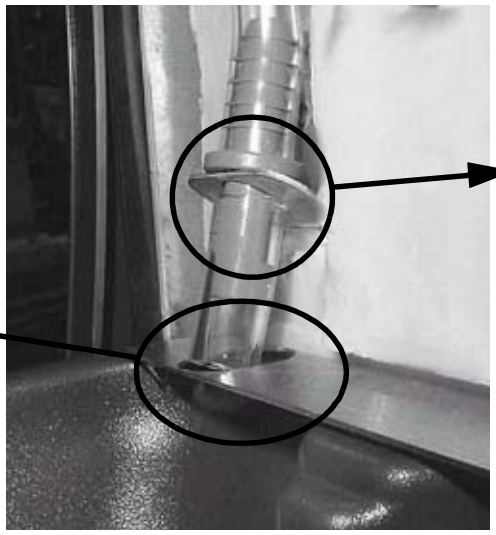
DETAIL A. Tube cut just above the metal plate

1. Bend the drain support bracket up about 20 degrees. This moves the outlet forward so it is aimed at the tray. (Figure 3, Detail B)
2. Cut the extension tube back so it inserts through the bracket but does not interfere with removing and replacing the drip tray itself. (Figure 3, Detail A)

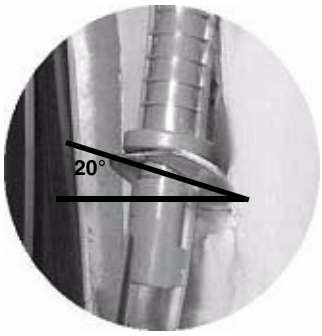
DETAIL B. 20 degree bend up on the bracket
