### Chassis Identification

**Jackson-Bell Model 62 Introduction**  
**Jackson-Bell Model 62 Factory Documentation**  
**Jackson-Bell Model 62 Technical Information**

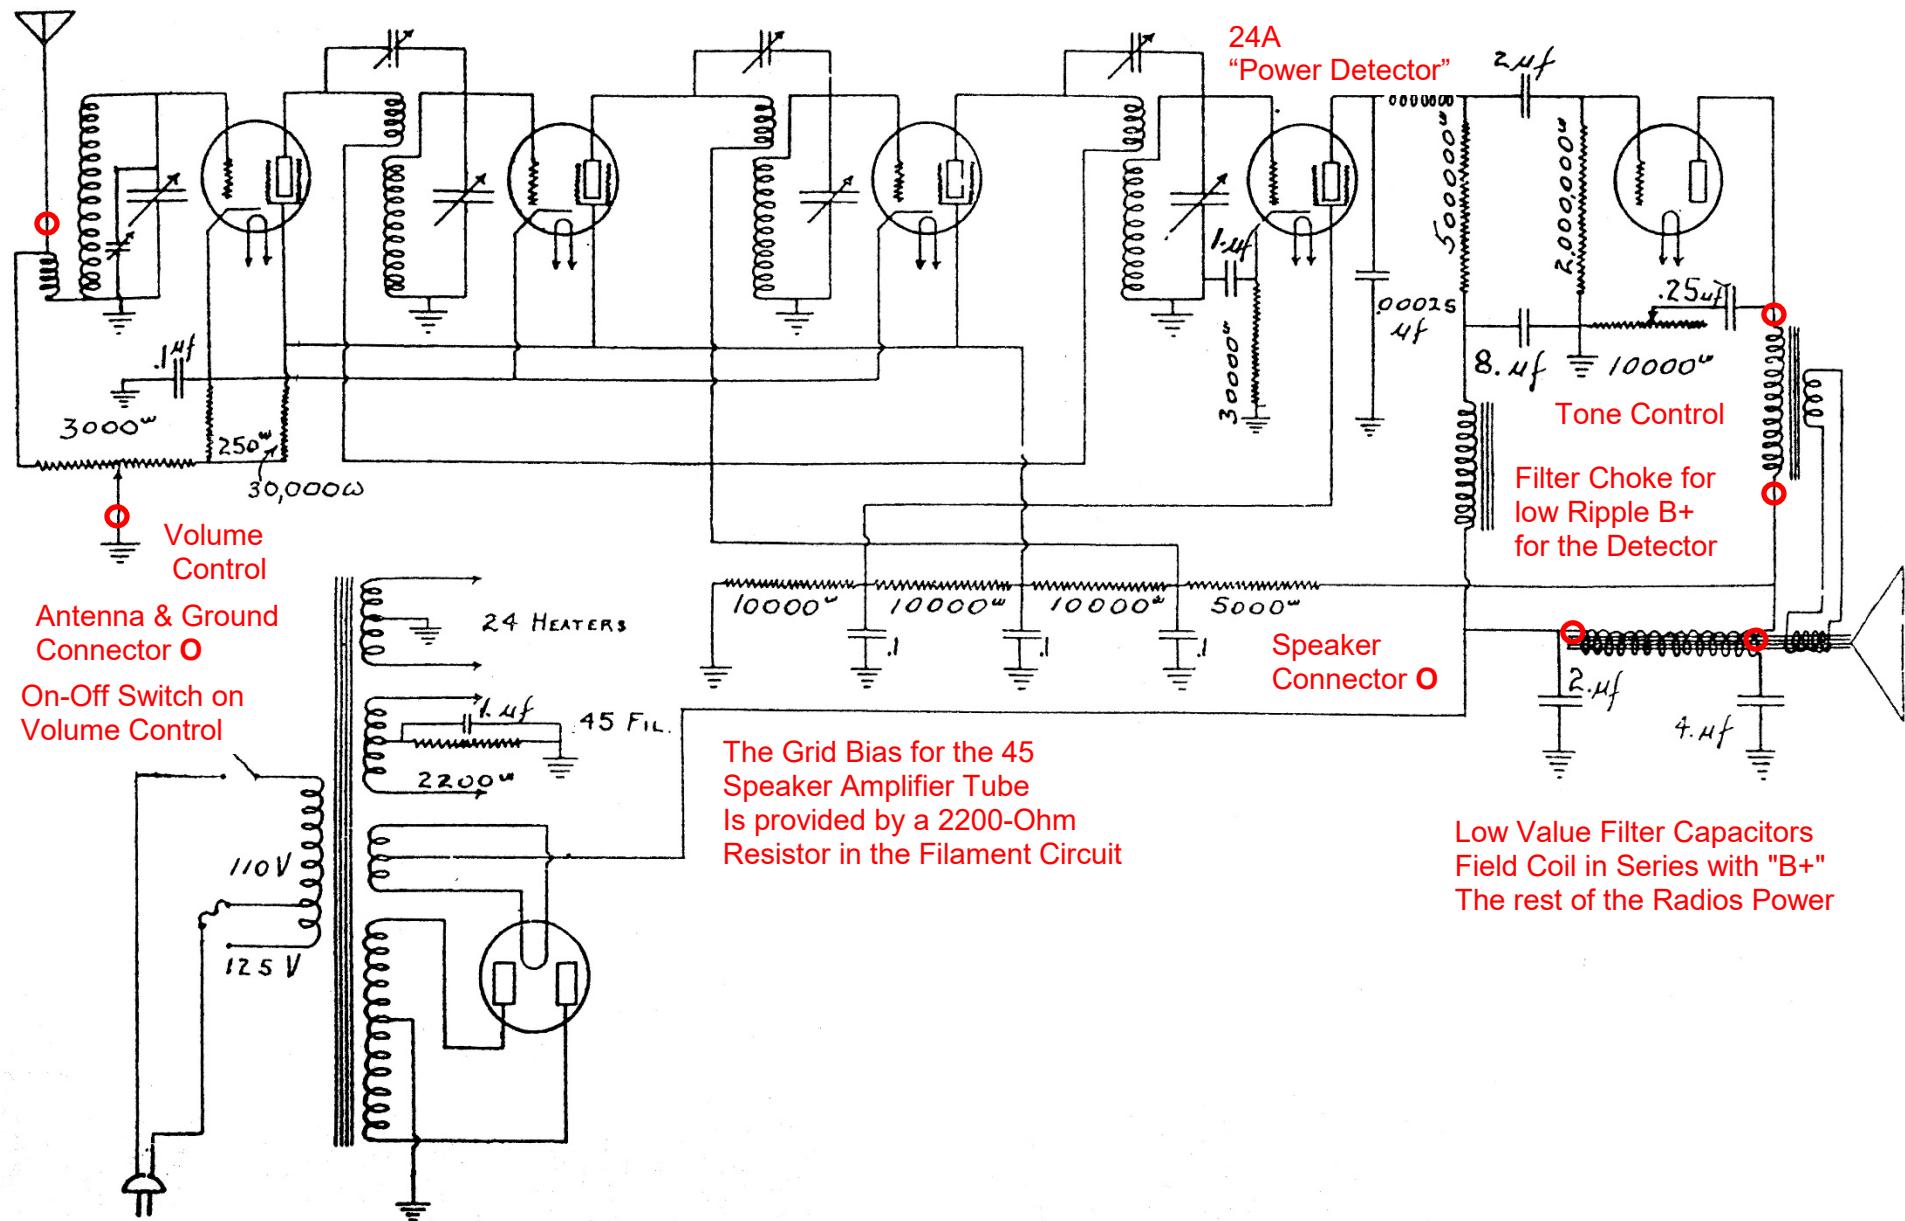
## Version 1 Chassis

The **First Version** of the Jackson Bell 62 did not use Mershon Electrolytic 8uF capacitors. The available capacitors were oil soaked paper and foil types. For a reasonable physical size and cost, a dual “2uF & 4uF filter block” was used in the power supply. The ripple (hum) level at the power supply output is high. To compensate, a choke and capacitor filter was included in the plate circuit of the detector. It was a very effective but expensive way to eliminate hum at the speaker output. The 245-power output tube bias was obtained by a resistor and bypass capacitor in the center-tap return to ground of the filament winding.

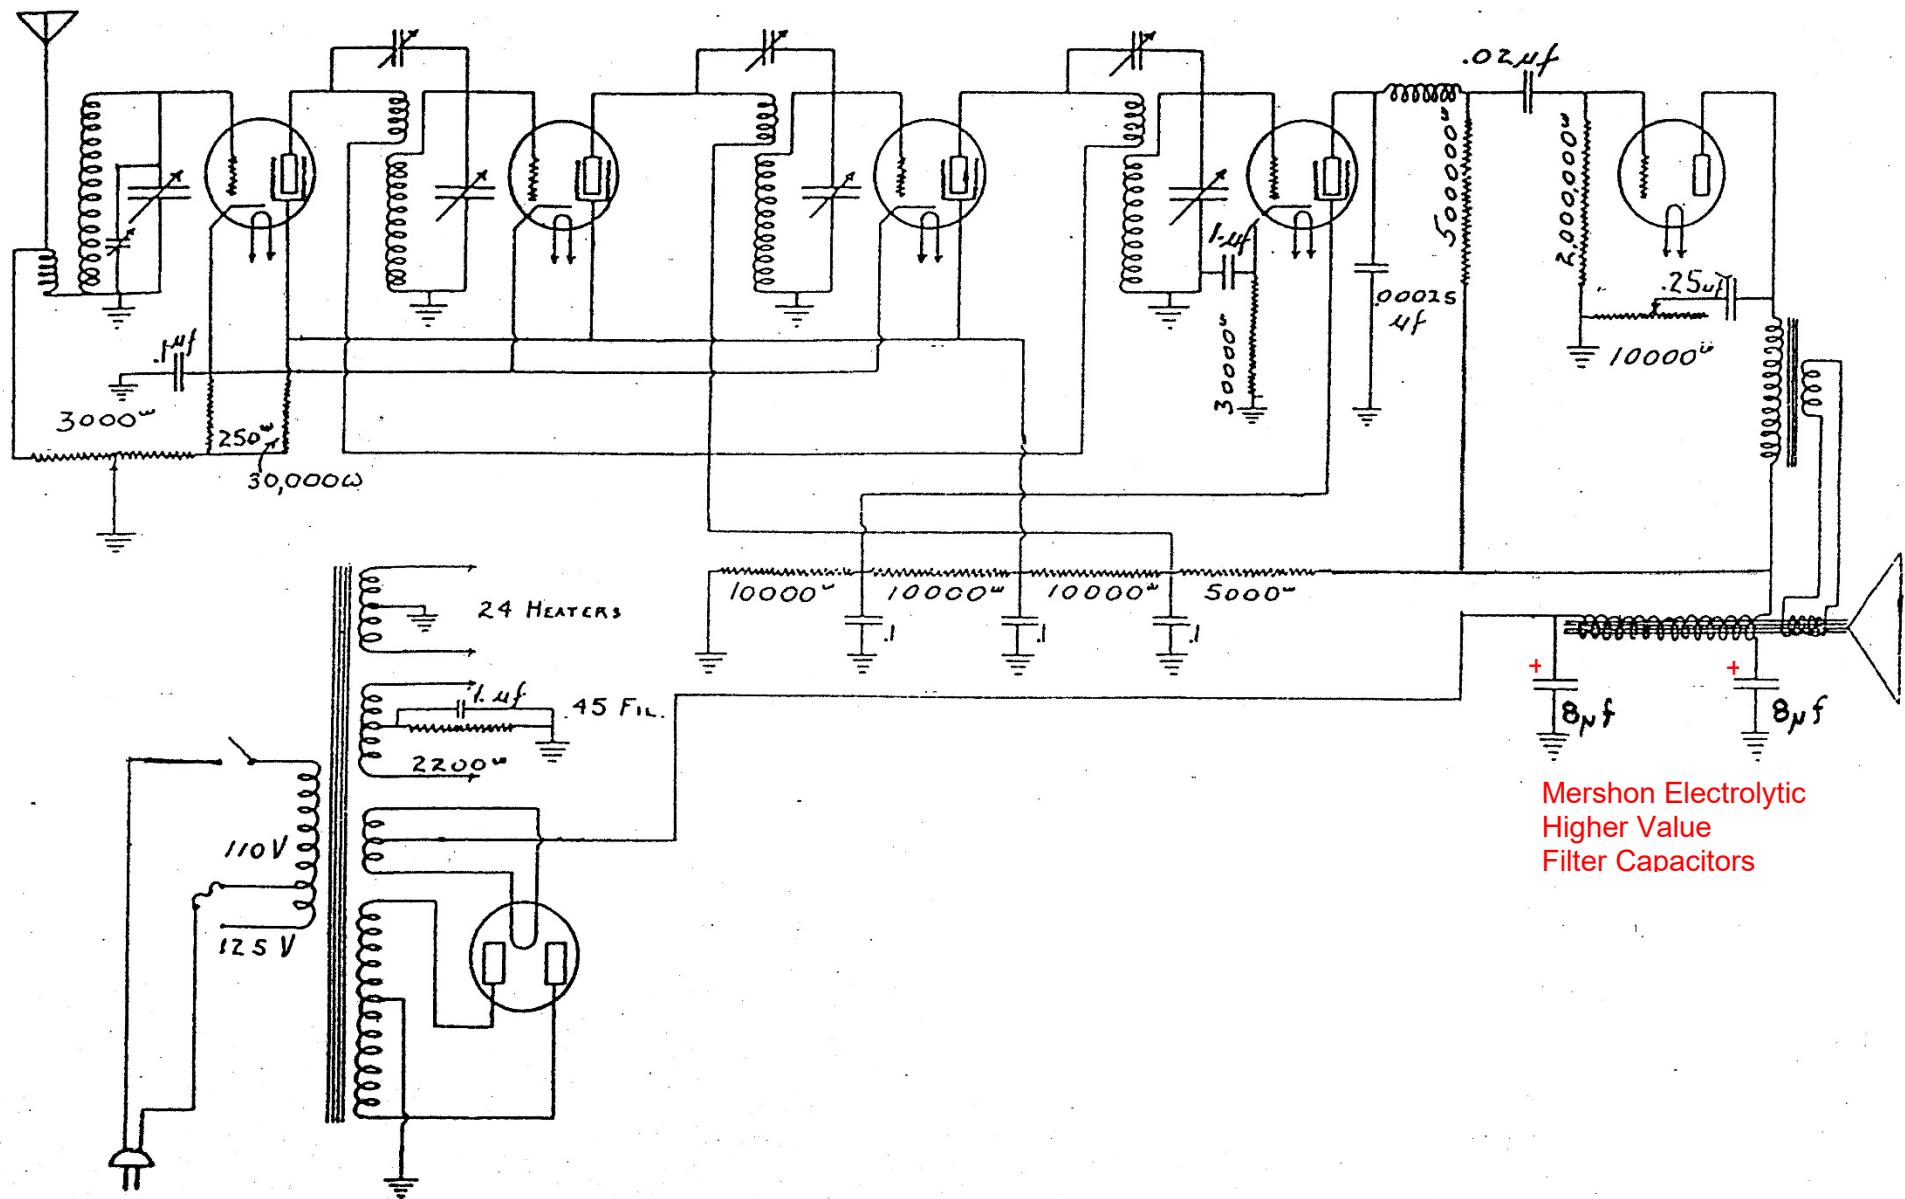
## Version 2 Chassis

The **Second Version** used Mershon Electrolytic 8uF capacitors in place of the filter block to allow removal of the choke and filter capacitor in the detector circuit. Hum in the speaker is acceptable. Presumably, this change reduced costs.

# Mershon Electrolytic Higher Value Filter Capacitors

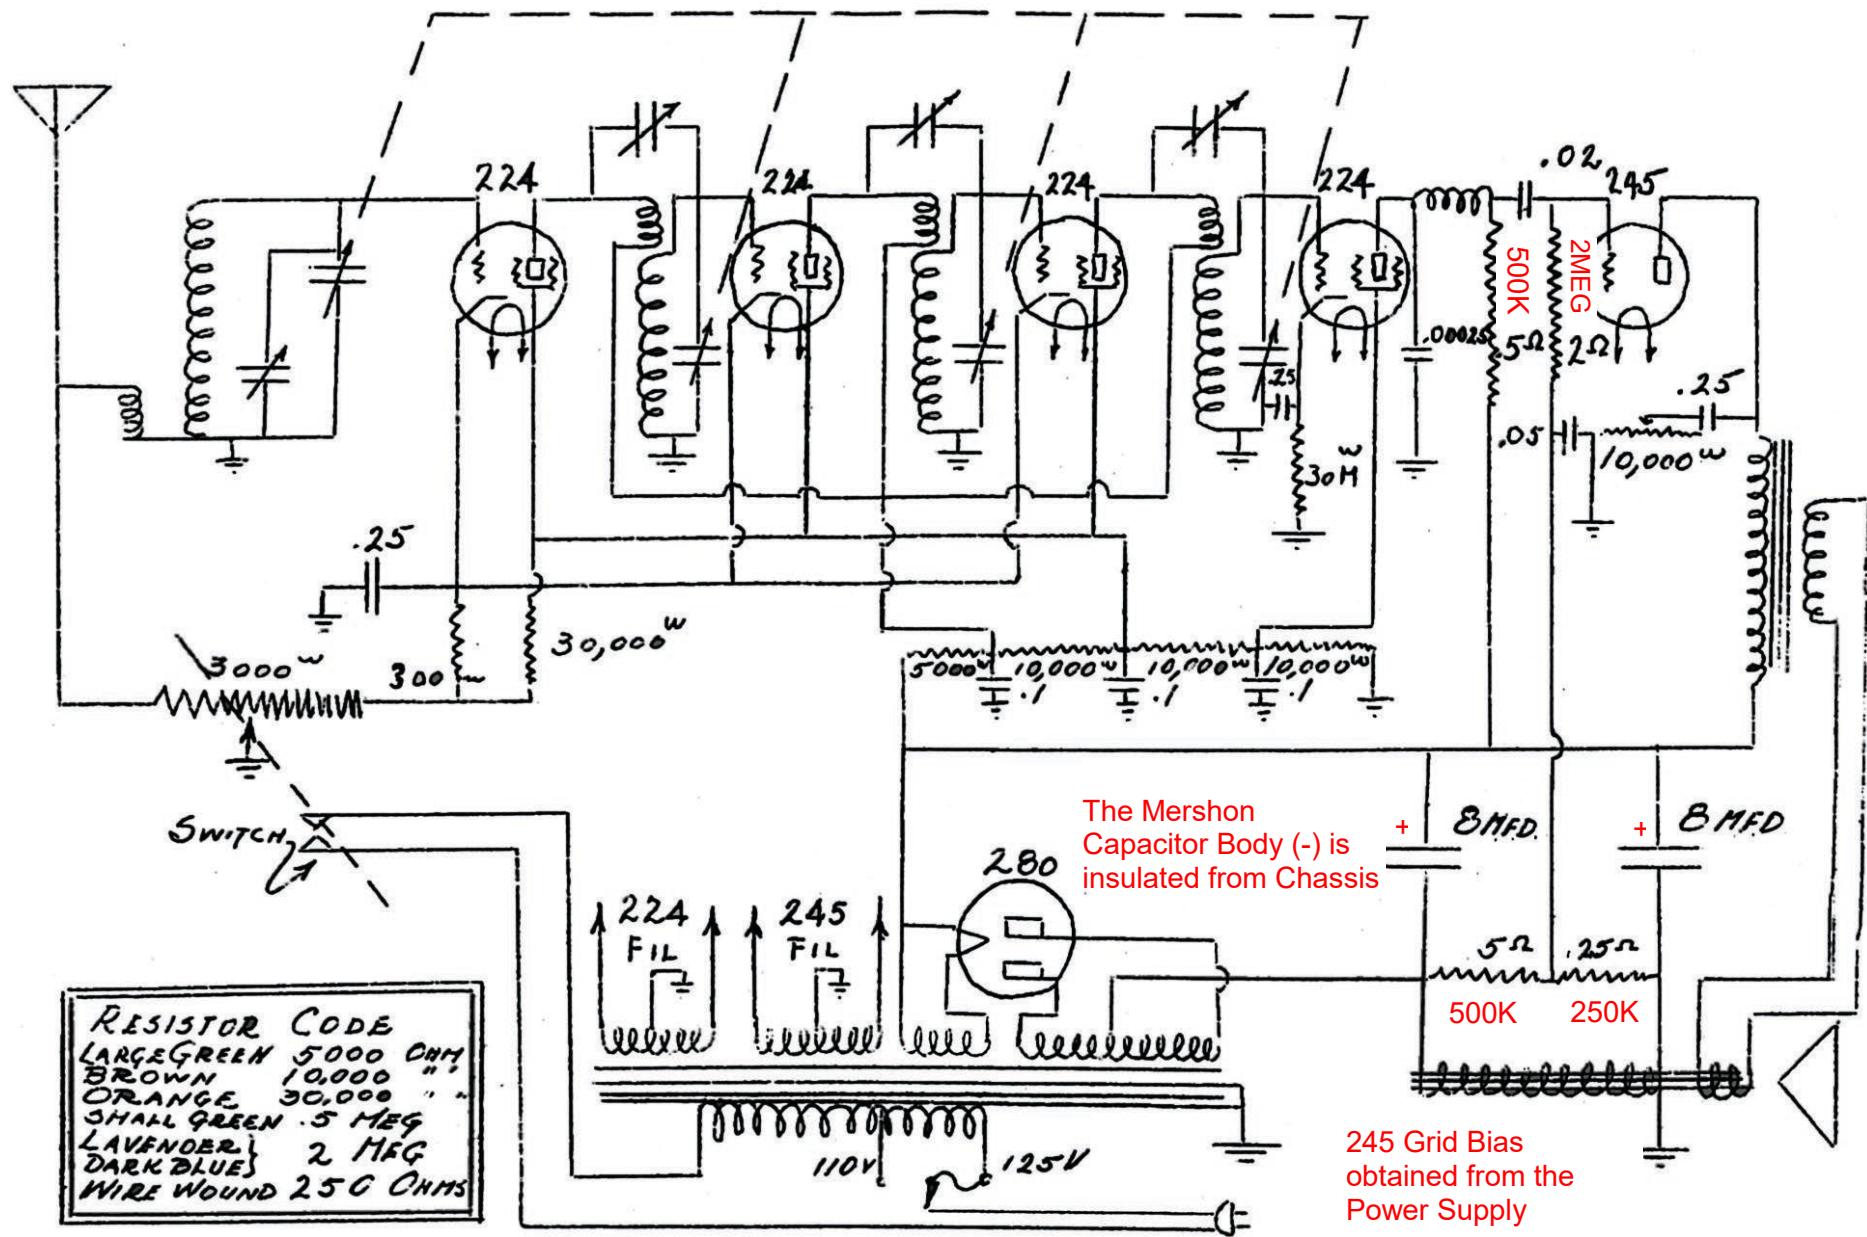
## Version 3 Chassis

The **Third Version** put the speaker field coil in the power supply ground return; providing a negative voltage with respect to ground. It is used here to bias the 245-power output tube grid. This “improvement” saved parts over previous versions but no functional advantage. A further cost reduction could have been obtained by having a power transformer with a single filament winding. Perhaps JB had a large inventory of Version One, and Two chassis transformers.

MODEL-62  
IMPROVED 1-22-31
