2 CULVERTS LESS THAN 10-FOOT SPAN

2.1 Definitions

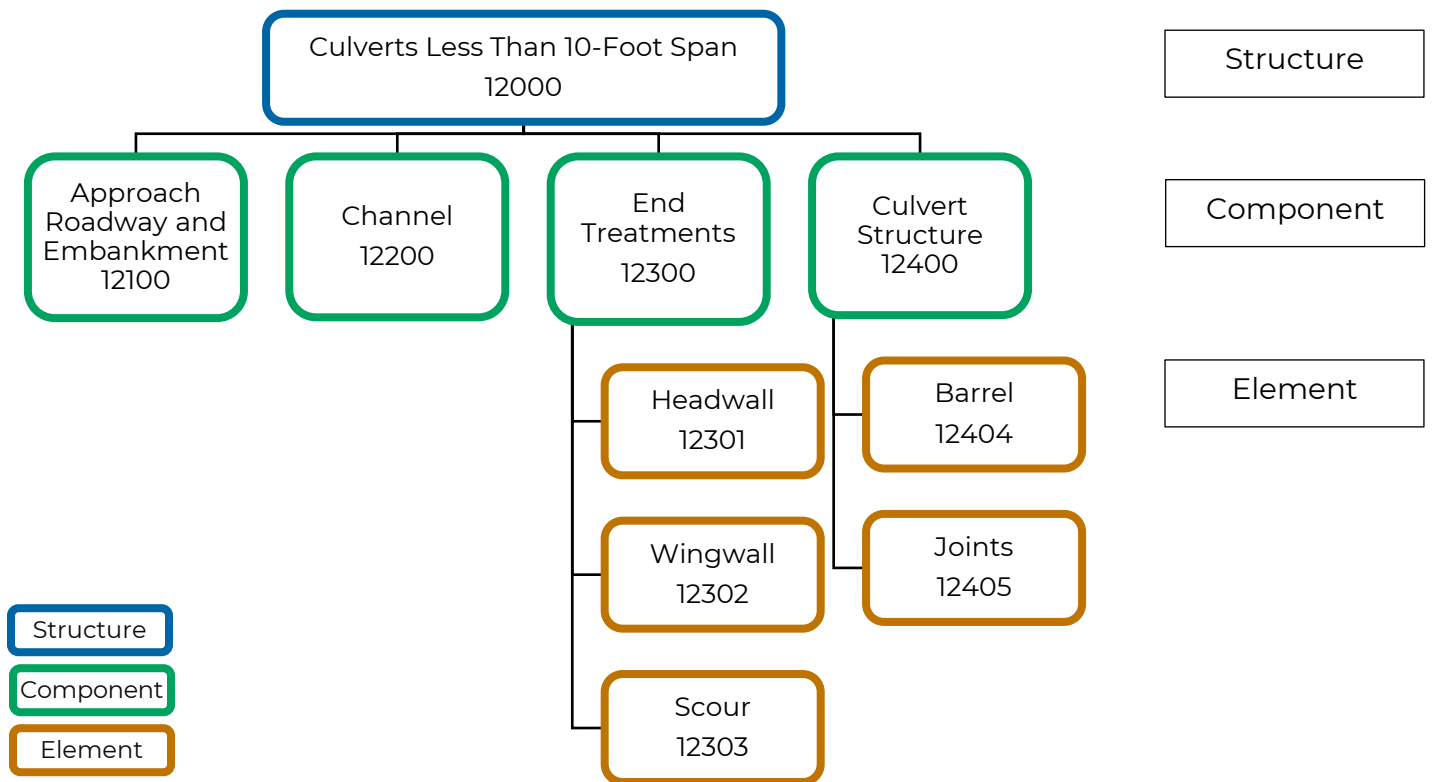
Figure 2-1: Component-element Structure for Culverts Less than 10-Foot Span

A representation of the rating structure for Culverts Less Than 10-foot Span is illustrated in Figure 2-1.

All components are rated based on the guidance provided in Section 2.4 Routine Inspection. The overall culvert rating reflects the minimum of the Approach Roadway and Embankment and Culvert Structure component ratings.

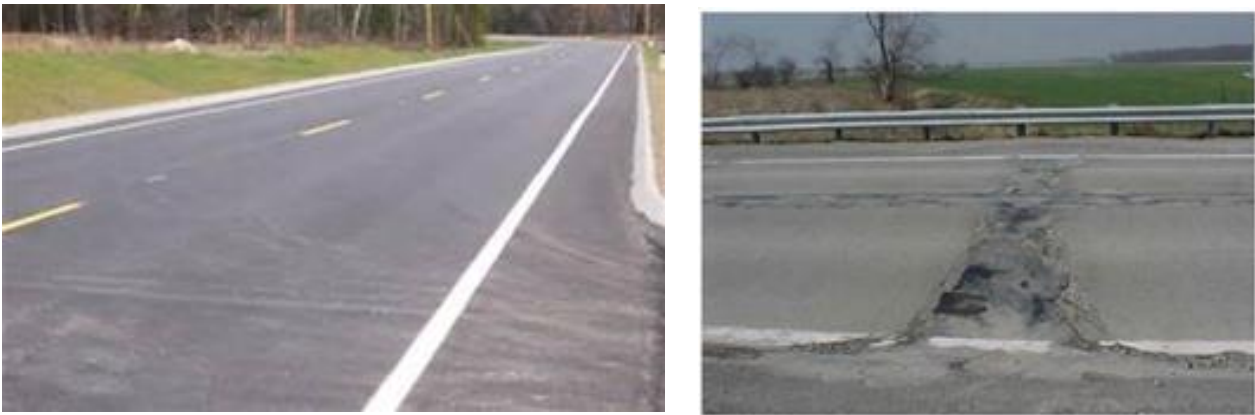
Figure 2-3: Approach roadway, without observable distress (left), clear distress over culvert (right)

Issues observed in the approach roadway can often be an indicator for culvert performance; however, they can equally be unrelated. Because of this, it is important for inspectors to evaluate the relationship between any identified approach roadway distress and culvert distress whenever possible.

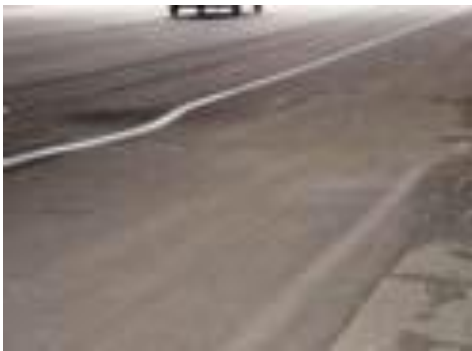
Figure 2-4: Pavement and shoulder issues above culverts

- A significant difference in soils used for roadway embankment compared to those used for pipe embedment
- Piping (washout of fines) along the culvert causing voids or cracks above
- Settlement of backfill material, allowing movement of the structure
- Flexible pipe barrels will deflect at their crown if:
 - Adequate lateral support is not provided by the surrounding embedment soil
 - Pipe is overloaded and deflects
- For rigid culverts, inadequate compaction or low-quality embedment soil can result in settlement on either side of the culvert, usually forming a hump over the buried pipe

Sighting along the edge of pavement or along pavement markings is also important and can reveal settlement indicators including humps, sags, and rutting.

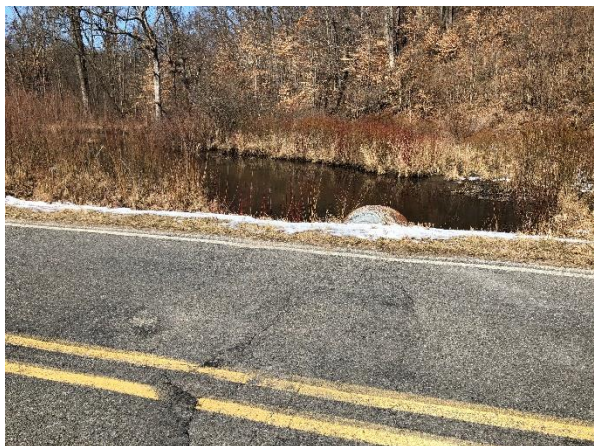
Figure 2-5: Transverse cracking of pavement above culvert

Transverse cracks are often related to culvert distress. These cracks run perpendicular to the direction of the road and are of primary interest as a distress indicator in culvert

inspection. Regularly spaced transverse cracks along long stretches of roadway are usually caused by temperature-induced expansion and contraction and may not indicate culvert distress. Try to locate any sags or humps that may be associated with transverse cracks over the culvert.

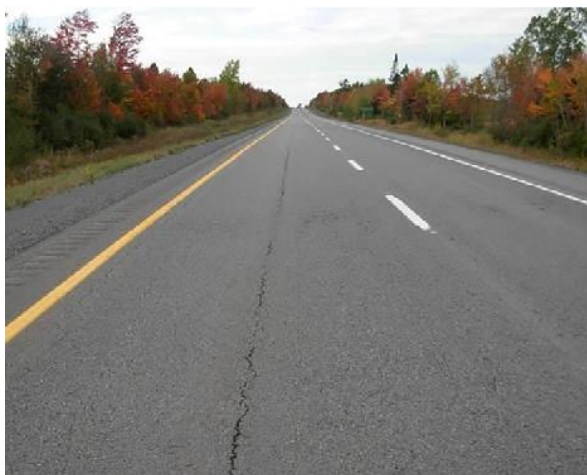
Figure 2-6: Longitudinal cracking

Longitudinal cracks run parallel to the direction of the road. Cracks within 1 foot of the lane edge are typically caused by shoulder settlement, frost action, or poor drainage, and may be unrelated to the presence of buried pipes. Consider these factors when assessing longitudinal cracks as distress indicators for a culvert. Longitudinal cracking that is not a distress indicator for the culvert does not need to be included in the condition rating but shall be noted in the comments.

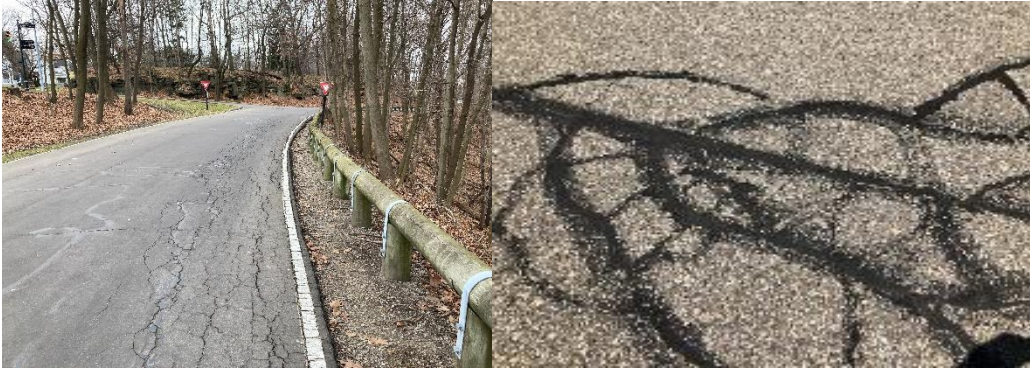
Figure 2-7: Pavement and shoulder alligator cracking

Alligator cracks are a form of fatigue cracking that forms a pattern of small angular pieces of pavement creating an appearance like alligator skin. This type of cracking is not typically associated with culvert distress. However, it may similarly indicate distress in the culvert if alligator cracking exists locally over the culvert but not in other areas. Note the presence of alligator cracking in the inspection report in the comments.

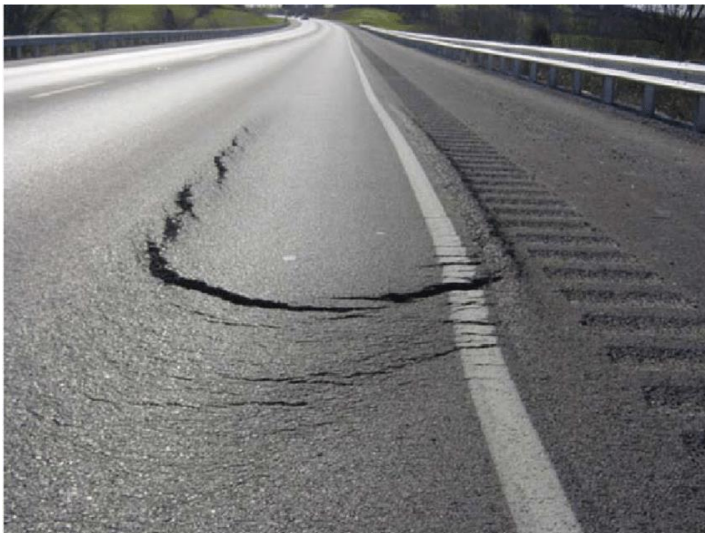
Figure 2-8: Slippage cracking

Slippage cracking is characterized by a generally rounded pattern caused by slippage between an overlay and underlying pavement occurring most commonly at intersections with high volumes of stop/start traffic. As with alligator cracking, slippage cracks do not typically indicate culvert distress. Note the presence of slippage cracks in the inspection report in the comments.

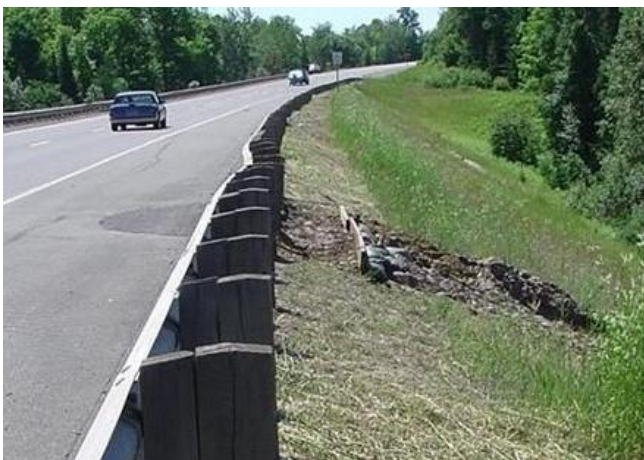
Figure 2-9: Example of embankment failure above a culvert

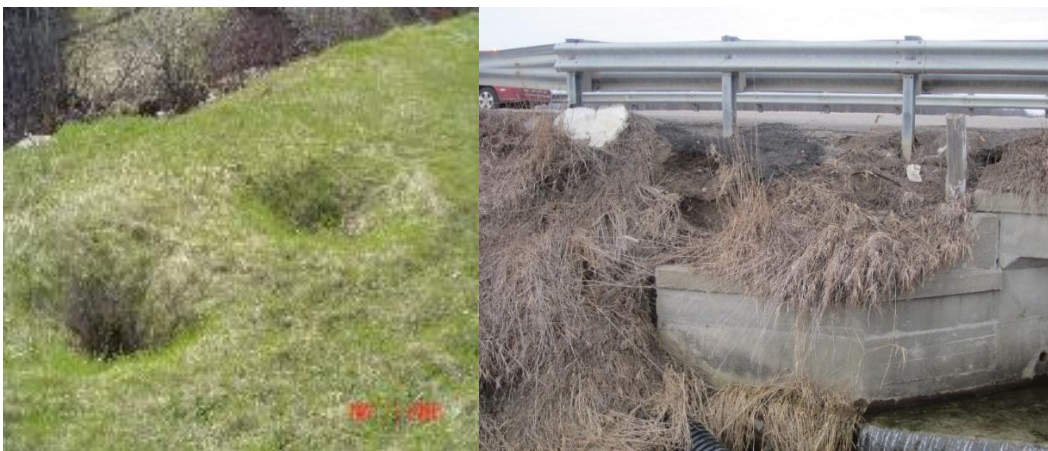
Figure 2-10: Example of embankment issues due to piping (left) or erosion (right)

Erosion of the backfill where water flows along the outside of the pipe. Piping along the outside of the barrel of the culvert can reduce backfill support and can lead to weakened embankment slope stability.

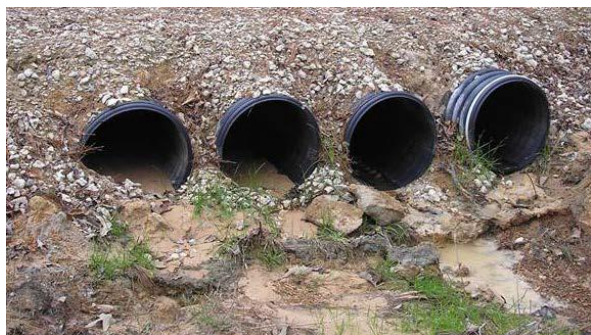
Figure 2-11: Culvert erosion—early-stage gully/rill erosion between the culverts

Specific types of surface erosion where runoff carves channels in the soil. This typically occurs with multiple barrel pipes and/or with mitered or projecting ends.

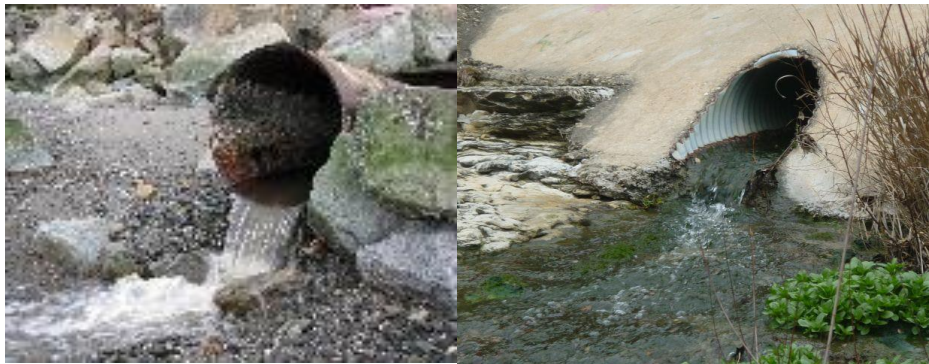
Figure 2-12: Stream channel poor vertical alignment (left) and horizontal alignment (right)

Poor vertical and horizontal alignment of the culvert relative to the stream channel can result in reduced hydraulic efficiency, increased erosion or sedimentation of the stream channel, damage to the embankment supporting the roadway, and damage to adjacent property. Often, protective measures are required to maintain stability of the channel and hydraulic and structural performance of the culvert.

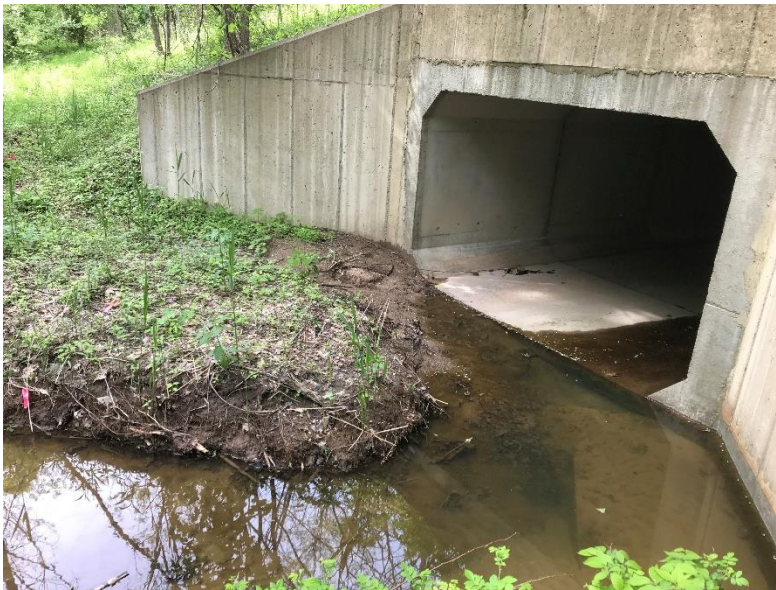
Figure 2-13: Stream channel poor horizontal alignment

Check for erosion and indicators of changes in the direction or location of the stream channel. Plan-view sketches and site photographs are used to document the condition and horizontal alignment of the channel relative to the culvert barrel at the time of inspection. The alignment is critical for a three-sided culvert which may be susceptible to failure due to scour. Abrupt changes in stream horizontal alignment (bends) retard flow and cause increased erosion along the outside of the bend, damage to the culvert and end treatments, and increased sedimentation along the inside of the bend. Where sharp channel bends exist at either the inlet or outlet of a culvert, check for sedimentation and erosion.

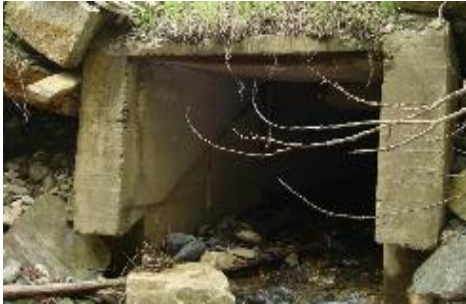
Figure 2-14: Vertical alignment issue leading to foundation undermining

Problems related to vertical alignment are usually indicated by scour or accumulation of sediment. Culverts on grades that differ significantly from the natural gradient (stream channel alignment) may present problems. Culverts on flat grades may have sediment build-up at the entrance or within the barrel. Culverts on moderate and steep grades generally have higher flow velocities than the natural stream and may have problems with outlet scour.

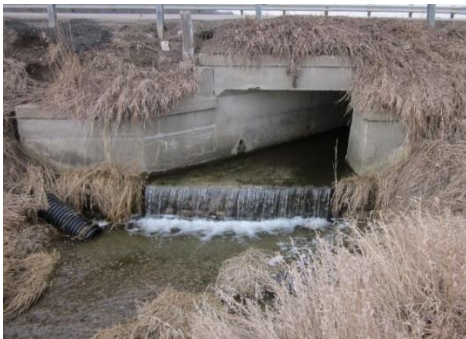
Figure 2-15: Vertical alignment issue leading to stream degradation

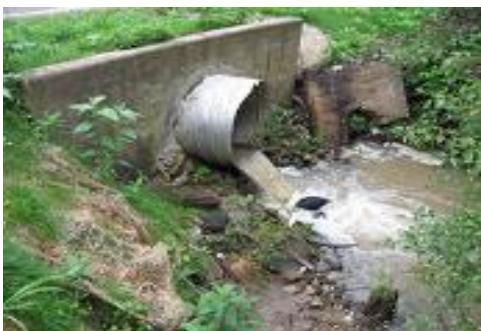
Figure 2-16: Vertical alignment distress; may have progressing washout due to high flow

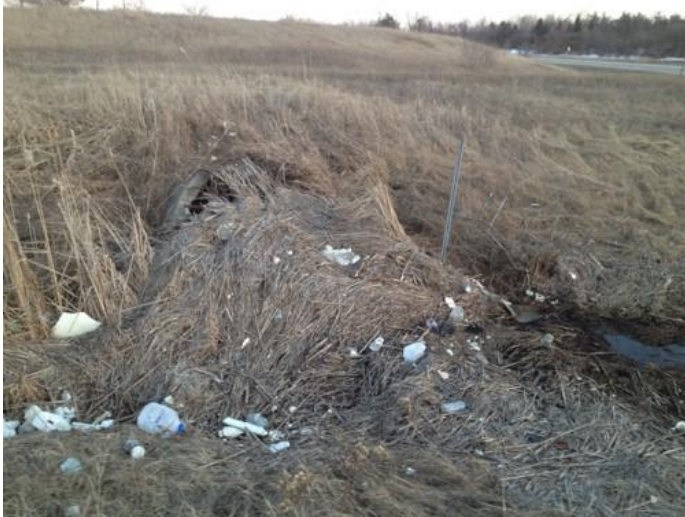
Figure 2-17: Blocked inlet

Accumulation of debris and sediment at the inlet or within the culvert barrel reduces both the size of the opening and the culvert's capacity to handle peak flows and may cause scour of the stream banks and roadway embankment, head cutting, or changes in the channel alignment. Debris and sediment accumulations at the culvert inlets or within the culvert barrel may result in roadway overtopping, excessive ponding, and the potential for damage due to buoyant forces. Note deposits of debris or sediment that could block the culvert or cause local scour in the stream channel. Downstream obstructions which cause water to pond at the culvert's outlet may also reduce the culvert's flow capacity.

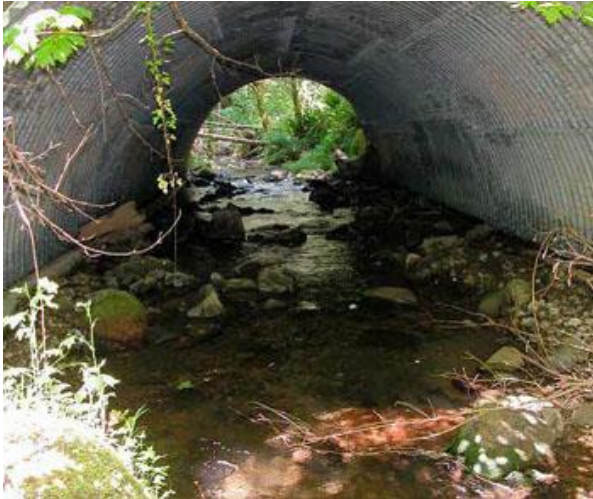
Figure 2-18: Intentional natural streambed

Note some culverts may be designed with fill in the bottom (invert) to create a more natural stream bed for fish. Identify these culverts to distinguish intentional fill from debris accumulation.

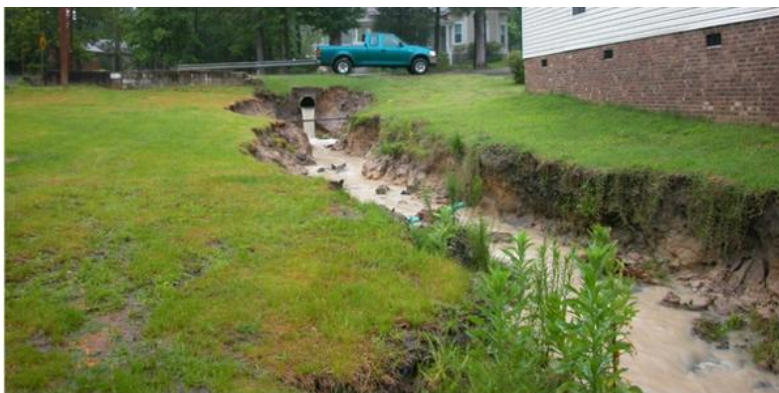
Figure 2-19: Bank erosion

Bank erosion, in contrast to general scour and head cutting, refers to loss of stream channel (bank) sidewall material and a lateral movement of the channel. Bank erosion includes expansion of the channel at a change in direction of the stream when protection is not provided or provided protection is not adequate. Signs of severe bank erosion include undercutting of bank edge and sod root overhangs.

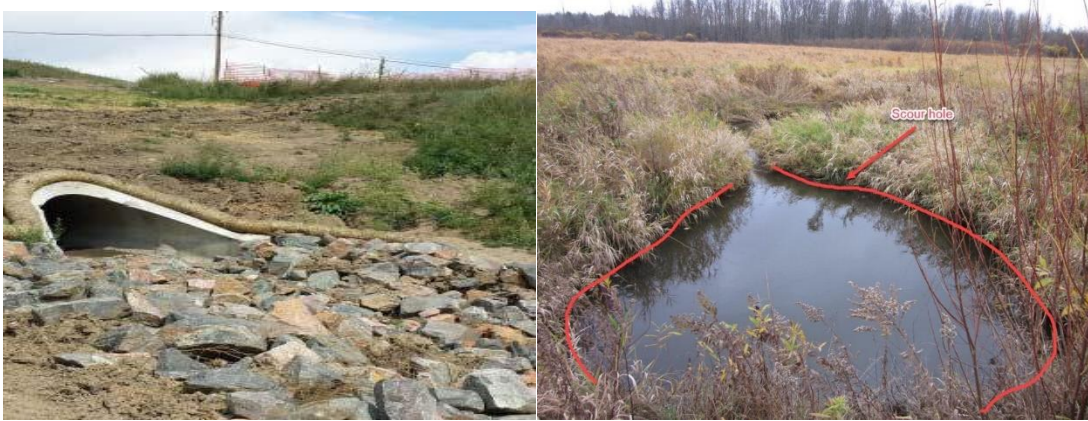
Figure 2-20: No scour (left), scour hole (right)

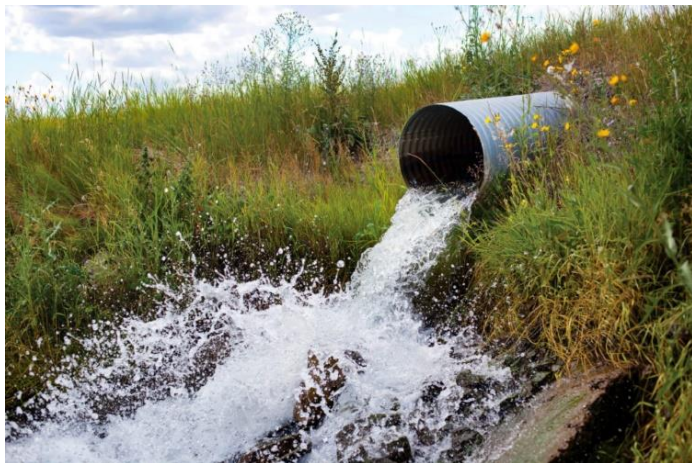
Figure 2-21: Projecting or perched outlet

Projecting ends have no end structure attached to the culvert barrel and the pipe barrel simply projects out of the embankment. Projecting outlets, such as perched outlets, often result from scour holes formed due to impact of high exit velocities and/or stream degradation. They also result from erosion and can be a barrier to fish passage.

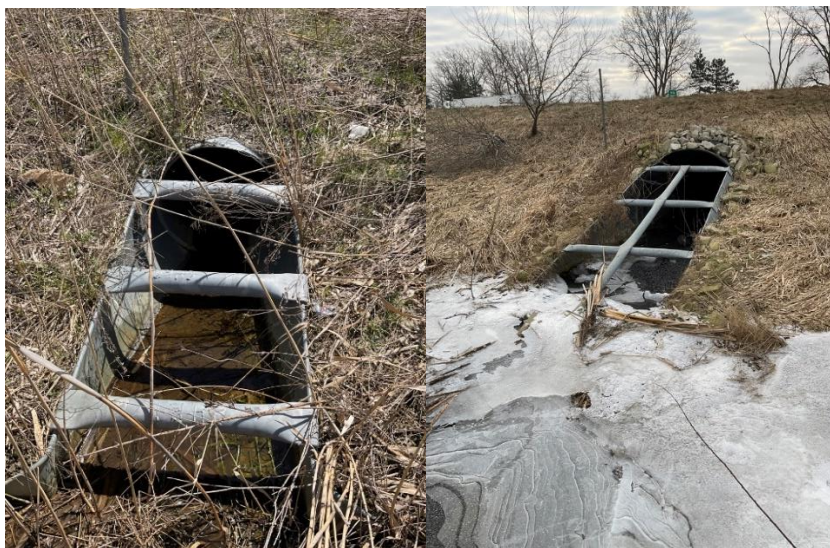
Figure 2-22: Sloped metal end sections

A sloped end section is a culvert end that has been modified to match the embankment slope. They often have safety bars that can trap debris. Culverts with mitered or skewed end treatments are inspected for the same types of problems as culverts with projecting ends. Sloped end sections include prefabricated metal or precast concrete sections that are placed on small diameter pipe.

Metal pipe culverts with a sloped end are inspected for deformation since cutting the ends reduces the structural integrity of the pipe. It is therefore important to check cut ends of culverts for signs of distress including deformation, erosion of the fill slope, and undercutting.

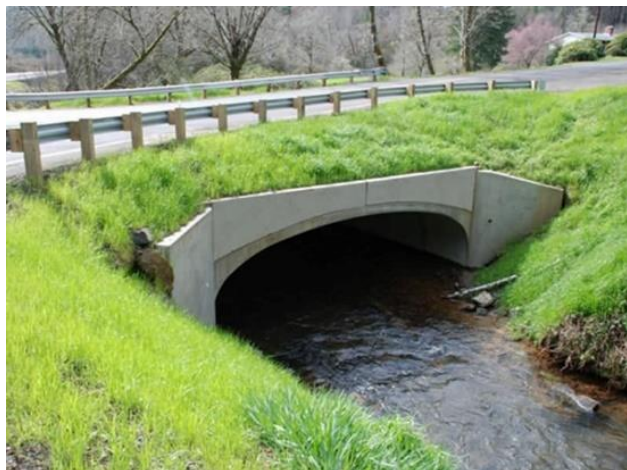
Figure 2-23: Concrete headwall and wingwall

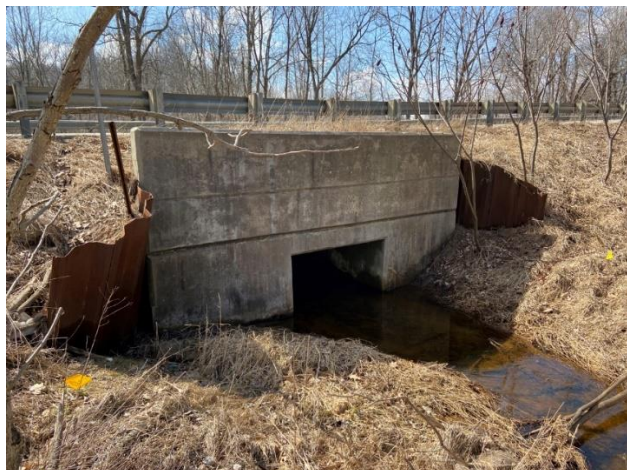
Figure 2-24: Concrete headwall and metal sheet pile wingwalls

Metal headwall and wingwall inspections should include checking for voids behind the walls which may indicate a loss of backfill, toe-out (rotation) of the base which may indicate scour in front of the wall, and outward movement of the wall top which may indicate damage to anchor rods.

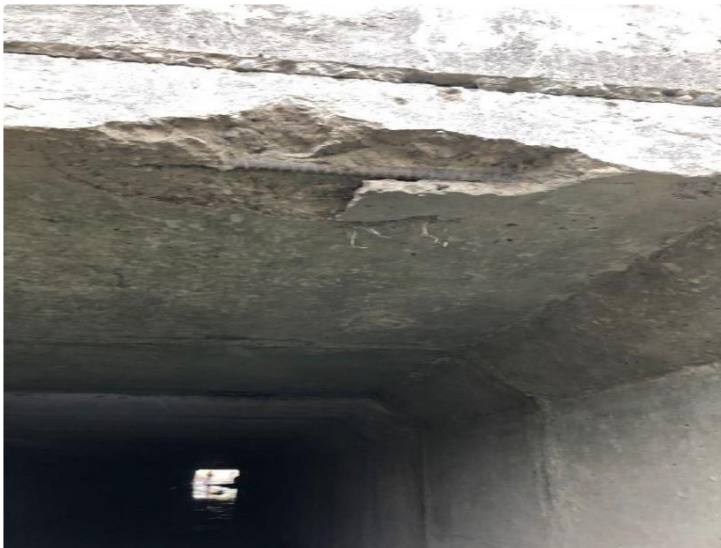
Figure 2-25: Spalled concrete at headwall

Spalling may be detected by visual examination of the concrete along the edges of cracks. Tapping with a hammer is performed along cracks to check for areas that have fractured but are not visibly debonded, as these areas will produce a hollow sound when tapped.

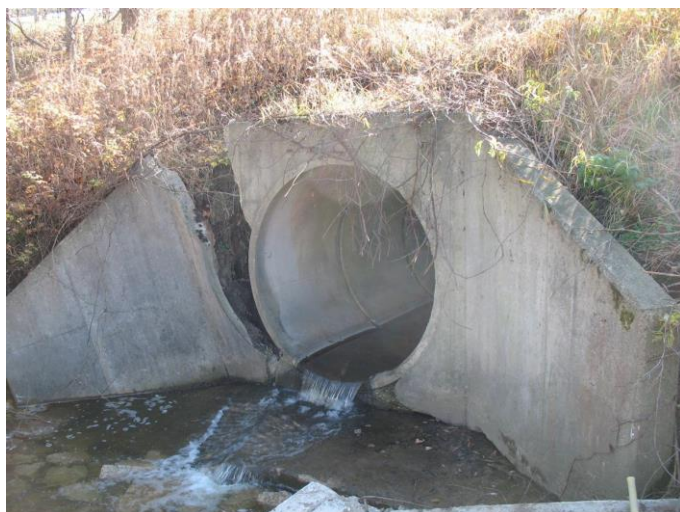
Figure 2-26: Concrete foundation and wingwall damage due to scour

Culvert scour consists of three types of scours: stream degradation, contraction scour, and local scour. Stream degradation is long term changes in the streambed elevation due to natural or human-induced causes, which can affect the reach of the river near the culvert. Contraction scour is removal of material from the bed and banks across all or most of the channel width, resulting from the contraction of the flow area. Local scour is removal of bed material from around the culvert foundation. Local scour is caused by the acceleration of flow and vortices resulting from flow around an obstruction.

The most common structural distress in concrete footings is differential settlement, typically due to scour undermining the footing. Differential settlement occurs when one section of a footing settles more than the rest of the footing. This can cause cracking in concrete, wrinkling in corrugated metal, distress to joints, or other damage or distortion in the supported culvert structure and in the footing. Flexible corrugated metal culverts can tolerate some differential settlement but will be damaged by excessive differential

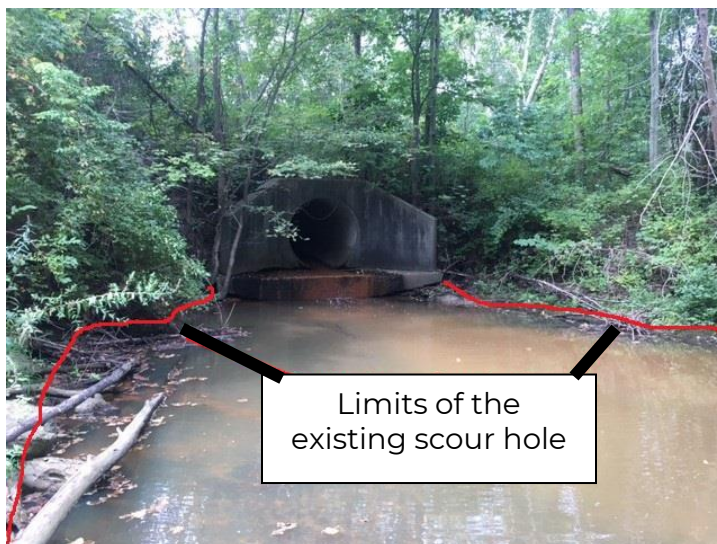
Figure 2-27: Perched outlet with large scour hole

Concrete invert slabs are checked for undermining and settlement. Undermining is checked by probing along the edge of the apron. Settlement can be detected by checking for cracks, rotation, and signs of movement at the joint with the headwall. The joints between concrete aprons and headwalls should also be checked for movement (separation) and water tightness. Slabs are checked for damage such as spalls, open cracks, holes, or missing portions. Undermining can lead to a perched condition where piping occurs underneath the barrel. This perched condition can be due to stream degradation, or local scour. In critical conditions, voids around the culvert might appear.

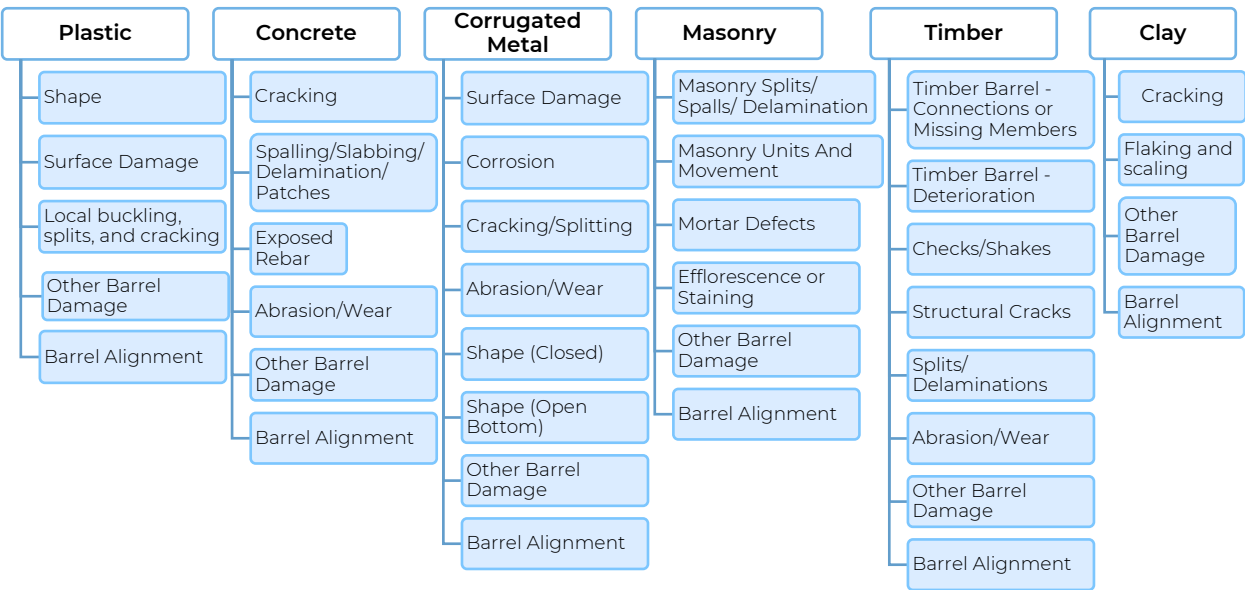
Figure 2-28: Applicable distresses for culvert barrel types

The elements and types of condition deficiencies can vary greatly by barrel type; therefore they are broken into different inspection/rating procedures based on material. Distresses associated with multiple material types are discussed initially, followed by distresses by material type. Distresses associated with each material type are described in detail.

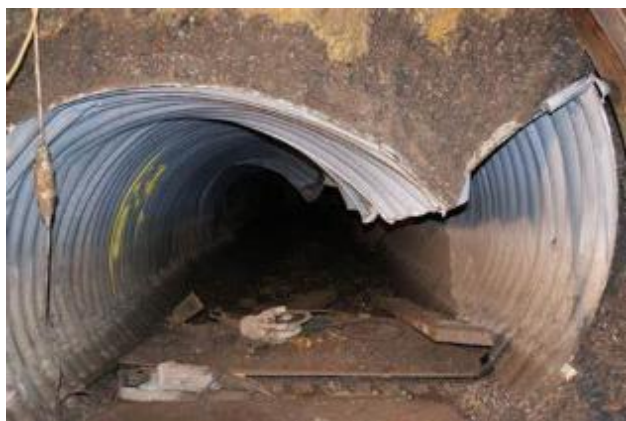
Figure 2-29: Loss of vertical alignment in a corrugated metal culvert

Vertical alignment is checked for distortion, including warping, sagging, local crushing, and heaving. Be aware that pipes are occasionally laid with a camber (concave downward curvature along the pipe length) or a grade change to allow for fill settlement due to differential foundation soils or differential embankment loads.

Warping is characterized by deviation from flatness as a result of stresses and uneven shrinkage. Sagging is vertical deformation that can be caused by overloading or by creep (permanent deformation due to constant loading over time). Sags impede water flow which may aggravate settlement problems by saturating the supporting soil through leaking joints. Sags may also impede movement of debris and decrease flow capacity. For

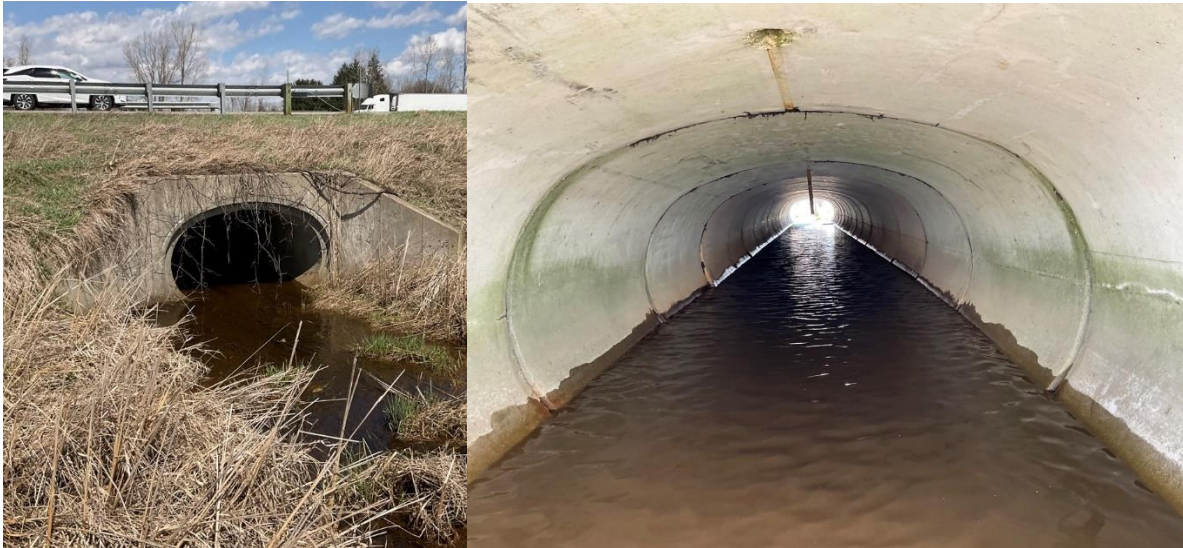
Figure 2-30: Concrete barrel culvert

Concrete culverts and storm drain barrels may be either precast or cast-in-place. Precast concrete pipe is manufactured in a fabrication facility. The manufacturing process is under controlled conditions enabling uniform quality concrete. Cast-in-place (CIP) concrete is cast at the site in formwork, placing reinforcement bars (rebar), and pouring concrete in its final location. Most CIP concrete culverts are single or multi-cell box culverts constructed using conventional bridge construction techniques. Both CIP and precast concrete culverts are somewhat protected by the soil backfill from rapid fluctuations in surface temperature and direct application chloride (salts) used for deicing. As a result, they are generally more resistant to surface material degradation than conventional concrete bridge elements, such as bridge decks.

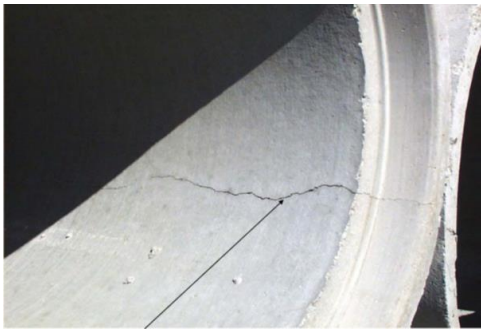
Figure 2-31: Longitudinal crack within a concrete barrel

Hairline longitudinal cracks in the crown and invert of the pipe usually develop as the rebar picks up the tensile stress due to circumferential bending. Measurements of crack width are taken as an indication of the structural condition of the pipe. Any visible wall vertical offset is noted in the inspection report.

Hairline cracks less than 0.01 in. in width are minor and only need to be noted in the inspection notes. Moderate cracks greater than hairline cracks are described in the inspection report and noted as possible candidates for maintenance. Major longitudinal cracking in equal to or excess of 0.1 inch in width may indicate overloading or poor bedding and side support and warrant further evaluation by an engineer.

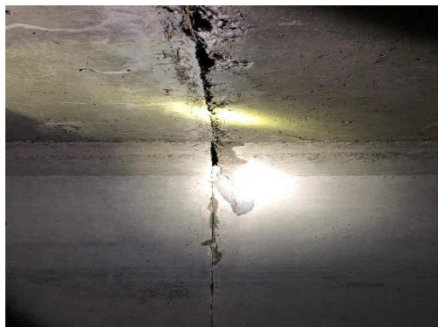
Figure 2-32: Spalling within a box culvert

Spalling is a fracture of the concrete parallel or inclined to the surface of the concrete.

In precast concrete pipe, spalls often occur along the edges of either longitudinal or transverse cracks when the crack is due to overloading or poor support rather than normal tension or shrinkage cracking. Spalling may also be caused by corrosion of the steel rebar when water is able to reach the rebar through wide cracks or shallow cover. As the rebar corrodes, the oxidized steel expands, causing the concrete covering to spall.

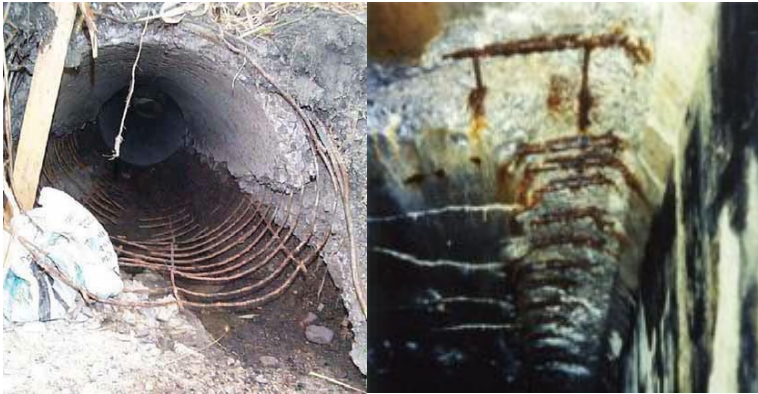
Figure 2-33: Concrete barrel deterioration

Delaminations are separations along a plane parallel to a surface, as in the separation of a coating from a substrate or the layers of a coating from each other, or, in the case of a concrete slab, a horizontal splitting, cracking, or separation of a slab in a plane roughly parallel to, and generally near, the upper surface. Delaminations are not visible from the surface but can be detected by tapping along the surface with a hammer or dragging a chain to detect hollow-sounding areas.

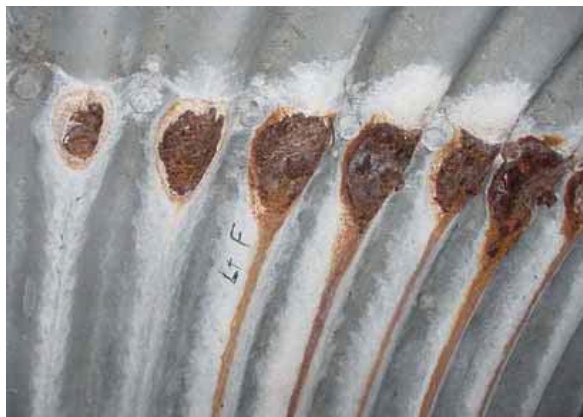
Figure 2-34: Corrosion of a metal culvert

iron or copper and their salts are present. The electrical resistivity of soil and water provide an indication of the likelihood of corrosion. In an aggressive environment, corrosion may result from the resistivity of the soil. Bacterial corrosion may also occur, particularly in the Upper Peninsula.

The inspection should include visual observations of metal corrosion. As steel corrodes, it expands considerably. Relatively shallow corrosion can produce thick deposits of scale. A pick hammer is used to scrape off heavy deposits of rust and scale for observation and nondestructive thickness measurement of the metal. A pick hammer can also be used to locate unsound areas of exterior corrosion by striking the culvert wall with the pick end. The pick will deform the wall or break through it at locations of severe exterior corrosion.

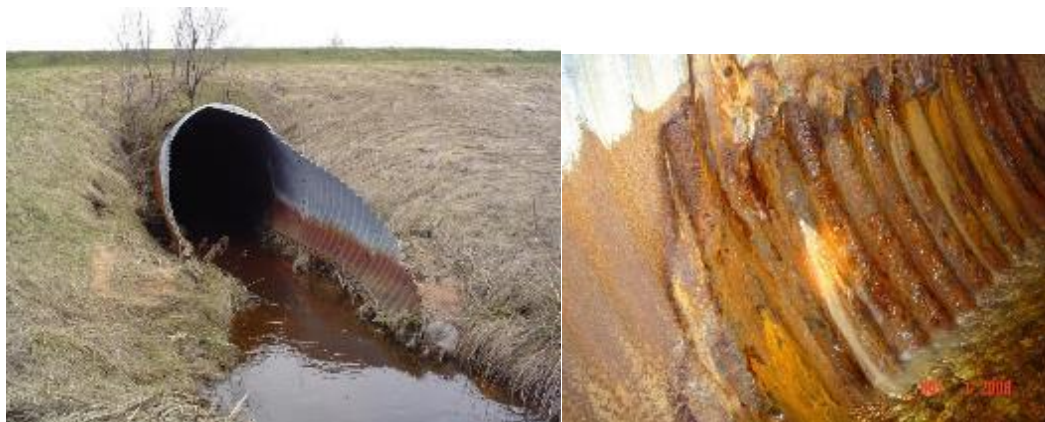
Figure 2-35: Loss of protective coatings contributing to corrosion

Protective coatings are examined for abrasion damage, tearing, cracking, and removal. Document the condition of coating, if applicable, and the extent and location of surface deterioration problems. These problems can all contribute to corrosion of the metal wall.

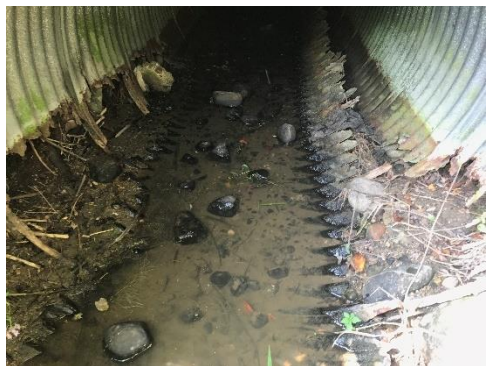
Figure 2-36: Abrasion wearing away corrugated metal pipe corrugations

Abrasion is the wearing away of culvert materials, typically at the invert, by the erosive action of bedload carried in the stream. Abrasion is generally most serious in steep or mountainous areas where high flow rates carry sand and rocks. Abrasion can accelerate

corrosion by wearing away protective coatings and previously corroded surfaces. Abrasion will wear the inside crests of the corrugations first.

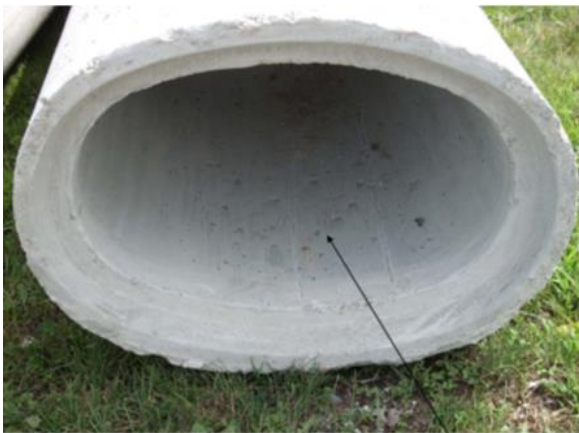
Figure 2-37: Elliptical concrete barrel

Shape evaluation of an ellipse is essentially the same as the evaluation of a crown section of round pipe (see "Round," previously), except that the curvature of the bottom should also be evaluated. Fair to Poor shape would be indicated when the bottom is flat in the center and corners are beginning to deflect downward or outward. Severe shape conditions would be indicated by reverse curvature in the bottom of arc.
