2 CULVERTS LESS THAN 10-FOOT SPAN

2.1 Definitions

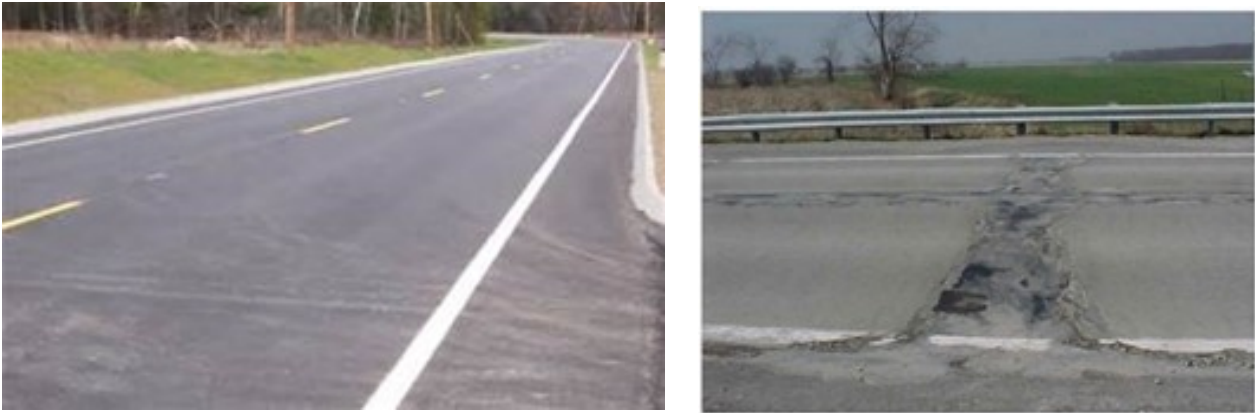
Figure 2-4: Approach roadway, without observable distress (left), clear distress over culvert (right)

Issues observed in the approach roadway can often be an indicator for culvert performance; however, they can equally be unrelated. Because of this, it is important for inspectors to evaluate the relationship between any identified approach roadway distress and culvert distress whenever possible.

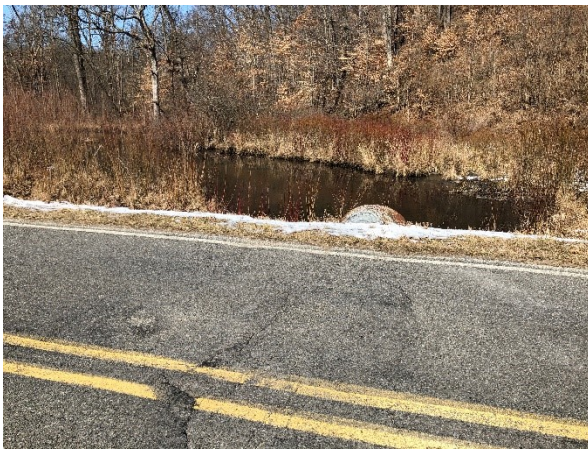
Transverse cracks are often related to culvert distress. These cracks run perpendicular to the direction of the road and are of primary interest as a distress indicator in culvert inspection. Regularly spaced transverse cracks along long stretches of roadway are usually caused by temperature-induced expansion and contraction and may not indicate culvert distress. Try to locate any sags or humps that may be associated with transverse cracks over the culvert.

Figure 2-6: Transverse cracking of pavement above culvert

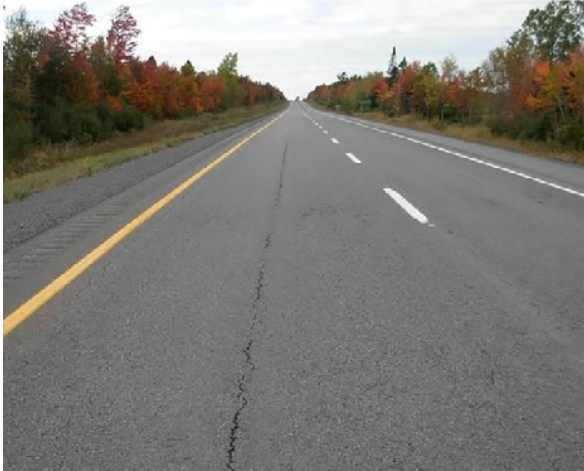
Longitudinal cracks run parallel to the direction of the road. Cracks within 1 foot of the lane edge are typically caused by shoulder settlement, frost action, or poor drainage, and may be unrelated to the presence of buried pipes. Consider these factors when assessing longitudinal cracks as distress indicators for a culvert. Longitudinal cracking that is not a distress indicator for the culvert does not need to be included in the condition rating but shall be noted in the comments.

Figure 2-7: Longitudinal cracking

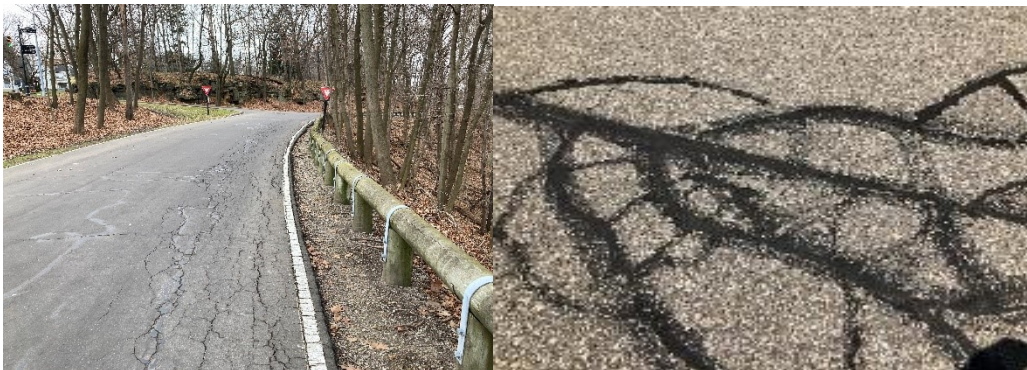
Alligator cracks are a form of fatigue cracking that forms a pattern of small angular pieces of pavement creating an appearance like alligator skin. This type of cracking is not typically associated with culvert distress. However, it may similarly indicate distress in the culvert if alligator cracking exists locally over the culvert but not in other areas. Note the presence of alligator cracking in the inspection report in the comments.

Figure 2-8: Pavement and shoulder alligator cracking

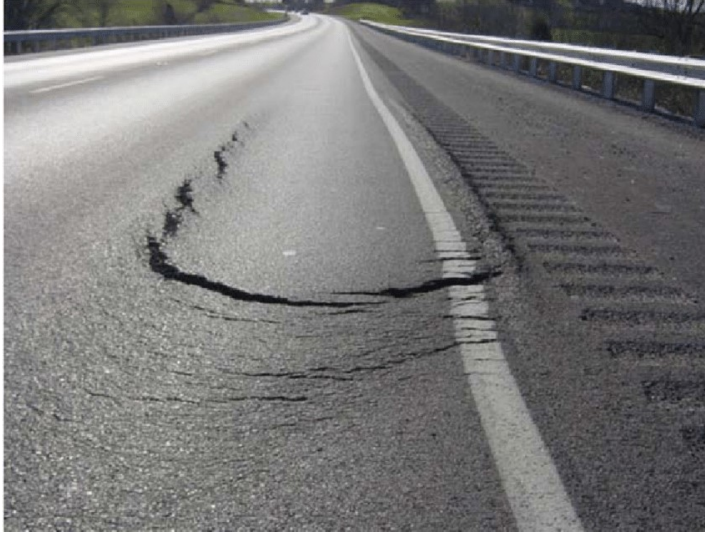
Slippage cracking is characterized by a generally rounded pattern caused by slippage between an overlay and underlying pavement occurring most commonly at intersections with high volumes of stop/start traffic. As with alligator cracking, slippage cracks do not typically indicate culvert distress. Note the presence of slippage cracks in the inspection report in the comments.

Figure 2-9: Slippage cracking

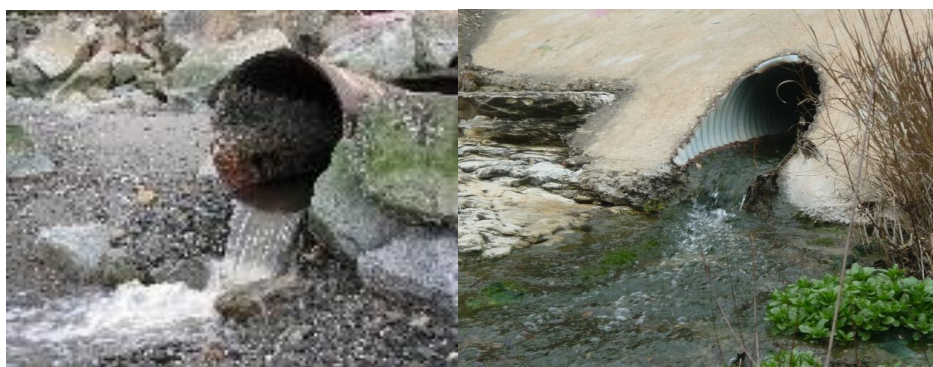
Poor vertical and horizontal alignment of the culvert relative to the stream channel can result in reduced hydraulic efficiency, increased erosion or sedimentation of the stream channel, damage to the embankment supporting the roadway, and damage to adjacent property. Often, protective measures are required to maintain stability of the channel and hydraulic and structural performance of the culvert.

Figure 2-13: Stream channel poor vertical alignment (left) and horizontal alignment (right)

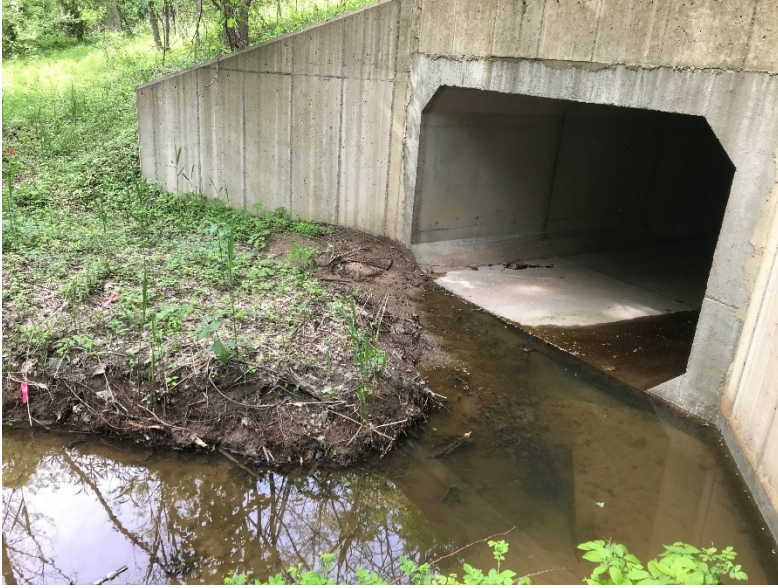
Check for erosion and indicators of changes in the direction or location of the stream channel. Plan-view sketches and site photographs are used to document the condition and horizontal alignment of the channel relative to the culvert barrel at the time of inspection. The alignment is critical for a three-sided culvert which may be susceptible to failure due to scour. Abrupt changes in stream horizontal alignment (bends) retard flow and cause increased erosion along the outside of the bend, damage to the culvert and end treatments, and increased sedimentation along the inside of the bend. Where sharp channel bends exist at either the inlet or outlet of a culvert, check for sedimentation and erosion.

Figure 2-14: Stream channel poor horizontal alignment

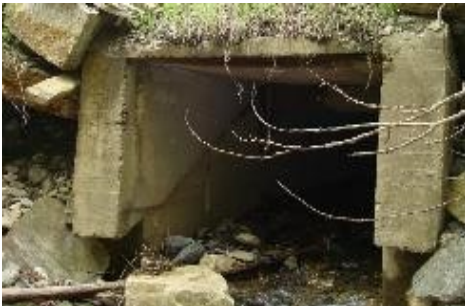
Figure 2-15: Vertical alignment issue leading to foundation undermining

Problems related to vertical alignment are usually indicated by scour or accumulation of sediment. Culverts on grades that differ significantly from the natural gradient (stream channel alignment) may present problems. Culverts on flat grades may have sediment build-up at the entrance or within the barrel. Culverts on moderate and steep grades generally have higher flow velocities than the natural stream and may have problems with outlet scour.

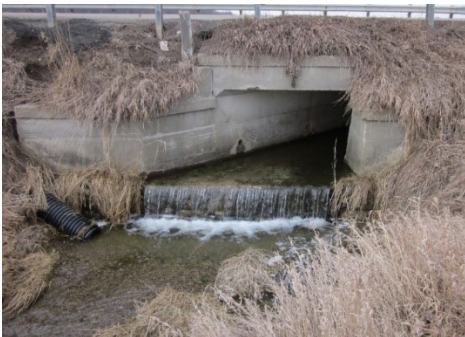
Figure 2-16: Vertical alignment issue leading to stream degradation

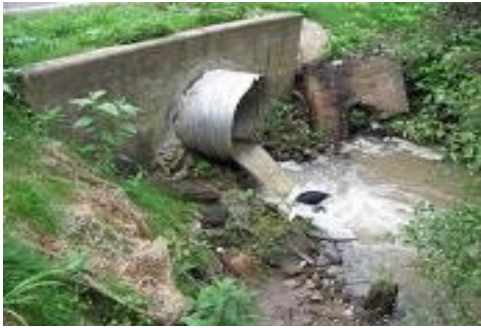
Figure 2-17: Vertical alignment distress; may have progressing washout due to high flow

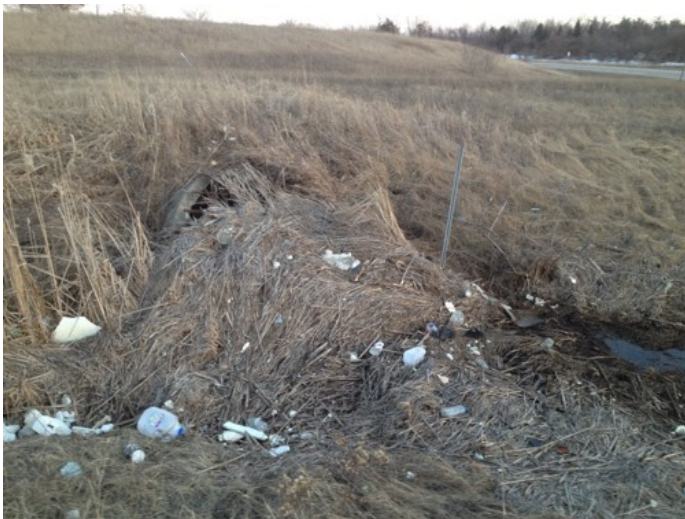
Figure 2-18: Blocked inlet

Accumulation of debris and sediment at the inlet or within the culvert barrel reduces both the size of the opening and the culvert's capacity to handle peak flows and may cause scour of the stream banks and roadway embankment, head cutting, or changes in the channel alignment. Debris and sediment accumulations at the culvert inlets or within the culvert barrel may result in roadway overtopping, excessive ponding, and the potential for damage due to buoyant forces. Note deposits of debris or sediment that could block the

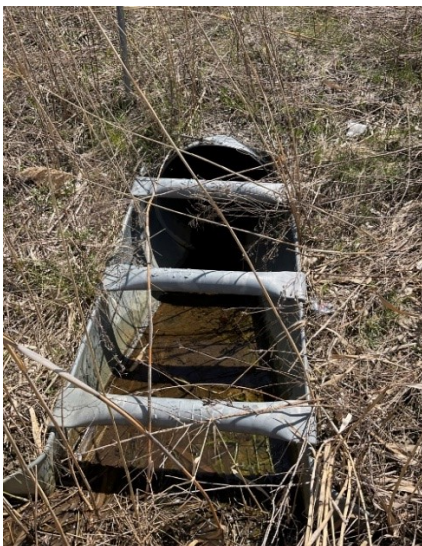
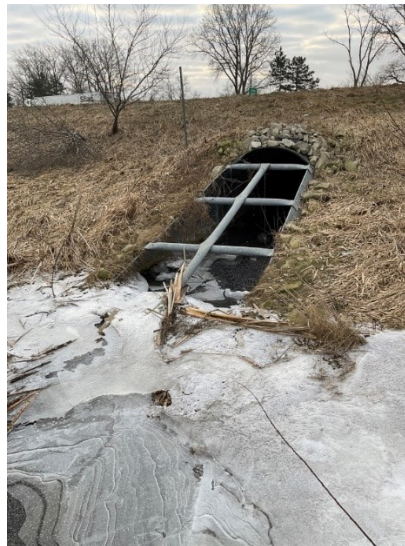
A sloped end section is a culvert end that has been modified to match the embankment slope. They often have safety bars that can trap debris. Culverts with mitered or skewed end treatments are inspected for the same types of problems as culverts with projecting ends. Sloped end sections include prefabricated metal or precast concrete sections that are placed on small diameter pipe.

Metal pipe culverts with a sloped end are inspected for deformation since cutting the ends reduces the structural integrity of the pipe. It is therefore important to check cut ends of culverts for signs of distress including deformation, erosion of the fill slope, and undercutting.

Figure 2-23: Sloped metal end sections

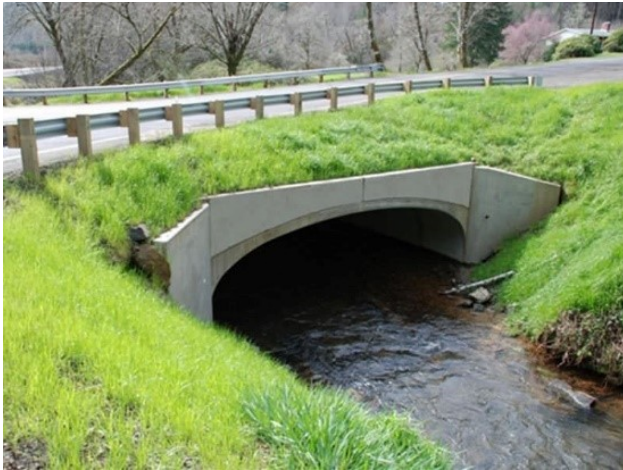
Figure 2-24: Concrete headwall and wingwall

Headwalls and wingwalls are inspected for any signs of undermining and settlement, such as cracking, tipping/rotation, or separation of the culvert barrel from the headwall. If the headwall is comprised of a metal or concrete material will determine the types of condition state distresses which apply. Cracking, surface damage, spalling, delamination, and exposed repair will apply to concrete headwalls. Corrosion, deformation, and damage apply to metal walls. Any visible wall vertical offset is noted in the inspection report.

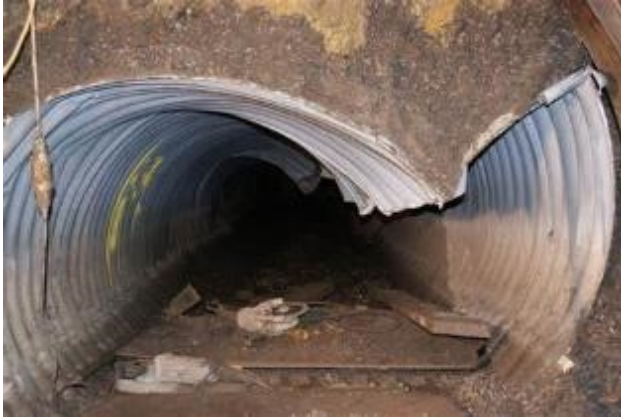
Figure 2-30: Loss of vertical alignment in a corrugated metal culvert

Vertical alignment is checked for distortion, including warping, sagging, local crushing, and heaving. Be aware that pipes are occasionally laid with a camber (concave downward curvature along the pipe length) or a grade change to allow for fill settlement due to differential foundation soils or differential embankment loads.

Warping is characterized by deviation from flatness as a result of stresses and uneven shrinkage. Sagging is vertical deformation that can be caused by overloading or by creep (permanent deformation due to constant loading over time). Sags impede water flow which may aggravate settlement problems by saturating the supporting soil through

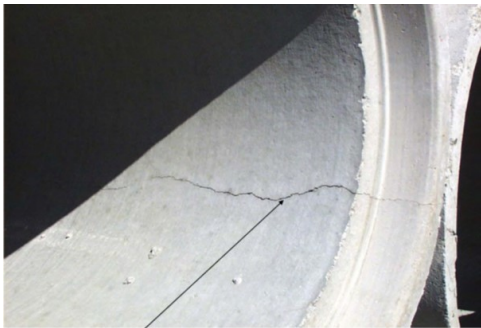
Figure 2-32: Longitudinal crack within a concrete barrel

Hairline longitudinal cracks in the crown and invert of the pipe usually develop as the rebar picks up the tensile stress due to circumferential bending. Measurements of crack width are taken as an indication of the structural condition of the pipe. Any visible wall vertical offset is noted in the inspection report.

Hairline cracks less than 0.01 in. in width are minor and only need to be noted in the inspection notes. Moderate cracks greater than hairline cracks are described in the inspection report and noted as possible candidates for maintenance. Major longitudinal cracking in equal to or excess of 0.1 inch in width may indicate overloading or poor bedding and side support and warrant further evaluation by an engineer.

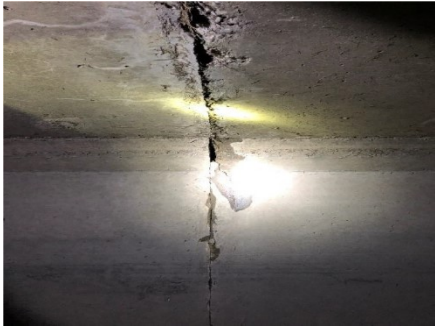
Figure 2-33: Spalling within a box culvert

Spalling is a fracture of the concrete parallel or inclined to the surface of the concrete.

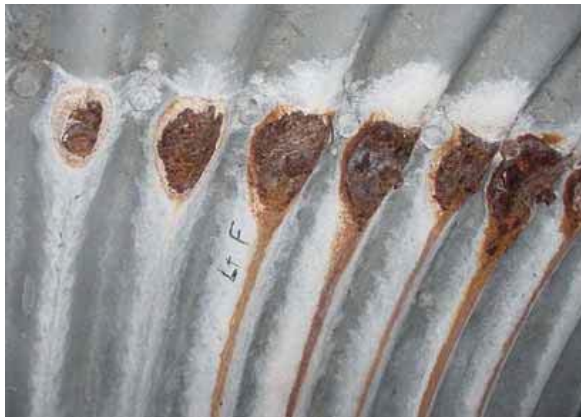
Figure 2-35: Corrosion of a metal culvert

The inspection should include visual observations of metal corrosion. As steel corrodes, it expands considerably. Relatively shallow corrosion can produce thick deposits of scale. A pick hammer is used to scrape off heavy deposits of rust and scale for observation and nondestructive thickness measurement of the metal. A pick hammer can also be used to locate unsound areas of exterior corrosion by striking the culvert wall with the pick end. The pick will deform the wall or break through it at locations of severe exterior corrosion.

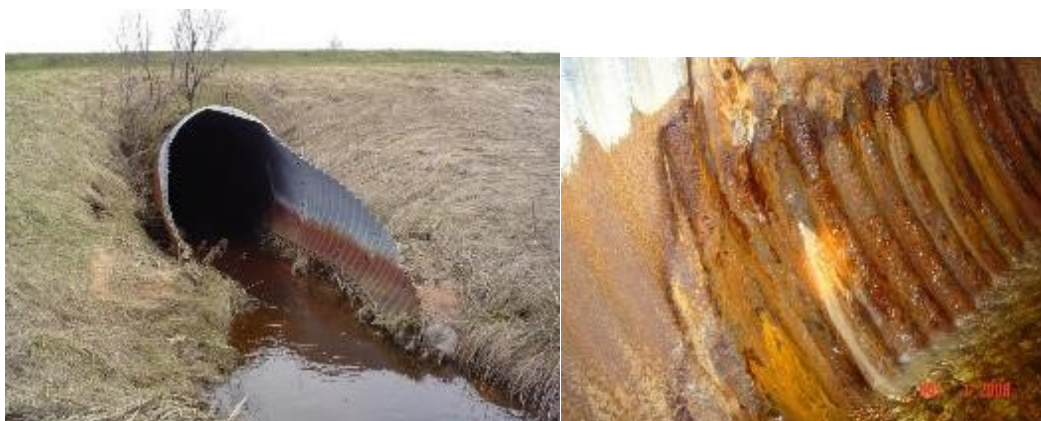
Figure 2-36: Loss of protective coatings contributing to corrosion

Protective coatings are examined for abrasion damage, tearing, cracking, and removal. Document the condition of coating, if applicable, and the extent and location of surface deterioration problems. These problems can all contribute to corrosion of the metal wall.

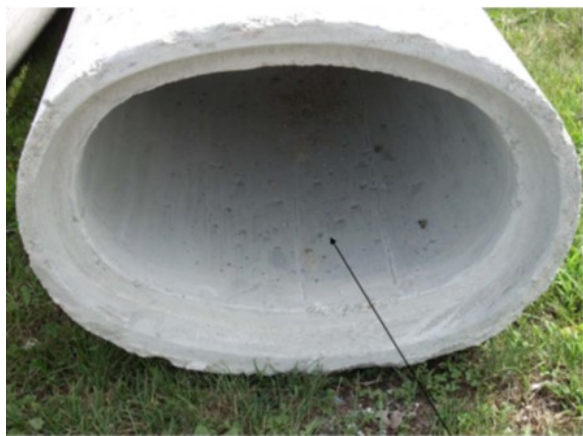
Figure 2-38: Elliptical concrete barrel

Shape evaluation of an ellipse is essentially the same as the evaluation of a crown section of round pipe (see "Round," previously), except that the curvature of the bottom should also be evaluated. Fair to Poor shape would be indicated when the bottom is flat in the center and corners are beginning to deflect downward or outward. Severe shape conditions would be indicated by reverse curvature in the bottom of arc.
