## 2 CULVERTS LESS THAN 10-FOOT SPAN

### 2.1 Definitions

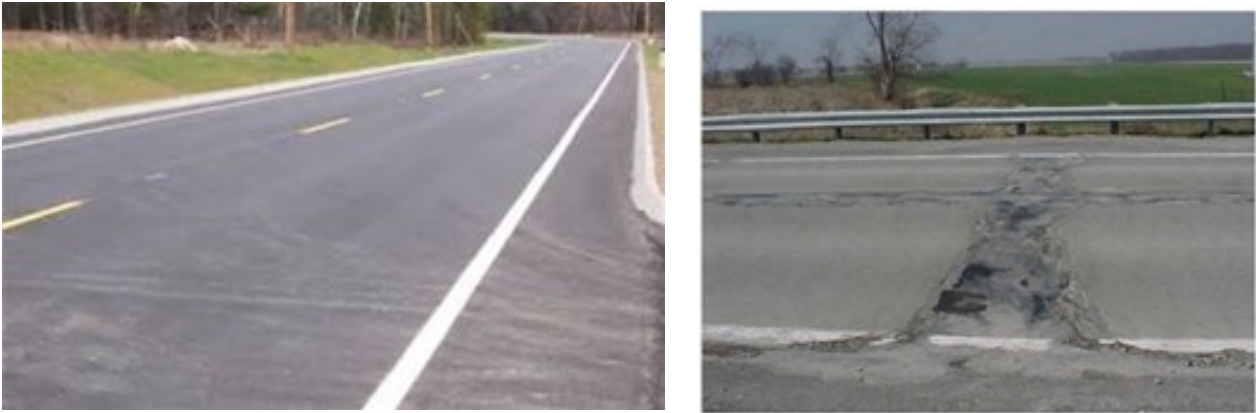
**Figure 2-4: Approach roadway, without observable distress (left), clear distress over culvert (right)**

Issues observed in the approach roadway can often be an indicator for culvert performance; however, they can equally be unrelated. Because of this, it is important for inspectors to evaluate the relationship between any identified approach roadway distress and culvert distress whenever possible.

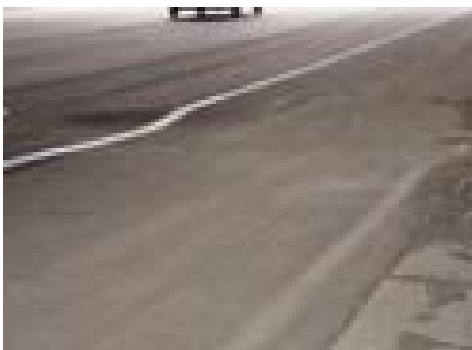
**Figure 2-5: Pavement and shoulder issues above culverts**

- Poorly compacted materials
- A significant difference in soils used for roadway embankment compared to those used for pipe embedment
- Piping (washout of fines) along the culvert causing voids or cracks above
- Settlement of backfill material, allowing movement of the structure
- Flexible pipe barrels will deflect at their crown if:
  - Adequate lateral support is not provided by the surrounding embedment soil
  - Pipe is overloaded and deflects
- For rigid culverts, inadequate compaction or low-quality embedment soil can result in settlement on either side of the culvert, usually forming a hump over the buried pipe

Sighting along the edge of pavement or along pavement markings is also important and can reveal settlement indicators including humps, sags, and rutting.

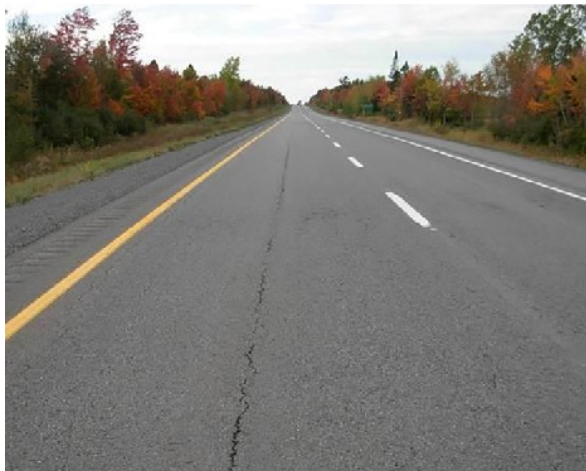
Longitudinal cracks run parallel to the direction of the road. Cracks within 1 foot of the lane edge are typically caused by shoulder settlement, frost action, or poor drainage, and may be unrelated to the presence of buried pipes. Consider these factors when assessing longitudinal cracks as distress indicators for a culvert. Longitudinal cracking that is not a distress indicator for the culvert does not need to be included in the condition rating but shall be noted in the comments.

**Figure 2-7: Longitudinal cracking**

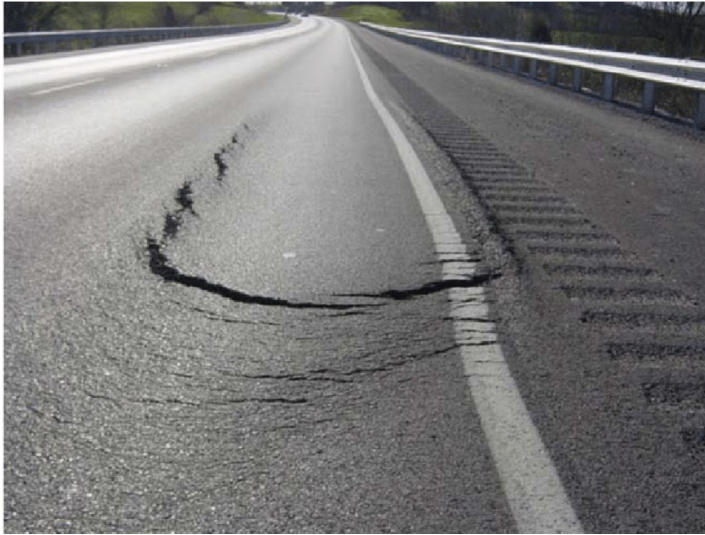
Slippage cracking is characterized by a generally rounded pattern caused by slippage between an overlay and underlying pavement occurring most commonly at intersections with high volumes of stop/start traffic. As with alligator cracking, slippage cracks do not typically indicate culvert distress. Note the presence of slippage cracks in the inspection report in the comments.

**Figure 2-9: Slippage cracking**

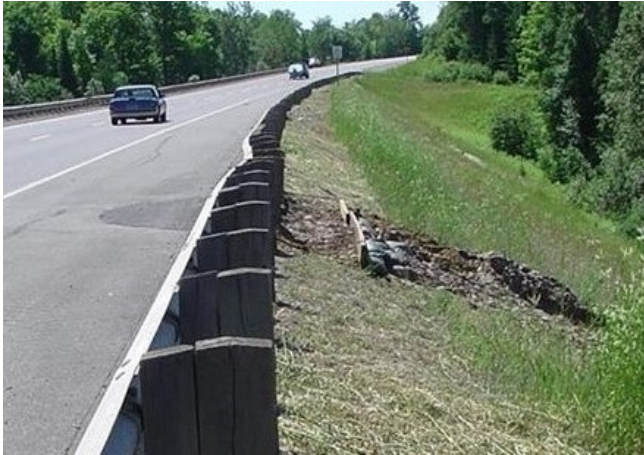
**Figure 2-10: Example of embankment failure above a culvert**

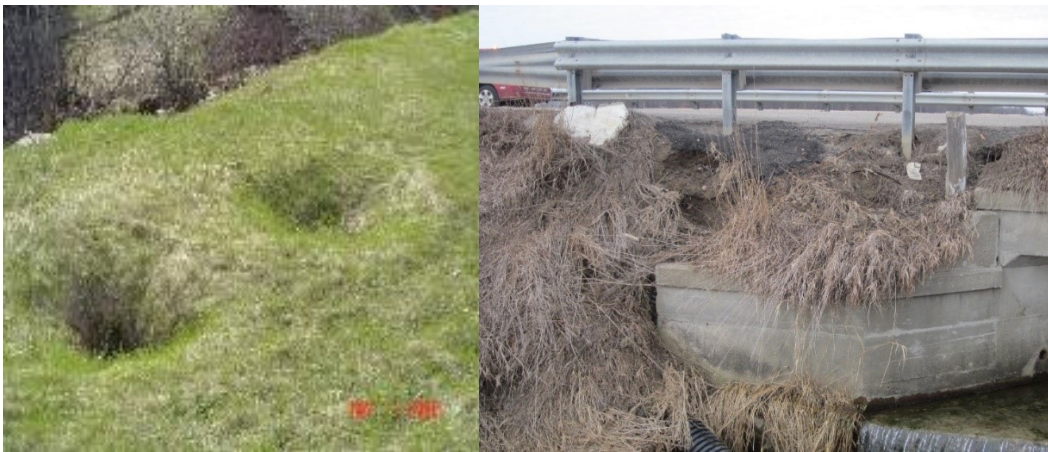
**Figure 2-11: Example of embankment issues due to piping (left) or erosion (right)**

Erosion of the backfill where water flows along the outside of the pipe. Piping along the outside of the barrel of the culvert can reduce backfill support and can lead to weakened embankment slope stability.

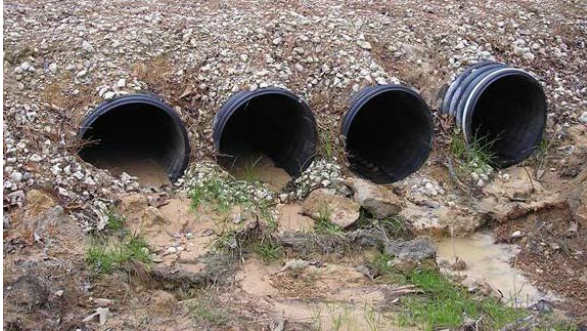
Specific types of surface erosion where runoff carves channels in the soil. This typically occurs with multiple barrel pipes and/or with mitered or projecting ends.

**Figure 2-12: Culvert erosion—early-stage gully/rill erosion between the culverts**

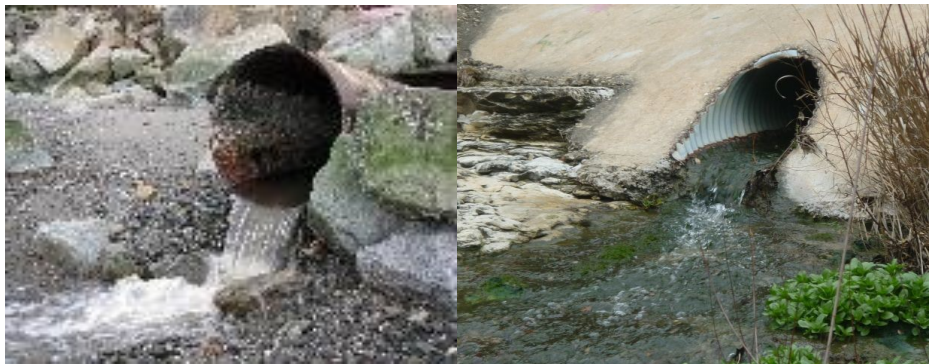
Poor vertical and horizontal alignment of the culvert relative to the stream channel can result in reduced hydraulic efficiency, increased erosion or sedimentation of the stream channel, damage to the embankment supporting the roadway, and damage to adjacent property. Often, protective measures are required to maintain stability of the channel and hydraulic and structural performance of the culvert.

**Figure 2-13: Stream channel poor vertical alignment (left) and horizontal alignment (right)**

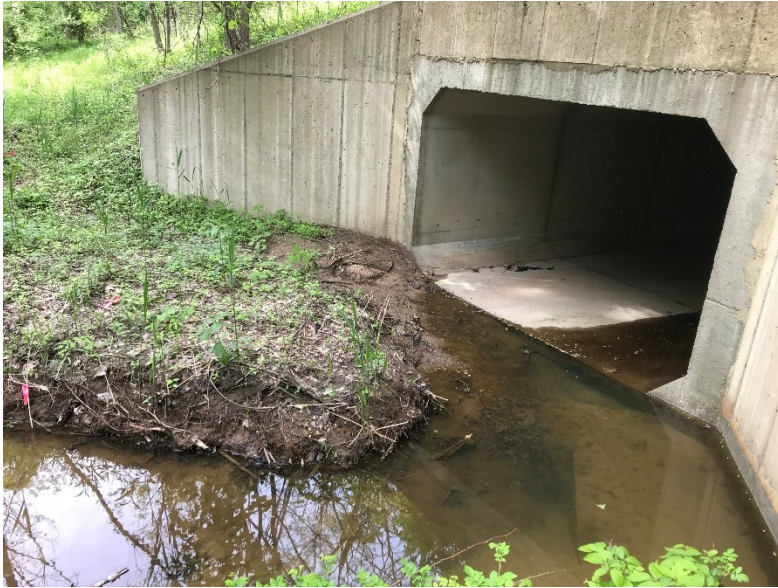
Check for erosion and indicators of changes in the direction or location of the stream channel. Plan-view sketches and site photographs are used to document the condition and horizontal alignment of the channel relative to the culvert barrel at the time of inspection. The alignment is critical for a three-sided culvert which may be susceptible to failure due to scour. Abrupt changes in stream horizontal alignment (bends) retard flow and cause increased erosion along the outside of the bend, damage to the culvert and end treatments, and increased sedimentation along the inside of the bend. Where sharp channel bends exist at either the inlet or outlet of a culvert, check for sedimentation and erosion.

**Figure 2-14: Stream channel poor horizontal alignment**

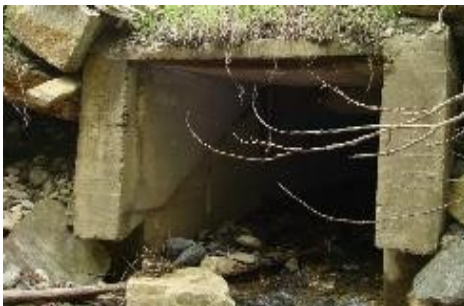
**Figure 2-15: Vertical alignment issue leading to foundation undermining**

Problems related to vertical alignment are usually indicated by scour or accumulation of sediment. Culverts on grades that differ significantly from the natural gradient (stream channel alignment) may present problems. Culverts on flat grades may have sediment build-up at the entrance or within the barrel. Culverts on moderate and steep grades generally have higher flow velocities than the natural stream and may have problems with outlet scour.

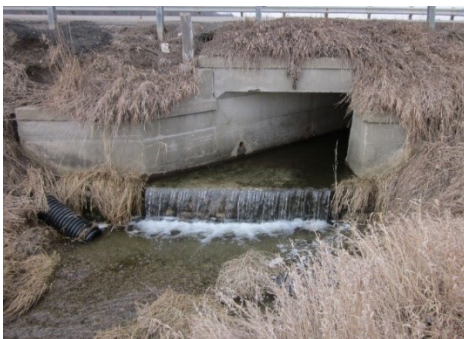
**Figure 2-16: Vertical alignment issue leading to stream degradation**

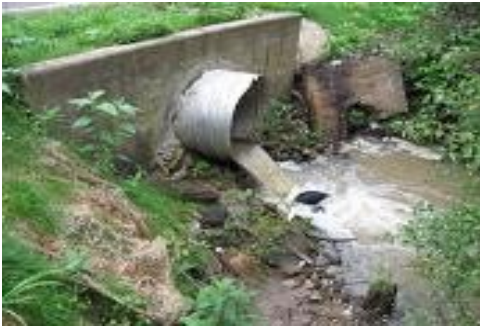
**Figure 2-17: Vertical alignment distress; may have progressing washout due to high flow**

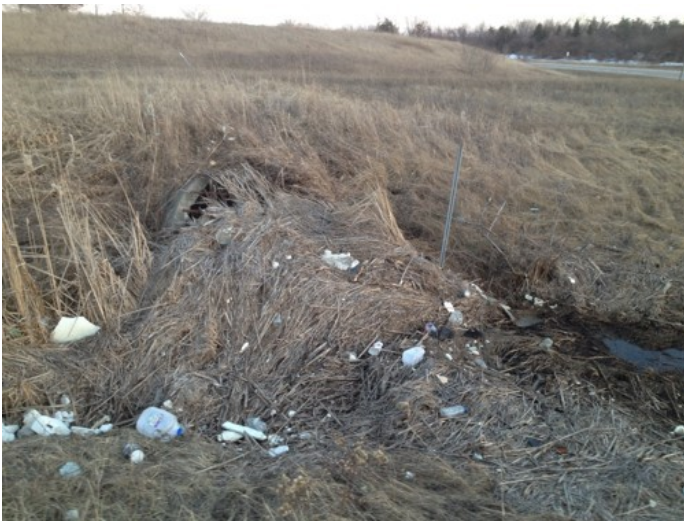
**Figure 2-18: Blocked inlet**

Determine the ability of the culvert to handle peak flows, changes in the watershed, changes in the stream channel which might affect the hydraulic performance, and, most commonly, levels of sedimentation and debris accumulation. Assessment of waterway adequacy includes inspection of highwater marks and waterway obstructions. Waterway adequacy may not be a large concern for smaller culvert component rating.

The high-water marks may not seem important, but they be an indicator for inadequacy of the culvert and shall be investigated. Note any indications of excessive ponding, flooding, or overtopping of the roadway. If the cause is apparent, such as a blocked inlet, note in the inspection comments.

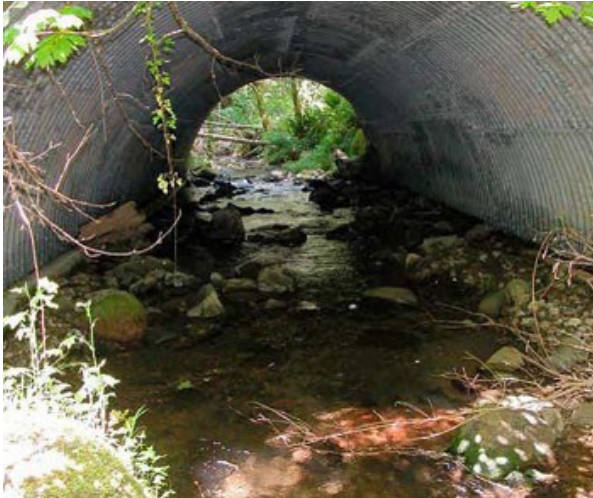
Note some culverts may be designed with fill in the bottom (invert) to create a more natural stream bed for fish. Identify these culverts to distinguish intentional fill from debris accumulation.

**Figure 2-19: Intentional natural streambed**

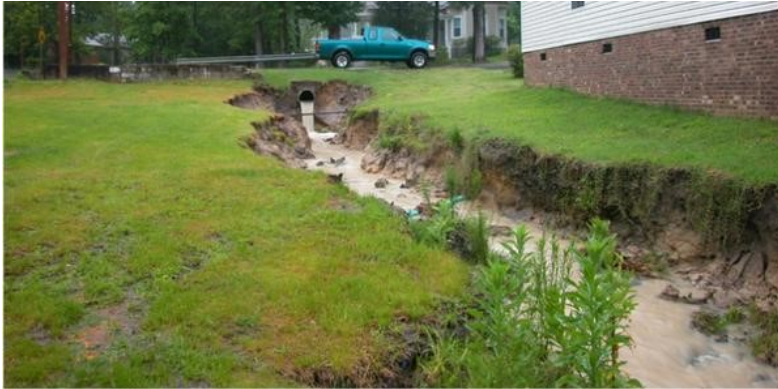
Bank erosion, in contrast to general scour and head cutting, refers to loss of stream channel (bank) sidewall material and a lateral movement of the channel. Bank erosion includes expansion of the channel at a change in direction of the stream when protection is not provided or provided protection is not adequate. Signs of severe bank erosion include undercutting of bank edge and sod root overhangs.

**Figure 2-20: Bank erosion**

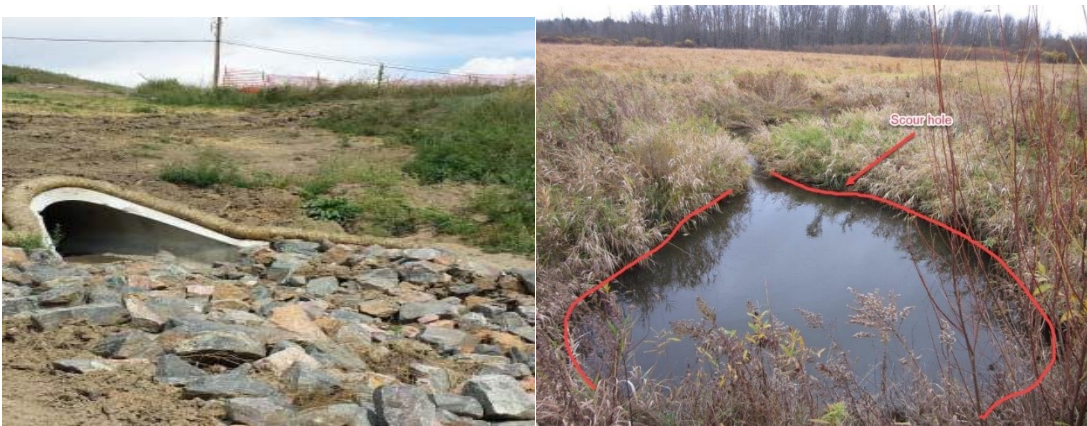
**Figure 2-21: No scour (left), scour hole (right)**

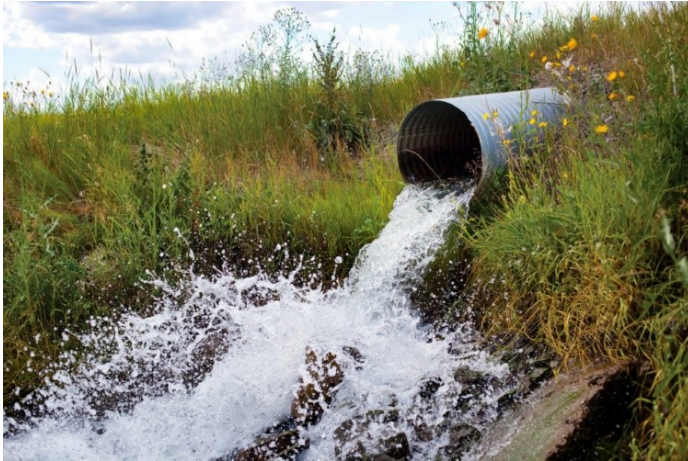
Projecting ends have no end structure attached to the culvert barrel and the pipe barrel simply projects out of the embankment. Projecting outlets, such as perched outlets, often result from scour holes formed due to impact of high exit velocities and/or stream degradation. They also result from erosion and can be a barrier to fish passage.

**Figure 2-22: Projecting or perched outlet**

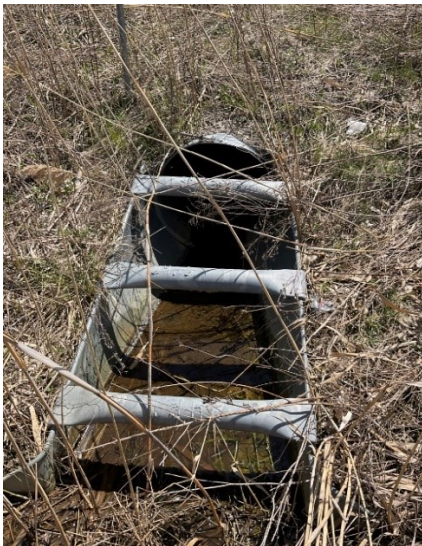
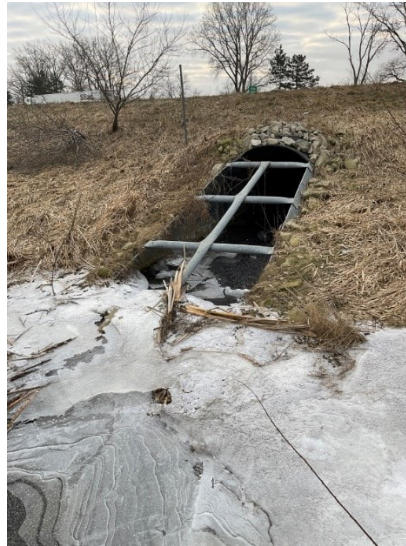
A sloped end section is a culvert end that has been modified to match the embankment slope. They often have safety bars that can trap debris. Culverts with mitered or skewed end treatments are inspected for the same types of problems as culverts with projecting ends. Sloped end sections include prefabricated metal or precast concrete sections that are placed on small diameter pipe.

Metal pipe culverts with a sloped end are inspected for deformation since cutting the ends reduces the structural integrity of the pipe. It is therefore important to check cut ends of culverts for signs of distress including deformation, erosion of the fill slope, and undercutting.

**Figure 2-23: Sloped metal end sections**

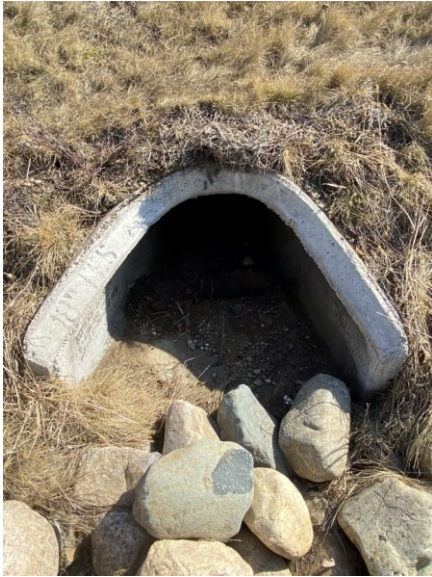
Precast concrete end sections are inspected for deformation and damage similar to sloped ends.

**Figure 2-24: Flared concrete end section**

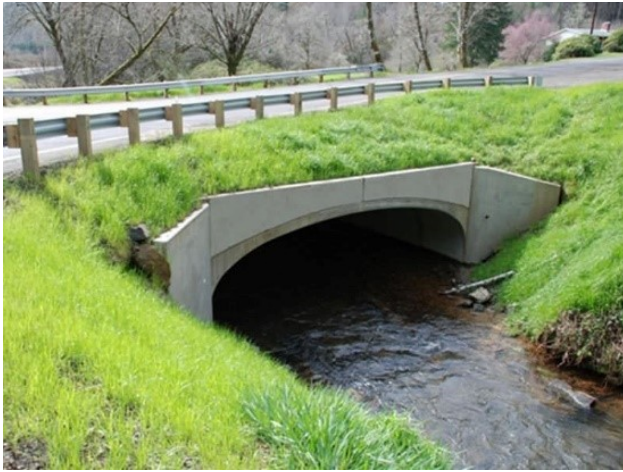
Headwalls and wingwalls are inspected for any signs of undermining and settlement, such as cracking, tipping/rotation, or separation of the culvert barrel from the headwall. If the headwall is comprised of a metal or concrete material will determine the types of condition state distresses which apply. Cracking, surface damage, spalling, delamination, and exposed repair will apply to concrete headwalls. Corrosion, deformation, and damage apply to metal walls. Any visible wall vertical offset is noted in the inspection report.

**Figure 2-24: Concrete headwall and wingwall**

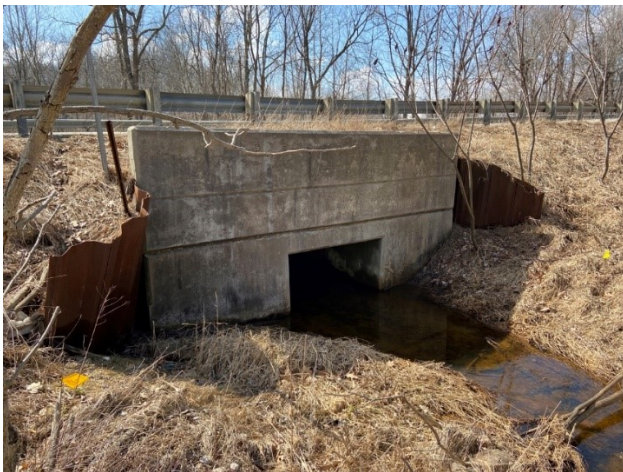
**Figure 2-25: Concrete headwall and metal sheet pile wingwalls**

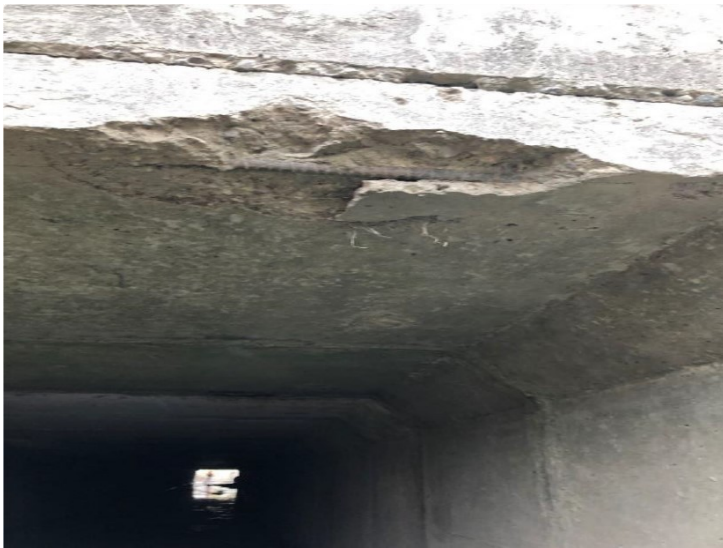
Spalling may be detected by visual examination of the concrete along the edges of cracks. Tapping with a hammer is performed along cracks to check for areas that have fractured but are not visibly debonded, as these areas will produce a hollow sound when tapped.

**Figure 2-26: Spalled concrete at headwall**

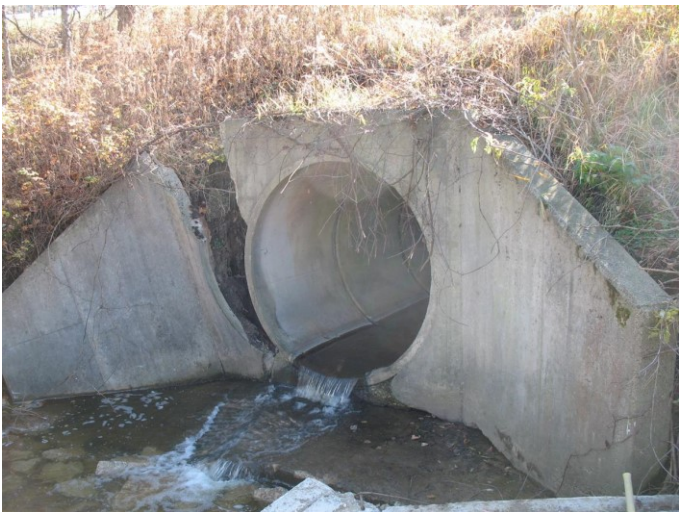
Culvert scour consists of three types of scours: stream degradation, contraction scour, and local scour. Stream degradation is long term changes in the streambed elevation due to natural or human-induced causes, which can affect the reach of the river near the culvert. Contraction scour is removal of material from the bed and banks across all or most of the channel width, resulting from the contraction of the flow area. Local scour is removal of bed material from around the culvert foundation. Local scour is caused by the acceleration of flow and vortices resulting from flow around an obstruction.

**Figure 2-27: Concrete foundation and wingwall damage due to scour**

The most common structural distress in concrete footings is differential settlement, typically due to scour undermining the footing. Differential settlement occurs when one section of a footing settles more than the rest of the footing. This can cause cracking in concrete, wrinkling in corrugated metal, distress to joints, or other damage or distortion in

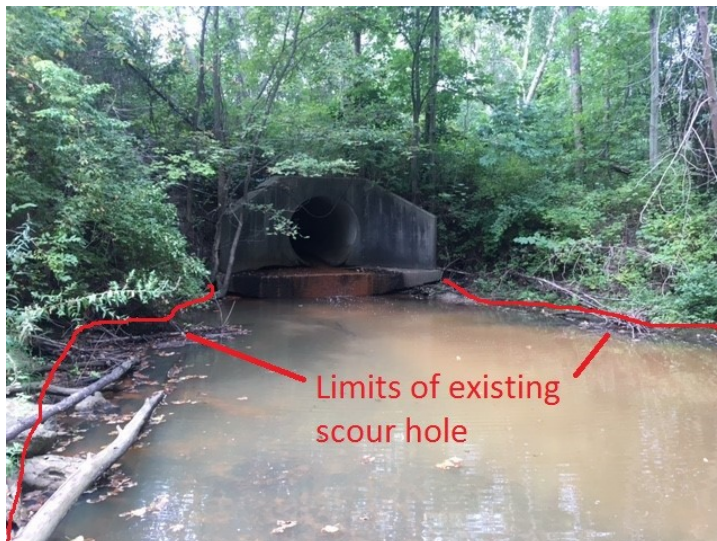
**Figure 2-28: Perched outlet with large scour hole**

Concrete invert slabs are checked for undermining and settlement. Undermining is checked by probing along the edge of the apron. Settlement can be detected by checking for cracks, rotation, and signs of movement at the joint with the headwall. The joints between concrete aprons and headwalls should also be checked for movement (separation) and water tightness. Slabs are checked for damage such as spalls, open cracks, holes, or missing portions. Undermining can lead to a perched condition where piping occurs underneath the barrel. This perched condition can be due to stream degradation, or local scour. In critical conditions, voids around the culvert might appear.

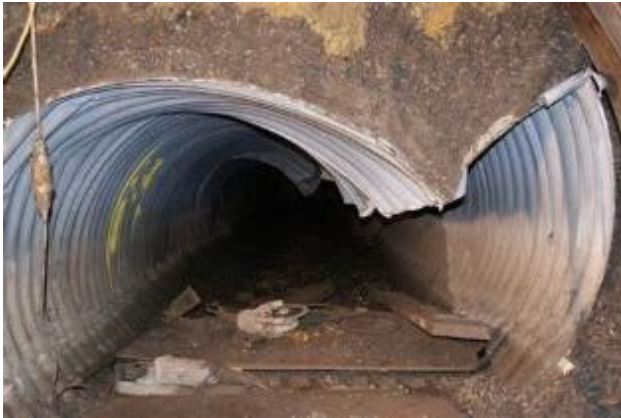
**Figure 2-30: Loss of vertical alignment in a corrugated metal culvert**

Vertical alignment is checked for distortion, including warping, sagging, local crushing, and heaving. Be aware that pipes are occasionally laid with a camber (concave downward curvature along the pipe length) or a grade change to allow for fill settlement due to differential foundation soils or differential embankment loads.

Warping is characterized by deviation from flatness as a result of stresses and uneven shrinkage. Sagging is vertical deformation that can be caused by overloading or by creep (permanent deformation due to constant loading over time). Sags impede water flow which may aggravate settlement problems by saturating the supporting soil through

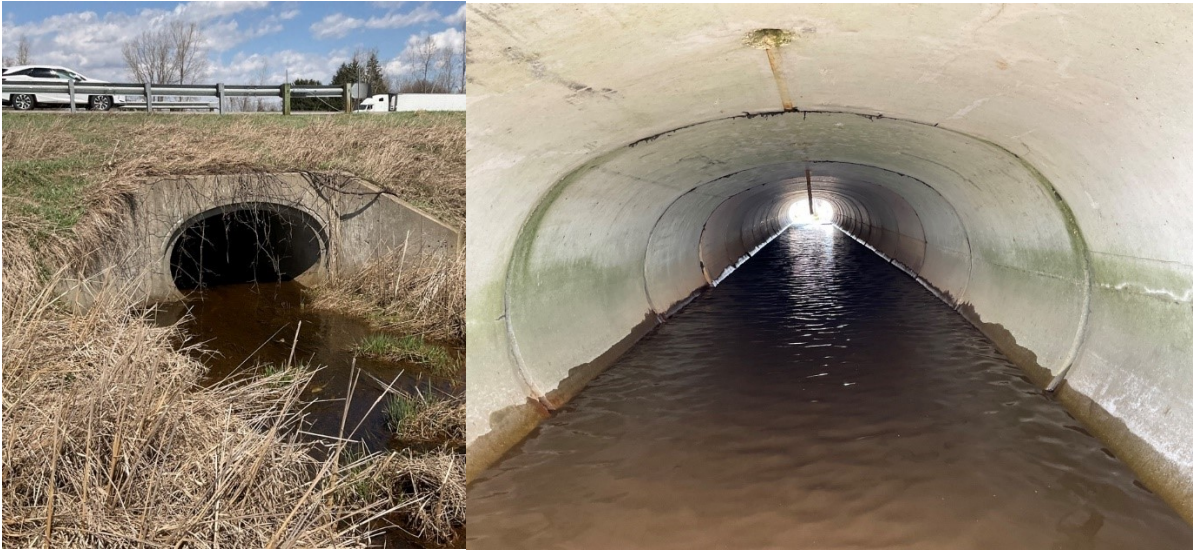
**Figure 2-31: Concrete barrel culvert**

Concrete culverts and storm drain barrels may be either precast or cast-in-place. Precast concrete pipe is manufactured in a fabrication facility. The manufacturing process is under controlled conditions enabling uniform quality concrete. Cast-in-place (CIP) concrete is cast at the site in formwork, placing reinforcement bars (rebar), and pouring concrete in its final location. Most CIP concrete culverts are single or multi-cell box culverts constructed using conventional bridge construction techniques. Both CIP and precast concrete culverts are somewhat protected by the soil backfill from rapid fluctuations in surface temperature and direct application chloride (salts) used for deicing. As a result, they are generally more resistant to surface material degradation than conventional concrete bridge elements, such as bridge decks.

Concrete culvert and storm drain barrels are classified as rigid structures because they do not bend or deflect appreciably under load before cracking or fracturing. As a result, shape evaluations, while very important in flexible structures, are of little value in inspecting concrete pipes. However, adequate stability of the surrounding soil, particularly below the pipe springline, is necessary to prevent excessive stress that can cause cracking of the pipe wall. Therefore, look for any indications of a lack of embedment soil stability as well as signs of structural distress such as cracking. Inspection of concrete barrels concentrates on distress in the walls of the structure.

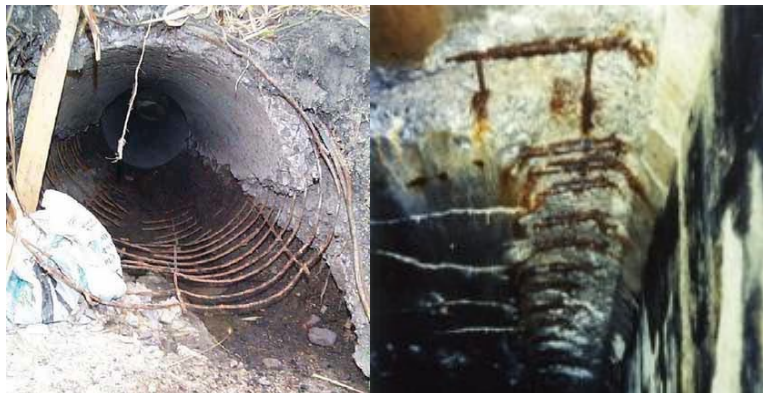
**Figure 2-34: Concrete barrel deterioration**

Delaminations are separations along a plane parallel to a surface, as in the separation of a coating from a substrate or the layers of a coating from each other, or, in the case of a concrete slab, a horizontal splitting, cracking, or separation of a slab in a plane roughly parallel to, and generally near, the upper surface. Delaminations are not visible from the surface but can be detected by tapping along the surface with a hammer or dragging a chain to detect hollow-sounding areas.

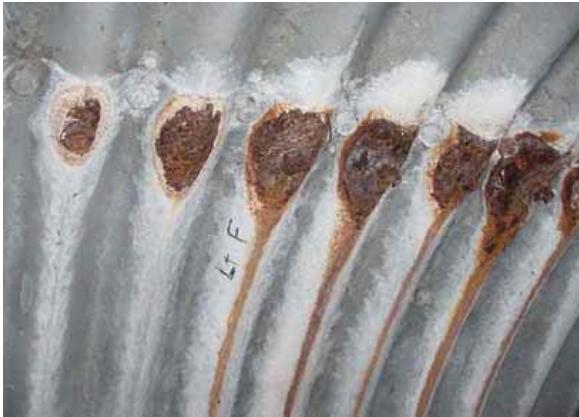
**Figure 2-35: Corrosion of a metal culvert**

The inspection should include visual observations of metal corrosion. As steel corrodes, it expands considerably. Relatively shallow corrosion can produce thick deposits of scale. A pick hammer is used to scrape off heavy deposits of rust and scale for observation and nondestructive thickness measurement of the metal. A pick hammer can also be used to locate unsound areas of exterior corrosion by striking the culvert wall with the pick end. The pick will deform the wall or break through it at locations of severe exterior corrosion.

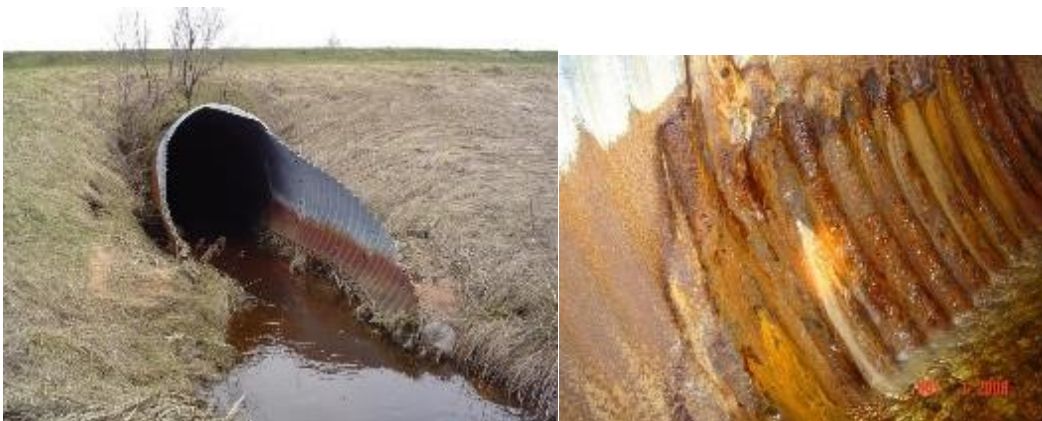
**Figure 2-36: Loss of protective coatings contributing to corrosion**

Protective coatings are examined for abrasion damage, tearing, cracking, and removal. Document the condition of coating, if applicable, and the extent and location of surface deterioration problems. These problems can all contribute to corrosion of the metal wall.

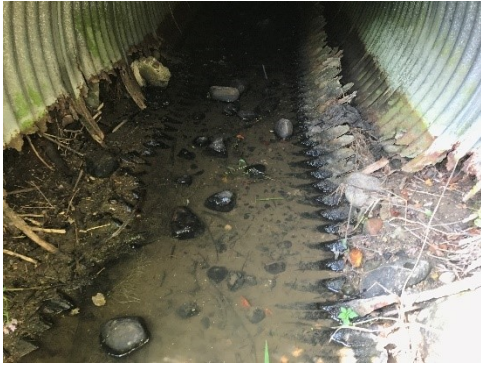
**Figure 2-37: Abrasion wearing away corrugated metal pipe corrugations**

Abrasion is the wearing away of culvert materials, typically at the invert, by the erosive action of bedload carried in the stream. Abrasion is generally most serious in steep or mountainous areas where high flow rates carry sand and rocks. Abrasion can accelerate corrosion by wearing away protective coatings and previously corroded surfaces. Abrasion will wear the inside crests of the corrugations first.

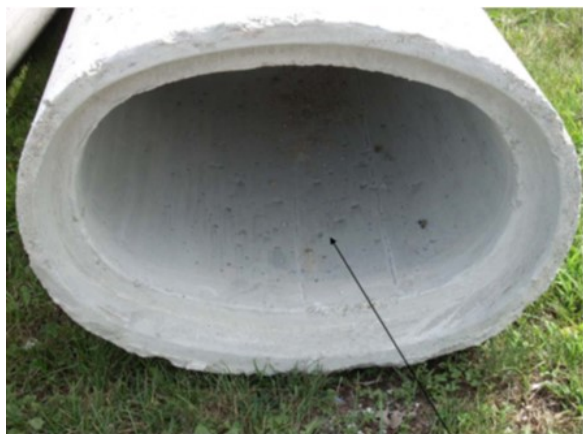
**Figure 2-38: Elliptical concrete barrel**

Shape evaluation of an ellipse is essentially the same as the evaluation of a crown section of round pipe (see "Round," previously), except that the curvature of the bottom should also be evaluated. Fair to Poor shape would be indicated when the bottom is flat in the center and corners are beginning to deflect downward or outward. Severe shape conditions would be indicated by reverse curvature in the bottom of arc.
