## 2 CULVERTS LESS THAN 10-FOOT SPAN

### 2.1 Definitions

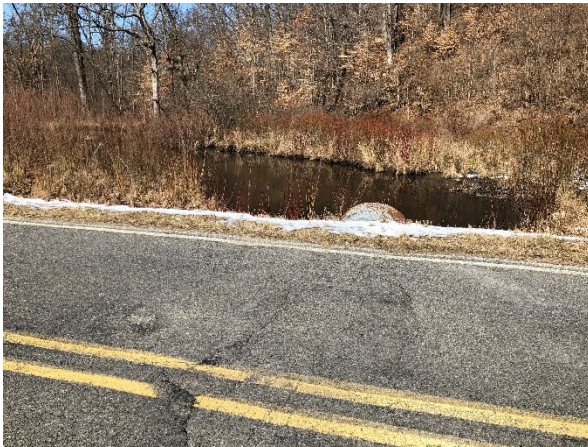
**Figure 2-6: Transverse cracking of pavement above culvert**

Transverse cracks are often related to culvert distress. These cracks run perpendicular to the direction of the road and are of primary interest as a distress indicator in culvert inspection. Regularly spaced transverse cracks along long stretches of roadway are usually caused by temperature-induced expansion and contraction and may not indicate culvert distress. Try to locate any sags or humps that may be associated with transverse cracks over the culvert.

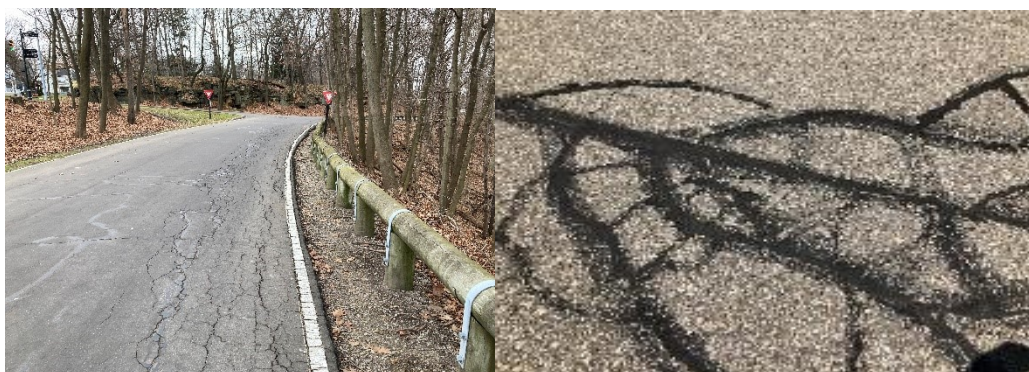
**Figure 2-8: Pavement and shoulder alligator cracking**

Alligator cracks are a form of fatigue cracking that forms a pattern of small angular pieces of pavement creating an appearance like alligator skin. This type of cracking is not typically associated with culvert distress. However, it may similarly indicate distress in the culvert if alligator cracking exists locally over the culvert but not in other areas. Note the presence of alligator cracking in the inspection report in the comments.

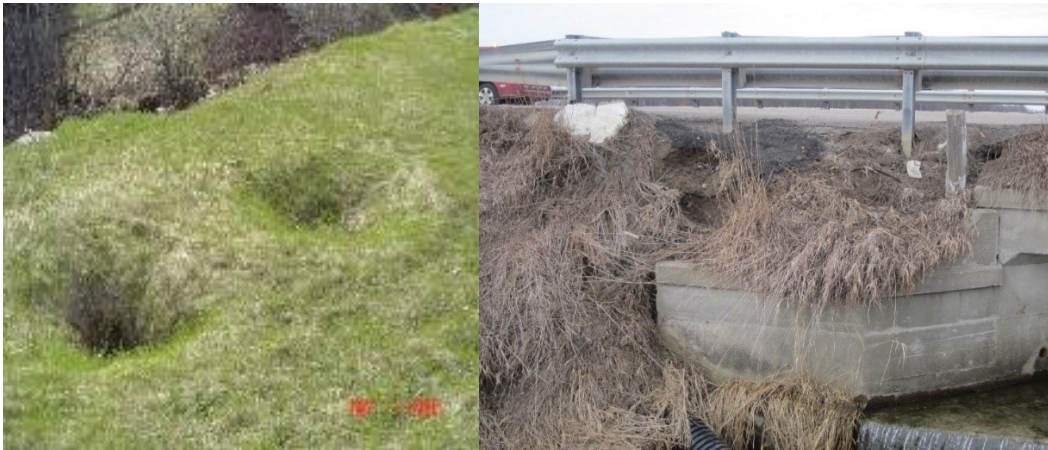
**Figure 2-11: Example of embankment issues due to piping (left) or erosion (right)**

Erosion of the backfill where water flows along the outside of the pipe. Piping along the outside of the barrel of the culvert can reduce backfill support and can lead to weakened embankment slope stability.

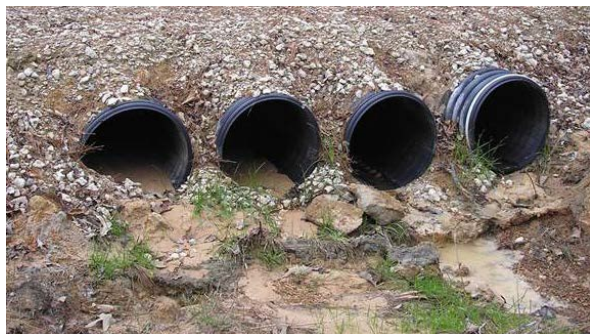
**Figure 2-12: Culvert erosion—early-stage gully/rill erosion between the culverts**

Specific types of surface erosion where runoff carves channels in the soil. This typically occurs with multiple barrel pipes and/or with mitered or projecting ends.

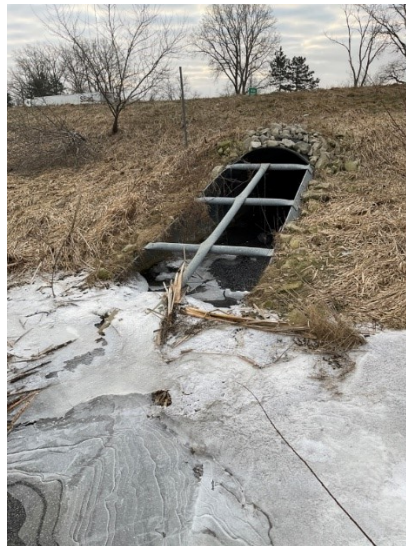
**Figure 2-23: Sloped metal end sections**

A sloped end section is a culvert end that has been modified to match the embankment slope. They often have safety bars that can trap debris. Culverts with mitered or skewed end treatments are inspected for the same types of problems as culverts with projecting ends. Sloped end sections include prefabricated metal or precast concrete sections that are placed on small diameter pipe.

Metal pipe culverts with a sloped end are inspected for deformation since cutting the ends reduces the structural integrity of the pipe. It is therefore important to check cut ends of culverts for signs of distress including deformation, erosion of the fill slope, and undercutting.

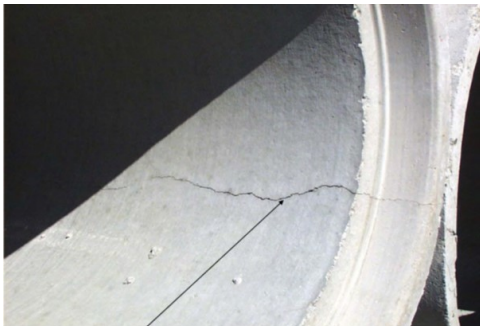
Hairline longitudinal cracks in the crown and invert of the pipe usually develop as the rebar picks up the tensile stress due to circumferential bending. Measurements of crack width are taken as an indication of the structural condition of the pipe. Any visible wall vertical offset is noted in the inspection report.

Hairline cracks less than 0.01 in. in width are minor and only need to be noted in the inspection notes. Moderate cracks greater than hairline cracks are described in the inspection report and noted as possible candidates for maintenance. Major longitudinal cracking in equal to or excess of 0.1 inch in width may indicate overloading or poor bedding and side support and warrant further evaluation by an engineer.

**Figure 2-32: Longitudinal crack within a concrete barrel**

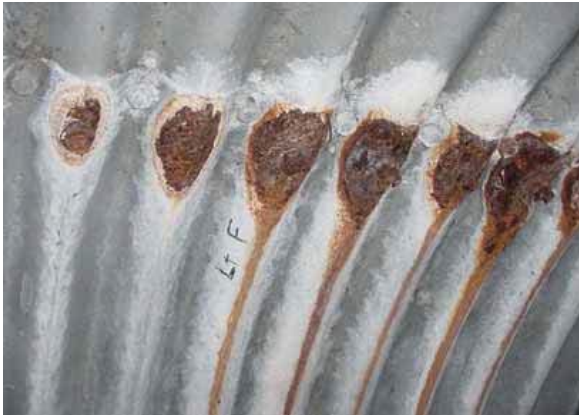
result from the resistivity of the soil. Bacterial corrosion may also occur, particularly in the Upper Peninsula.

**Figure 2-35: Corrosion of a metal culvert**
