# Operator's Manual

For DM100 VDR G1, G2, G3 and DM100 S-VDR G2, G3

| Document Number | MAN15872 |

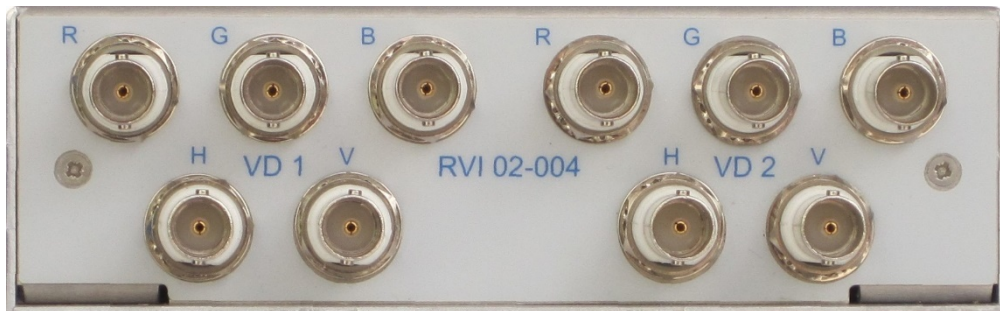
The DM100 may use RVI 02-004 and RVI 02-004D for image capture. The DM100 will power RVIs connected to the RVI or RDI port on the DAU. An RVI may be connected to a LAN port on the DAU if the RDI and RVI ports on the DPU are being used for other purposes. An AC power kit (p/n 2304449) will be required as the power source.

*RVI 02-004*
