## The effects of top drive misalignment with the well center - a case study

### Os efeitos do desalinhamento do Top Drive com o centro do poço - um estudo de caso

## 2 METHODOLOGY FOR TOP DRIVE ALIGNMENT

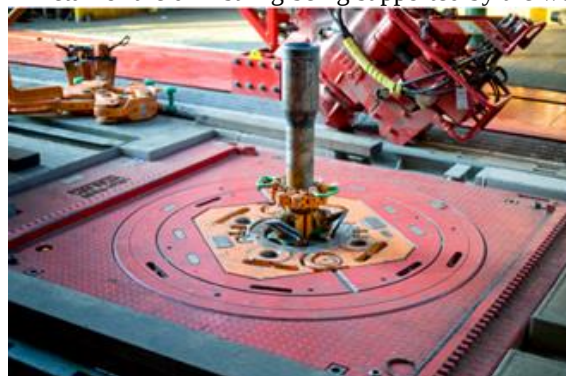
Figure 1 - Detail of the drill string being supported by the wedges

The oil well drilling process occurs as follows: the drill string is formed by several pipes; they are interconnected to increase the length of the column. The drilling process occurs until the bit reaches the ground. Upon reaching the ground, the entire drill string is supported by the slip (Figure 1) and then the Top Drive shaft is connected to the drill pipe.

Firstly, a drill pipe section is inserted into the center of the well, using slips on the rotary table to support the pipes, as previously illustrated in Figure 1. The height of the connection must be 5.5 +/- 1.0 feet above the drill floor.

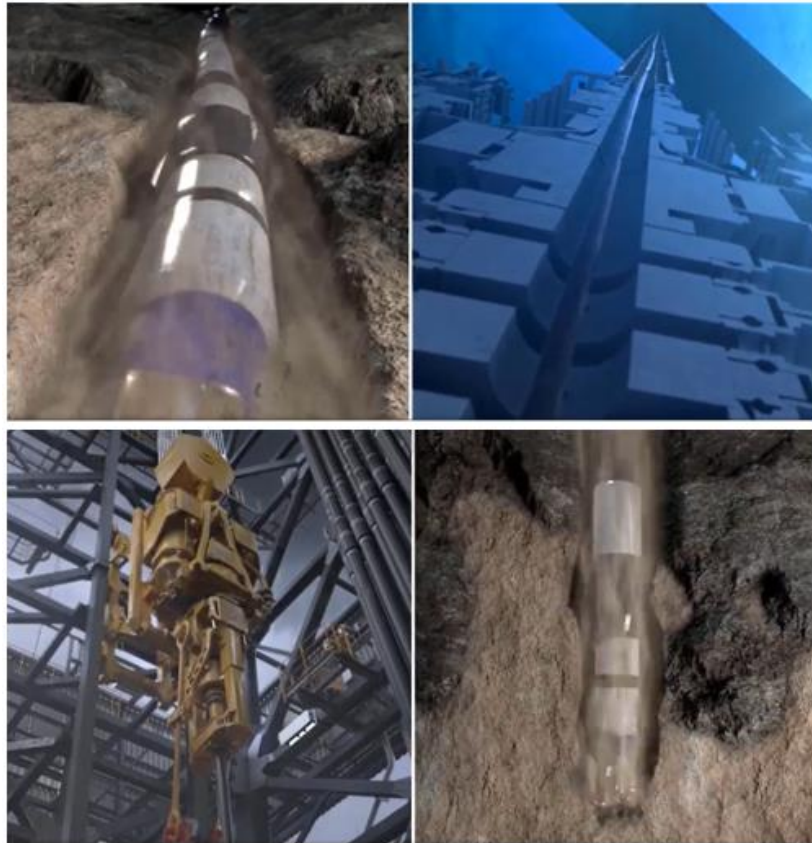
Figure 2 - Top Drive detail during the well drilling operation.

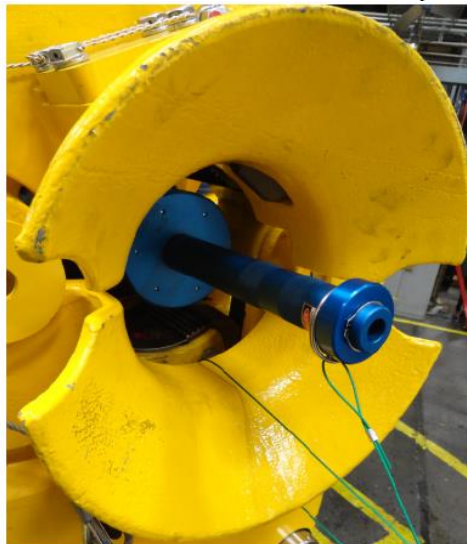
Figure 5 - Detail of the laser attached to the Top Drive shaft.

It is important to find the center of the well on the rotary table to check the alignment. To do so, two pieces of string can be used, and the lifting points of the Power Slip should be used as a reference point. The strings must be positioned as illustrated in Figure 5. The point where the strings meet is the center of the well. At this point, a mark must be made on the rotary table protection cover to indicate the position.

Based on the guidelines described in the document PIB 16569188 issued by NOV, the laser P/N 11412491-001 should be used to verify the angular alignment of the Top Drive shaft with the center of the well. Before positioning the laser, the face of the Top Drive shaft end must be cleaned to fix the laser's magnetic base as can be seen in Figure 6.

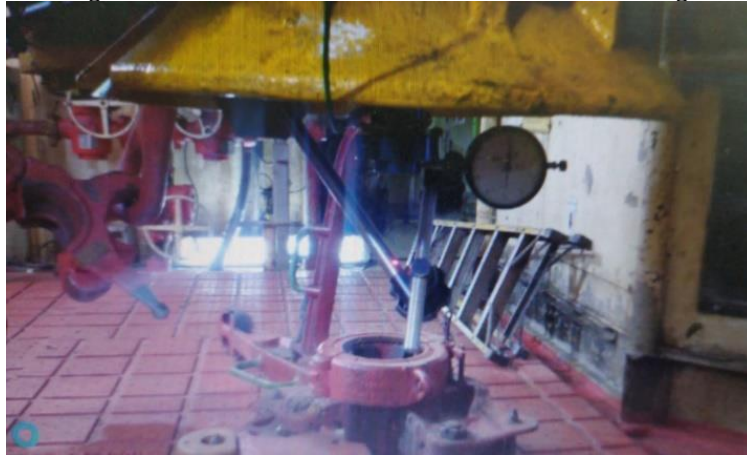
A dial indicator must be used afterward to center the laser to the axis, as shown in figure 6. It is worth mentioning that the visualization of alignment becomes easier after centering the laser.

Figure 6 - Detail of the dial indicator in the laser centering.

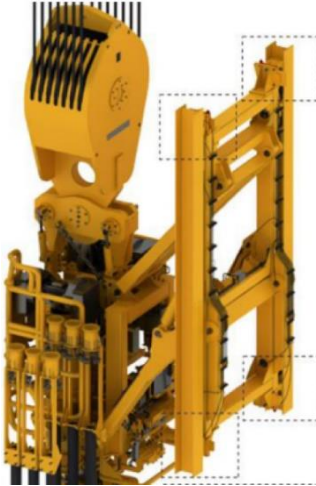
After analyzing the results obtained in the verification of the Top Drive alignment and considering the necessity to correct angle B (leaning to the left / to the right) or lateral parallel (to the left / to the right), shims must be added or removed from the side rollers of the Dolly. The amount of shim depends on the misalignment displayed. Figure 11 illustrates the Dolly and the location where the shims should be inserted or removed.

Figure 11 - Detail of the Top Drive Dolly.

During shim adjustment, it is important to notice that the clearance between the side rollers and the guide rail must be 3 mm  $\pm$  1.5 mm and the total clearance is 6 mm  $\pm$  3 mm, as reported in the document V3409-Z-KA-003 provided by NOV.

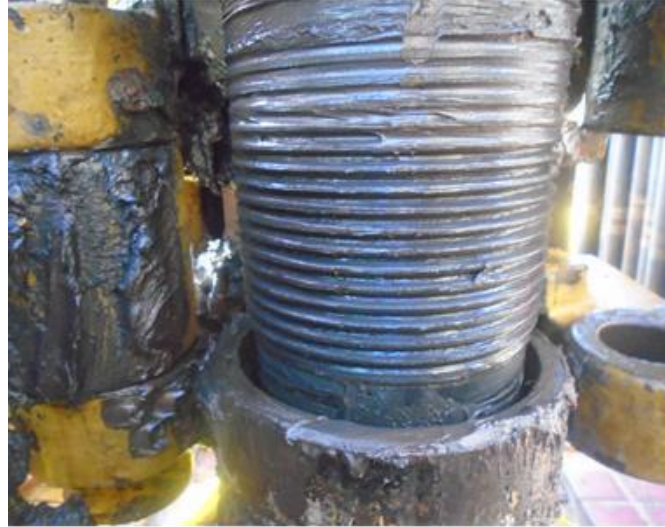
The Top Drive alignment must be periodically checked and, if necessary, the procedure must be carried out. Figure 12 illustrates an ideal alignment between axes.

Figure 12 - Top Drive shaft aligned with drill pipe.
