An Introduction
Updated 2026

National Ops & Technology Conference 2026.

Telemetry started testing remote monitoring sensors in McDonald's Restaurants back in 2017 to see if soft drink quality could be improved through the use of better data.

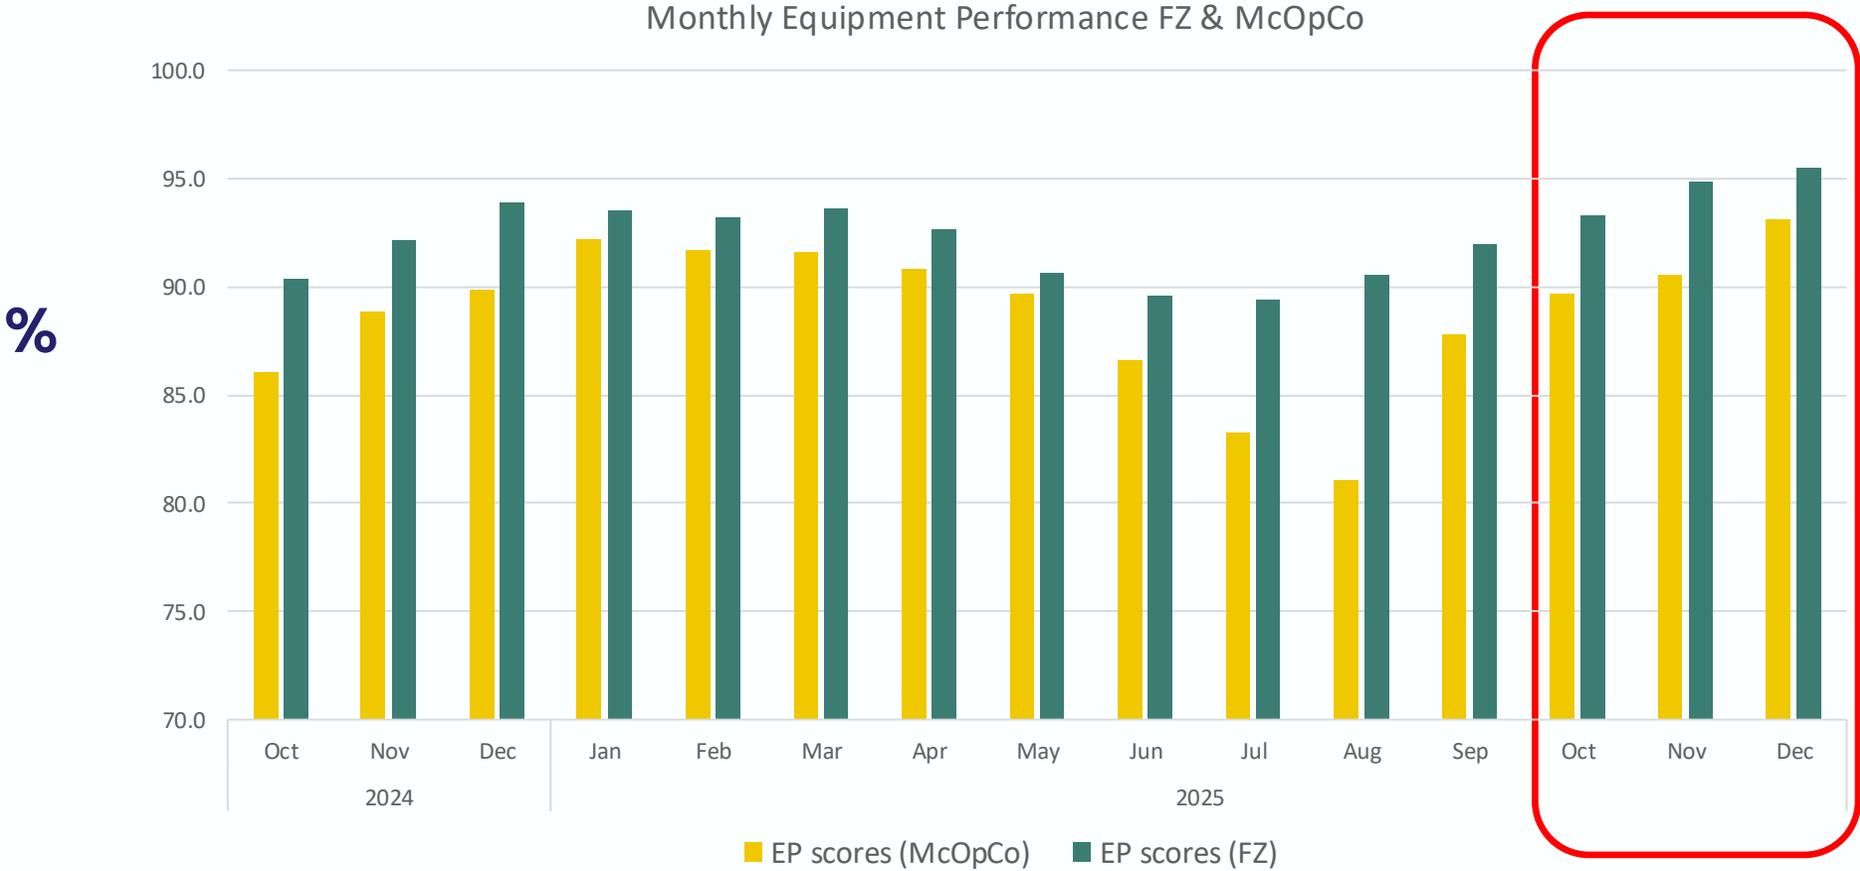
Equipment Performance. Last 15mths

*Based on average soft drink sales across a 24hr period.

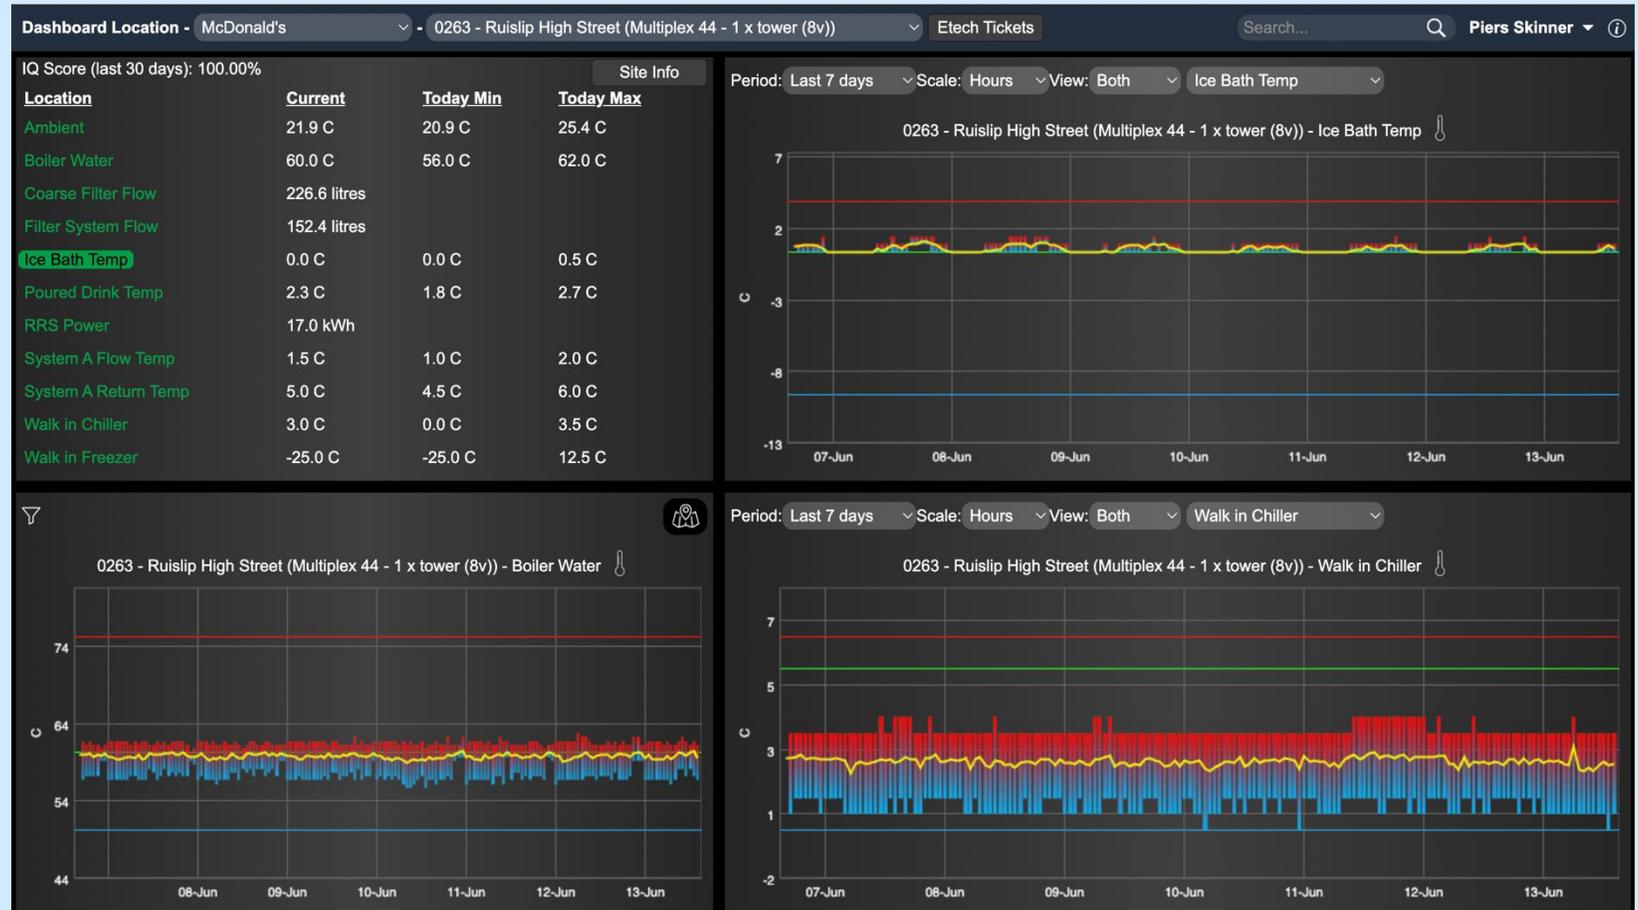
Portal.

Each restaurant gets its own page on our portal.

The performance of every sensor can be seen/monitored in graph format with adjustable timeframes & units (minutes/hours/days)

Alert parameters can be set/alterd whenever necessary

The portal is integrated with eTech & logs all eTech tickets raised against soft drinks

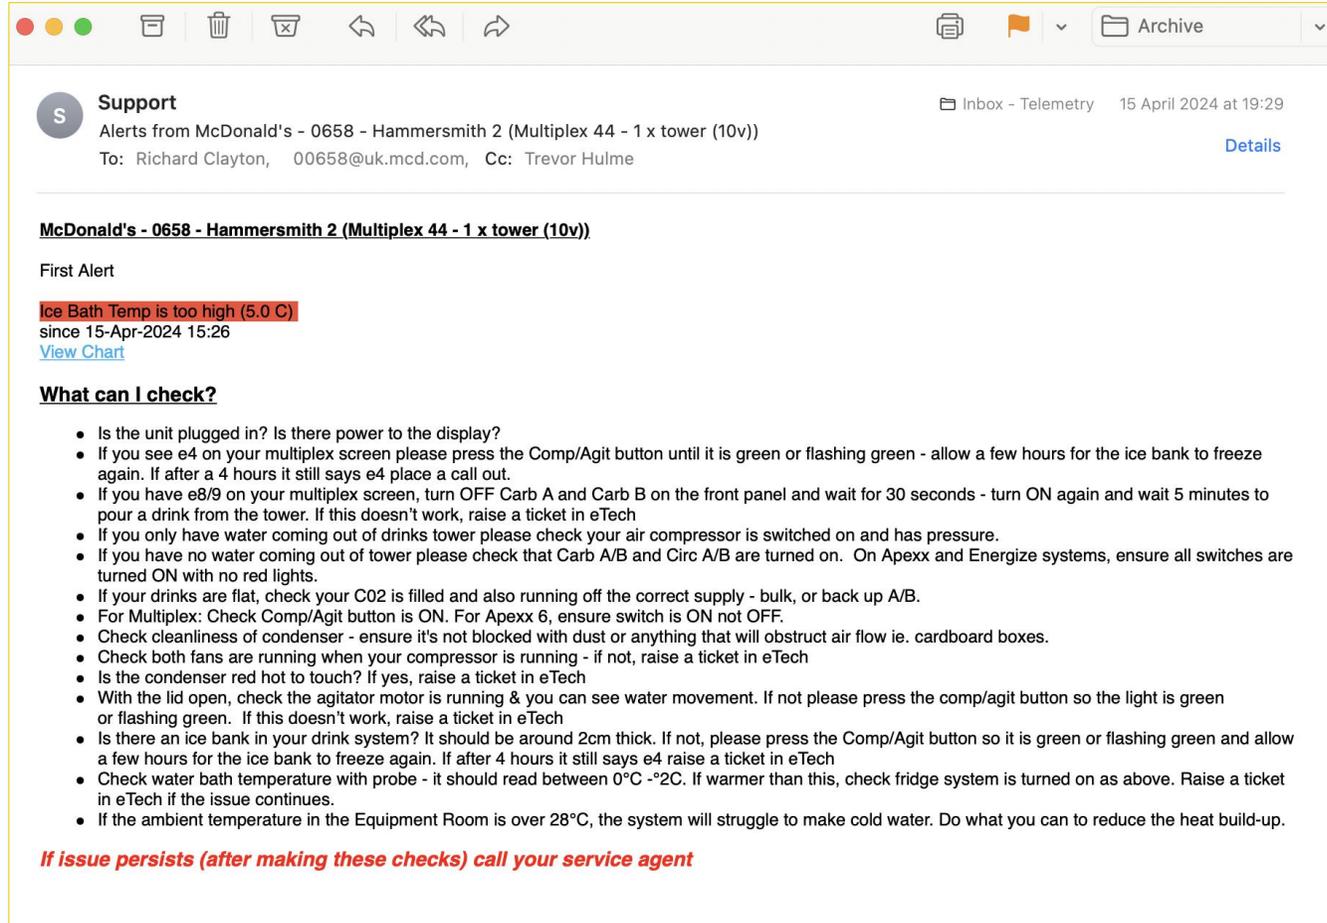
Alerts.

The screenshot shows an email interface with a support ticket. The subject is 'McDonald's - 0658 - Hammersmith 2 (Multiplex 44 - 1 x tower (10v))'. The email body contains a 'First Alert' with the subject 'Ice Bath Temp is too high (5.0 C)' and a timestamp of 'since 15-Apr-2024 15:26'. Below the alert is a section titled 'What can I check?' with a list of 15 troubleshooting steps. At the bottom, there is a red instruction: 'If issue persists (after making these checks) call your service agent'.

Ice Bath Temp is too high (5.0 C)
since 15-Apr-2024 15:26
[View Chart](#)

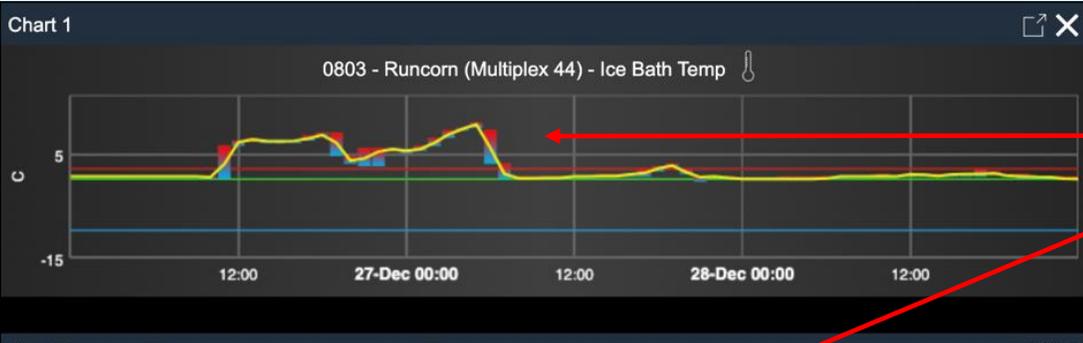
Ice bath temperature rise + power drop in Multiplex = possible accidental mistake **OR** refrigeration issue (thus needs a specialist refrigeration engineer)

Accurate fault analysis is key to sending the right engineers to the restaurant with the right part to avoid multiple visits

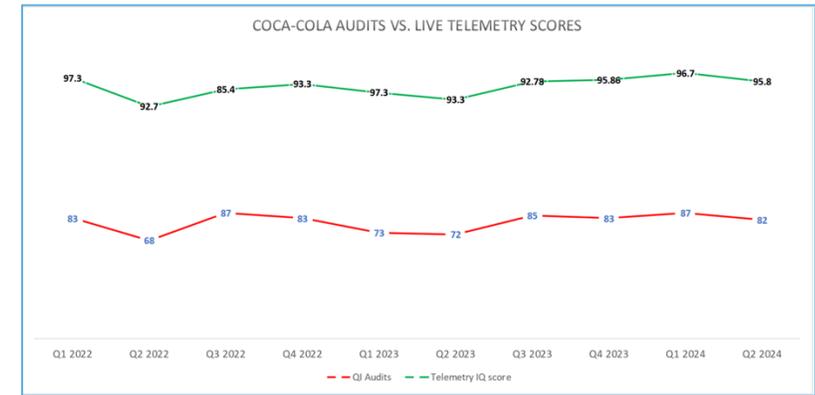
QMP visits take place twice a year, but QMP 2.0 with Telemetry introduces an 'always on' system, which enables you to monitor soft drinks quality and equipment performance 24 hours a day. **The Telemetry system sends alerts to the restaurant and your Service Company to take action that would otherwise go unnoticed. Often a phone fix is all that is needed.** As a result, Quality in restaurants with Telemetry is substantially higher (see graph).

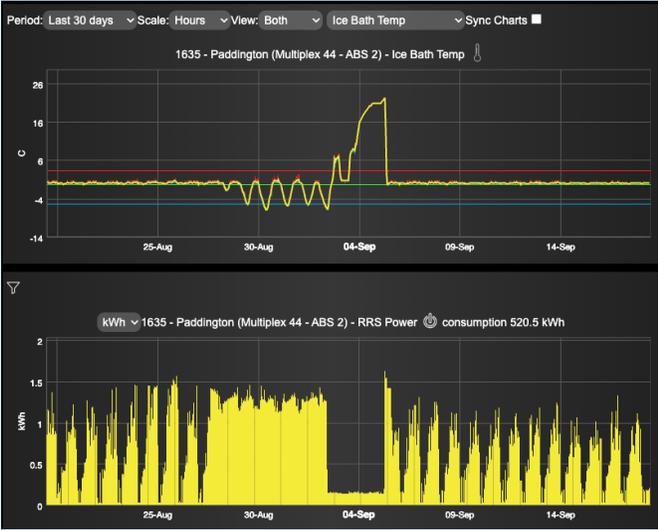
1635 Paddington – PCB relay failure

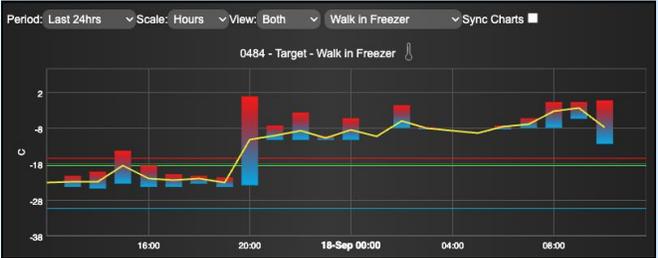
0484 Target – Walk-in freezer high temp alert

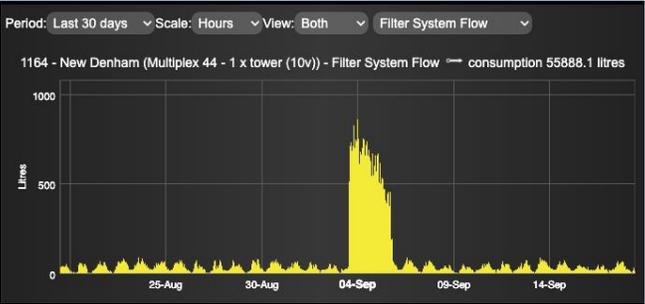
1164 New Denham – accidental drain valve left open

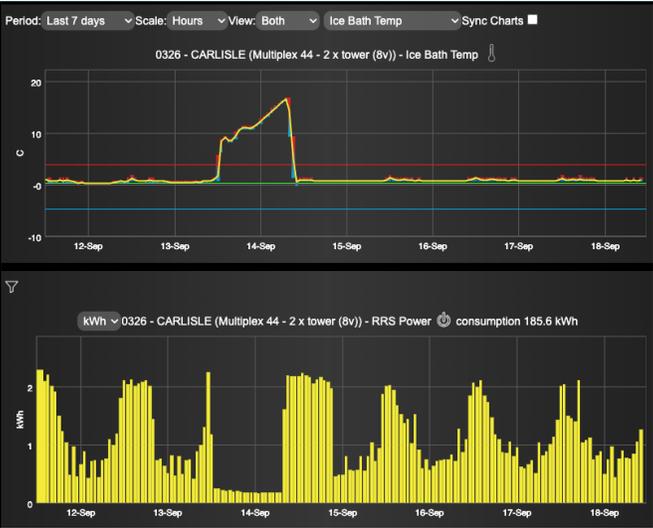
0326 Carlisle - accidental motor switch-off

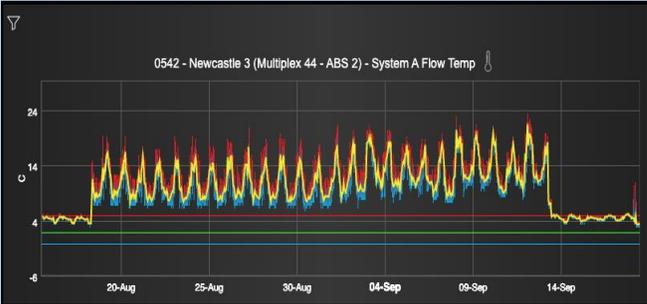
0542 Newcastle – recirculation pump failure

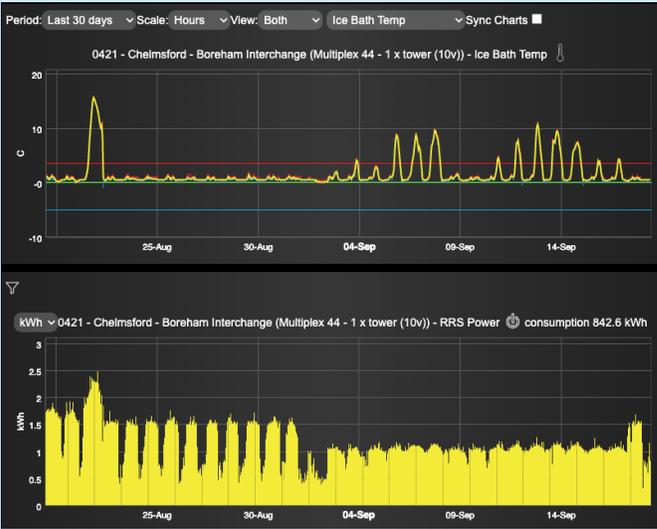
0421 Chelmsford – Power fluctuation affecting ice bath temperature

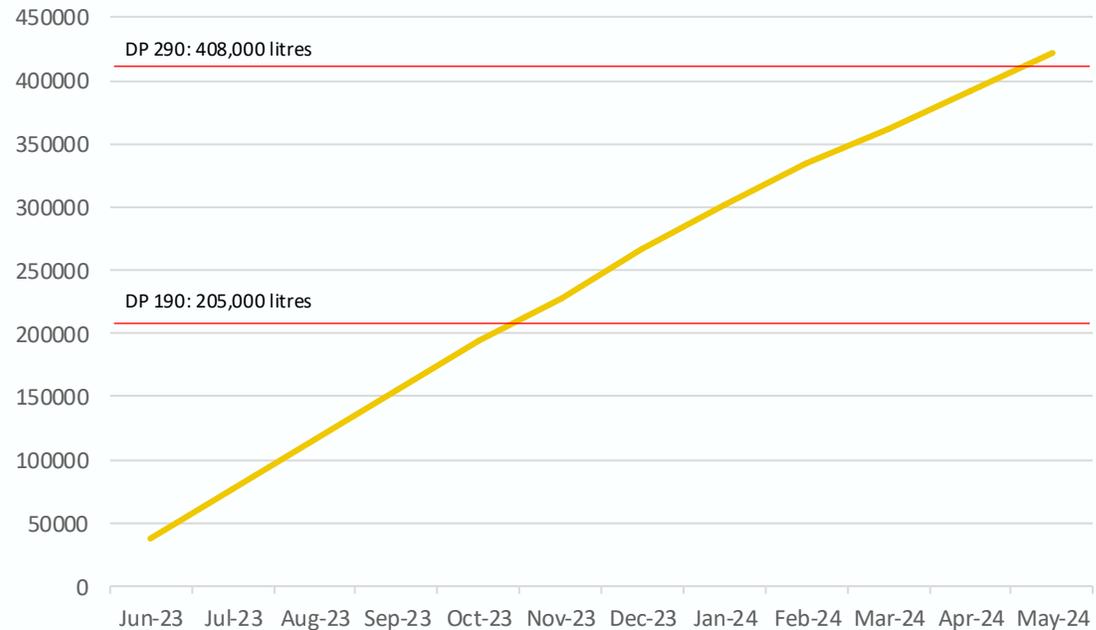
Filter Pack: Cumulative Litres

Example

This restaurant has a DP190 which can be replaced twice a year (£165 each) rather than upgrading to a DP290 (which requires installing a new head: £276.71 + labour) costing £300.90 per annual replacement.

The flow meters we install accurately assess exactly how often they need replacing (this no longer needs to be once a year) & whether an upgrade is justified

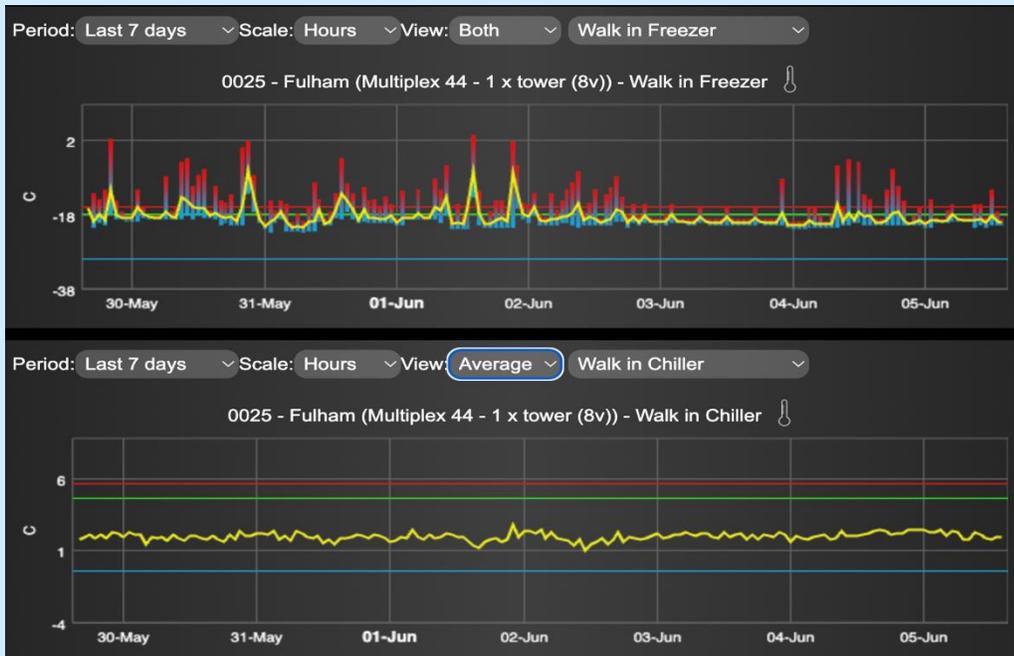
We can also put temperature monitors into the walk-in Chiller & Freezer. Parameters are set to alert far more quickly (1-2hrs)

Raw data can be used for HACCP reporting
(we have an FSA Feasibility Study that supports this)

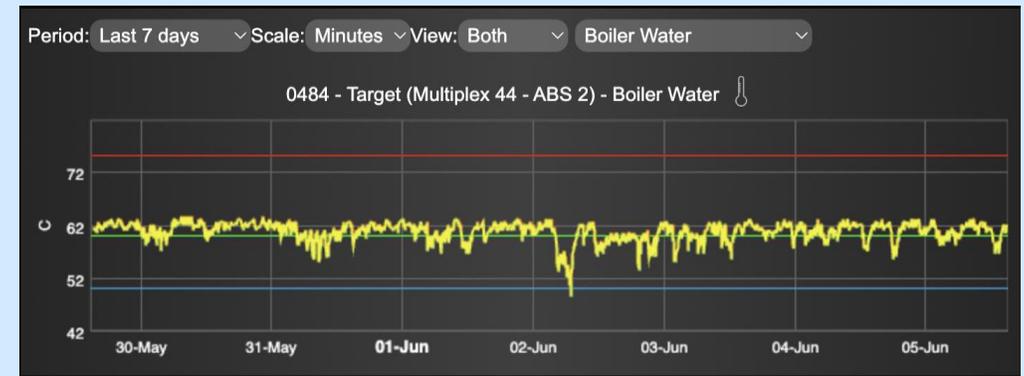
We've also been tasked by some Franchisees to supply a temperature sensor on the Boiler outflow pipe to ensure that water stays above 50°C as part of HSE regulations re. Legionella
