**Site-Specific Design of Stabilization Measures in Selected  
High-Hazard Portions of the Route of the Proposed Mountain  
Valley Pipeline Project in the Jefferson National Forest**

Prepared by:

**Mountain Valley Pipeline, LLC**

**Updated March 13, 2018**

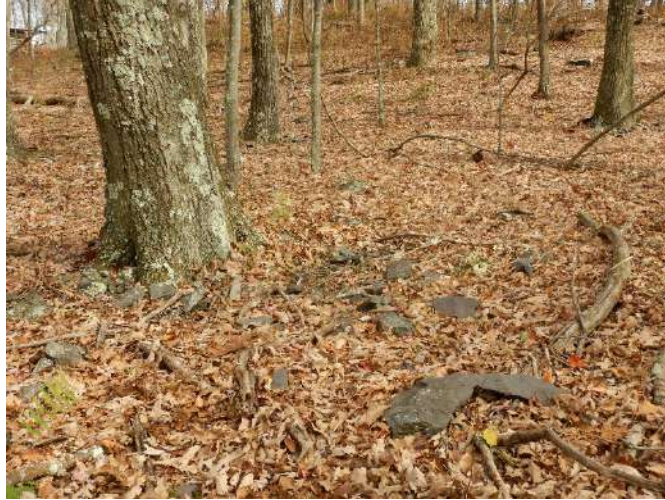
*Photo 1: Red and brown sandstones characteristic of the Rose Hill Formation were observed as float upslope of the JNF Priority Site #1 area (view is toward north-northwest)*

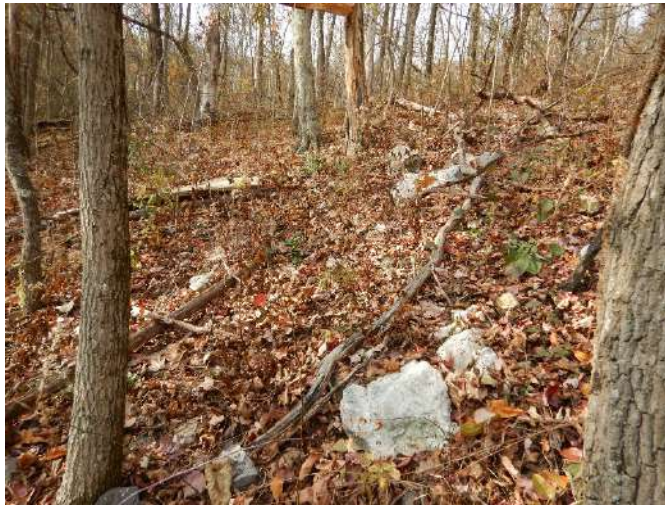
*Photo 2: White to gray sandstone talus blocks characteristic of the Tuscarora Formation observed as abundant float near the vicinity of the JNF Priority Site #1 (view is upslope toward the west)*

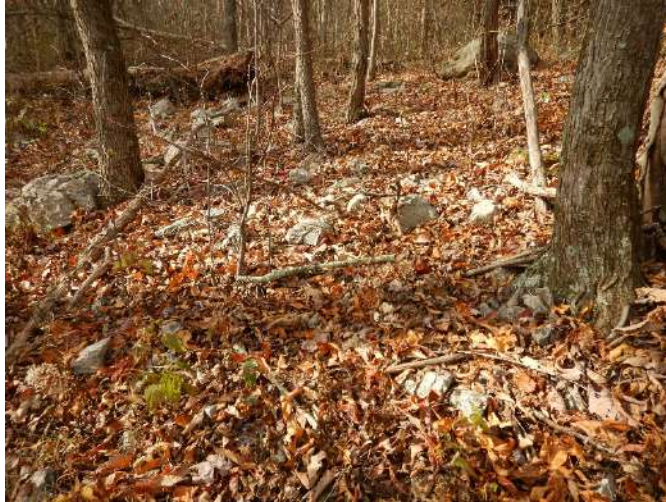
*Photo 3: The JNF Priority Site #1 situated on an ancient colluvial fan composed primarily of Tuscarora sandstone (view is sideslope to the southwest)*

Schultz et al (1986) map these characteristic areas as “Colluvium undifferentiated: boulders, gravel, sand and silt; includes rock fall, talus, debris train, and block field deposits”.

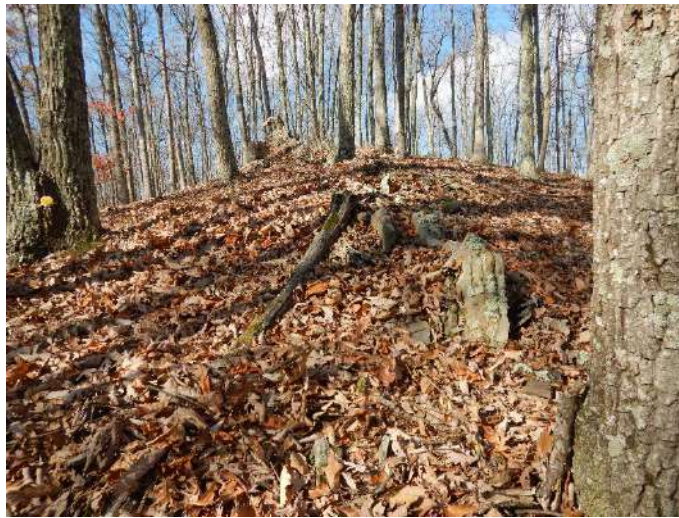
*Photo 6: Exposure of the Price sandstone outcrop at the ridge line near JNF Priority Site #2*

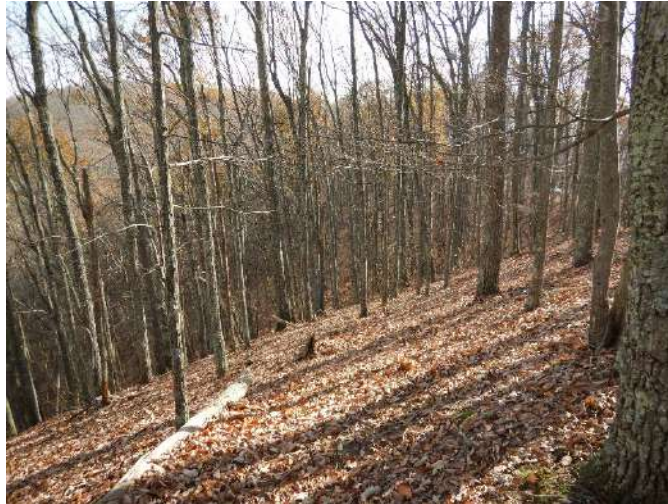
*Photo 7: Downslope exposure of bedrock was not observed, but the steep slopes in the vicinity of the JNF Priority Site #2 suggest only a thin overburden mantle overlies the downslope Devonian age bedrock (view is to the north)*

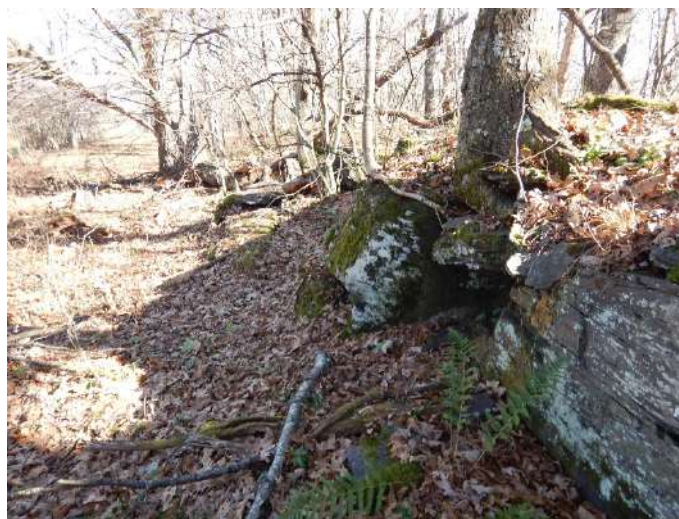
*Photo 8: Rose Hill sandstone outcrop on ridge top north of the JNF Priority Site #3, dipping to the south (view to northeast)*

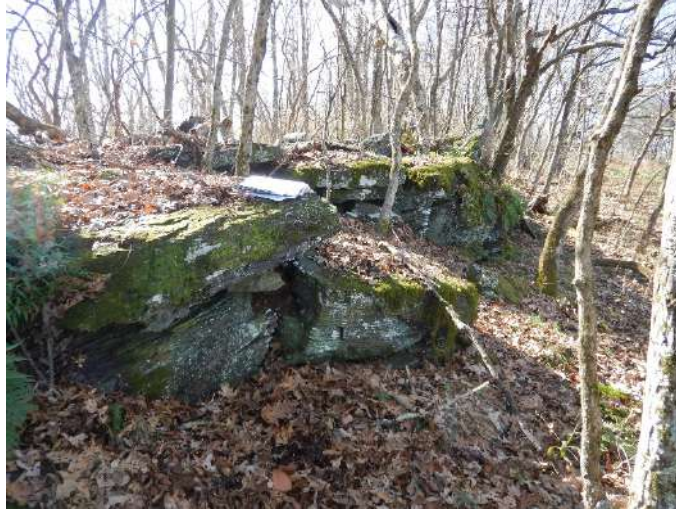
*Photo 9: Rose Hill sandstone outcrop on ridge top north of the JNF Priority Site #3, dipping to the south (view to the southwest)*

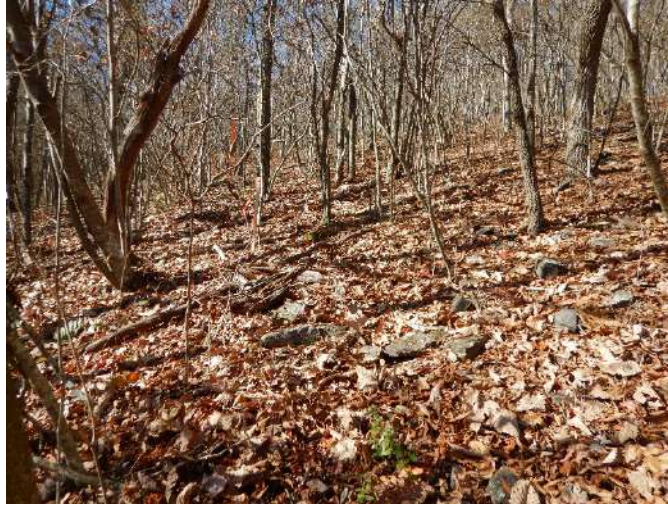
*Photo 11: Colluvial deposit float (predominantly Rose Hill sandstone) at ground surface in the near vicinity of the JNF Priority Site #3 (view is to the west toward the upslope ridgeline)*

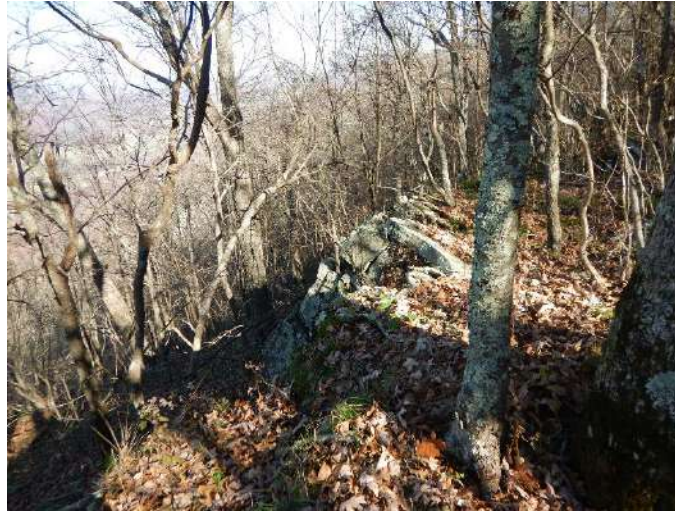
*Photo 12: White Medina (Tuscarora) sandstone forming ridgeline, dipping south-southeast back into the ridge (view is to the north)*

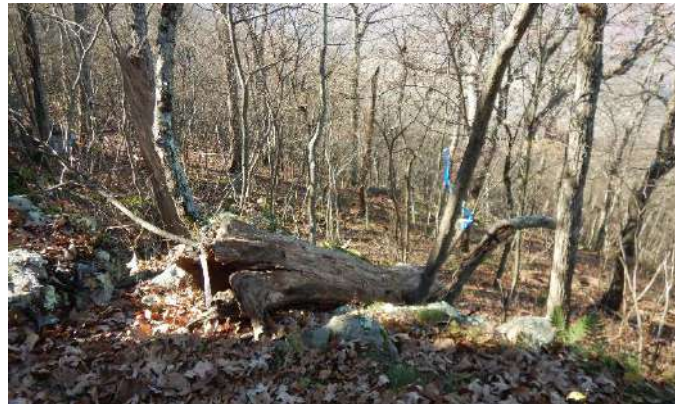
*Photo 13: Downslope to the north-northwest from the ridgeline near where slopes are reduced toward JNF Priority Site #5 (below bore pit), underlain by Martinsburg Series bedrock (view is to the west-southwest)*

As noted above, the JNF Priority Site #5 is located downslope from the ridge line and downslope from the bore pit. This site is analogous to JNF Priority Site #2, with relatively thin residual soil overburden overlying clastic sedimentary bedrock.

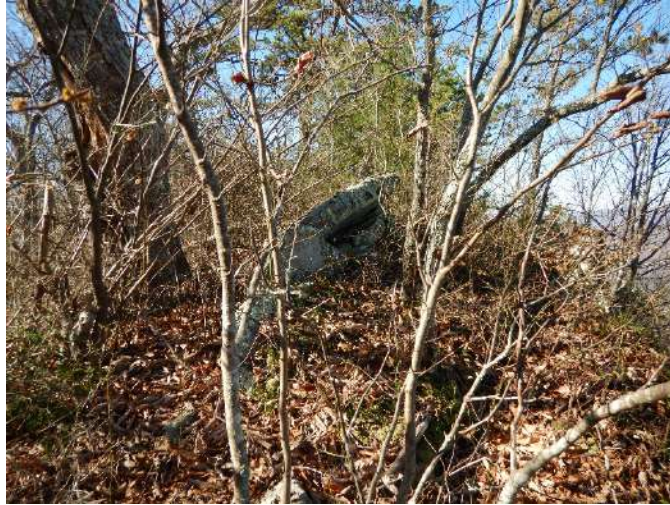
*Photo 14: Tuscarora Formation sandstone observed to outcrop at the ridge line (view is to the southwest)*

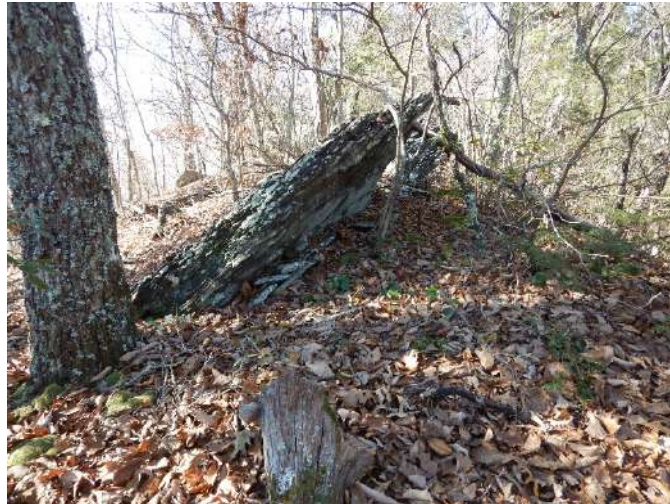
*Photo 15: Further to the southwest, the Rose Hill Formation sandstones outcrop at the ridge line (view is to the southwest)*

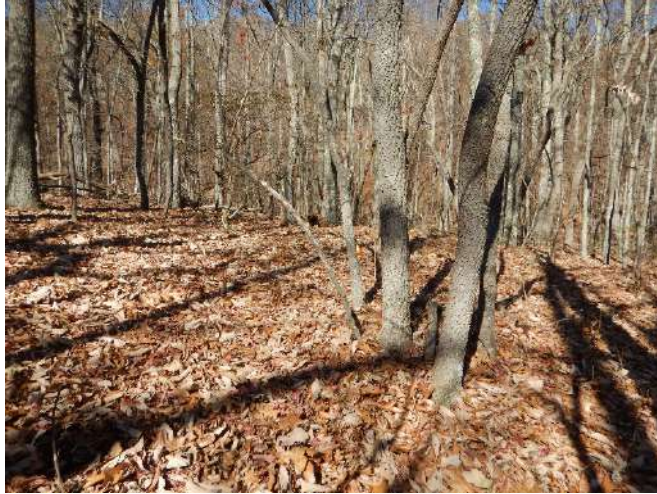
*Photo 17: View of the shallow slope apparently formed by rock-block slump, viewed toward the ridge line that is somewhat visible by trees in background defined by skyline approximately 800 feet to the west (view is to the west-southwest)*

Field reconnaissance of the JNF Priority Site #6 confirmed a near-horizontal portion of the slope within approximately 800 feet downslope (south) of the ridge line that corresponds to the rock-block slump, and a steep slope leading up to the ridge line (north-northwest) that is primarily the result of a release of the rock-block when it slumped.

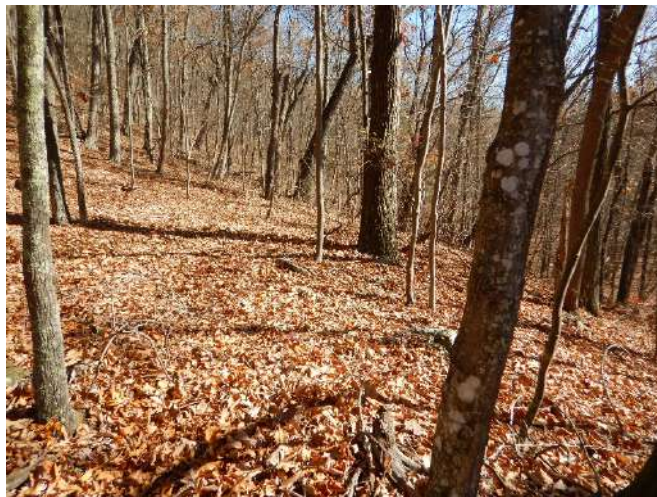
*Photo 16: South extent of the shallow slope formed by an apparent rock-block slump downslope from the ridge line (view is to the northeast)*

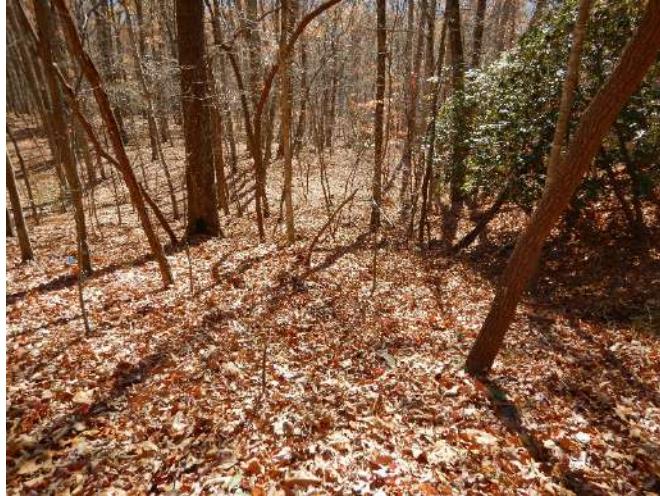
*Photo 17: Hummocky ground with variable size float (boulders, cobbles, pebbles, sand, silt) that corresponds to a mapped debris flow downslope (to the south-southeast) from the rock-block slump feature (view is to the south-southeast)*

Continuing downslope, the pipeline is mapped as crossing colluvium (Qcr in the exhibit above), derived from the Rose Hill Formation and consisting of debris transported downslope from the ridgeline and rock-block slide. Field reconnaissance revealed hummocky terrain, abundant Rose Hill and Tuscarora float at the ground surface and a well graded agglomeration of fine-to-coarse sand, pebbles, cobbles and boulders of Rose Hill and Tuscarora (observed in tree-fall root balls) that are characteristic of the ancient debris flow (see Photo 19, below).
