## Baseline Assessment – Stream Attributes

**Reach S-KL54 (Pipeline ROW)**

**Franklin County, Virginia**

## Spread I Stream S-KL54 (Pipeline ROW) Franklin County

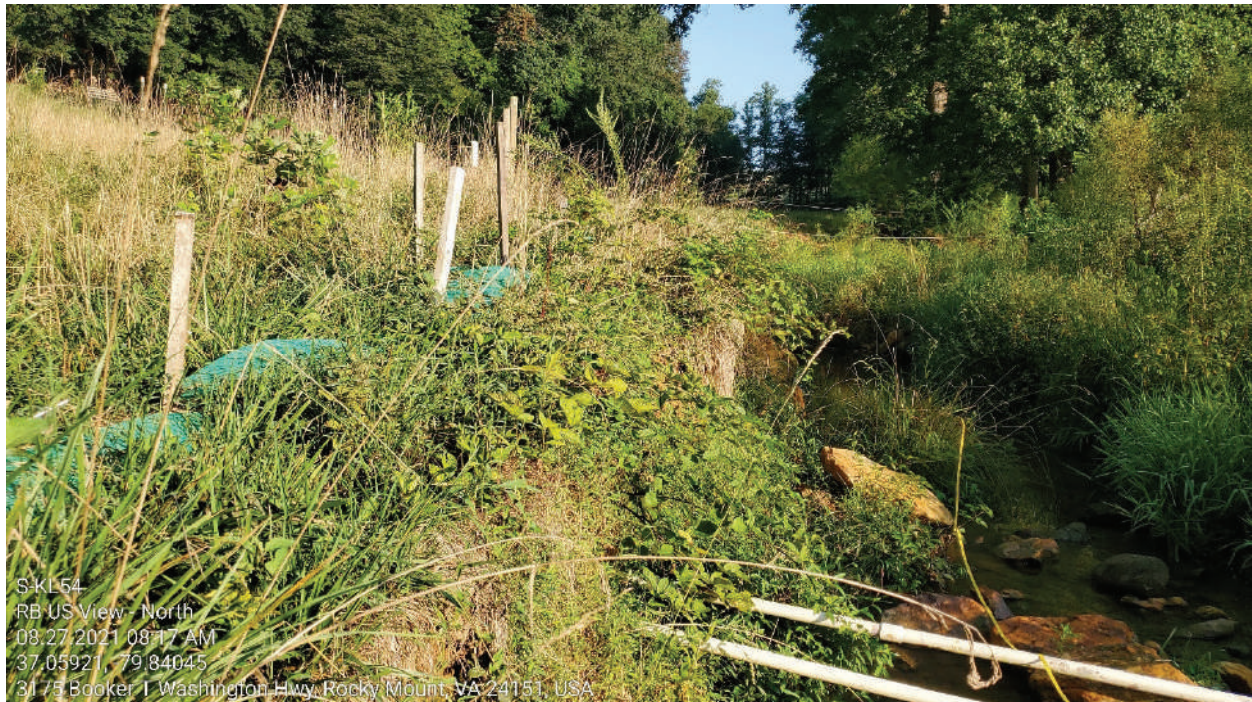
Photo Type: RB US VIEW

Location, Orientation, Photographer Initials: Downstream at ROW/LOD on right bank looking N upstream, DW

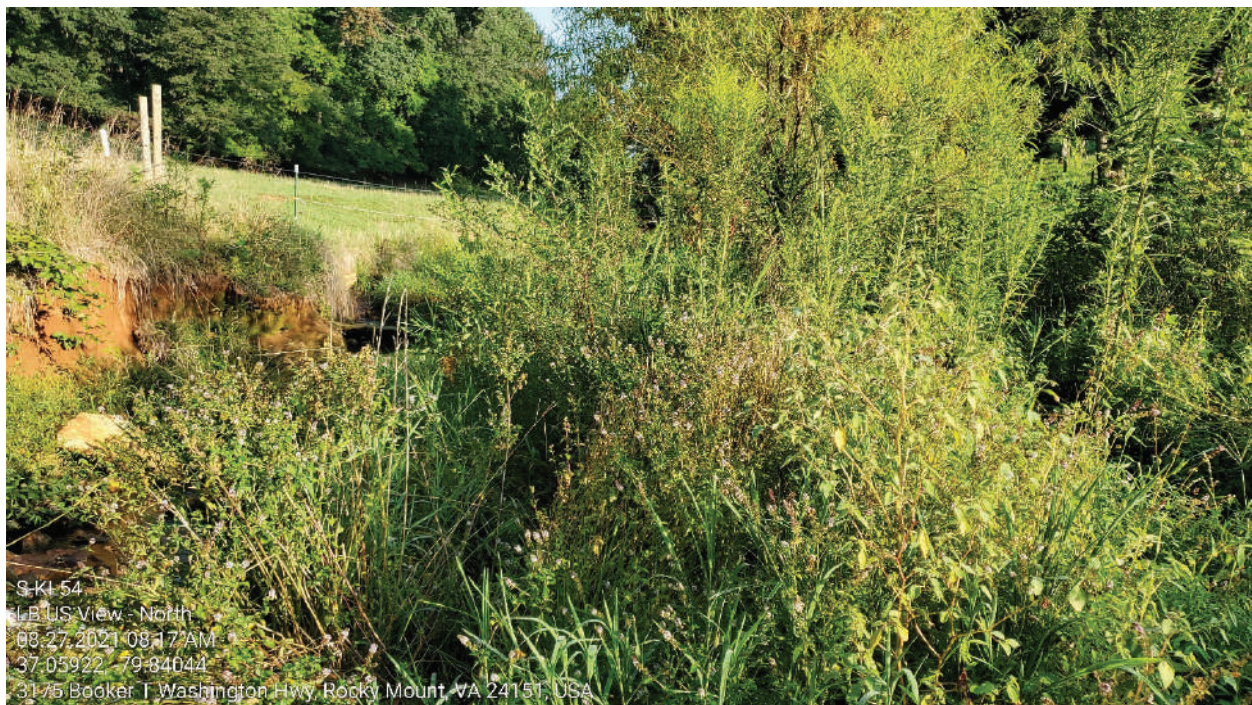
Photo Type: LB US VIEW

Location, Orientation, Photographer Initials: Downstream at ROW/LOD on left bank looking N upstream, DW

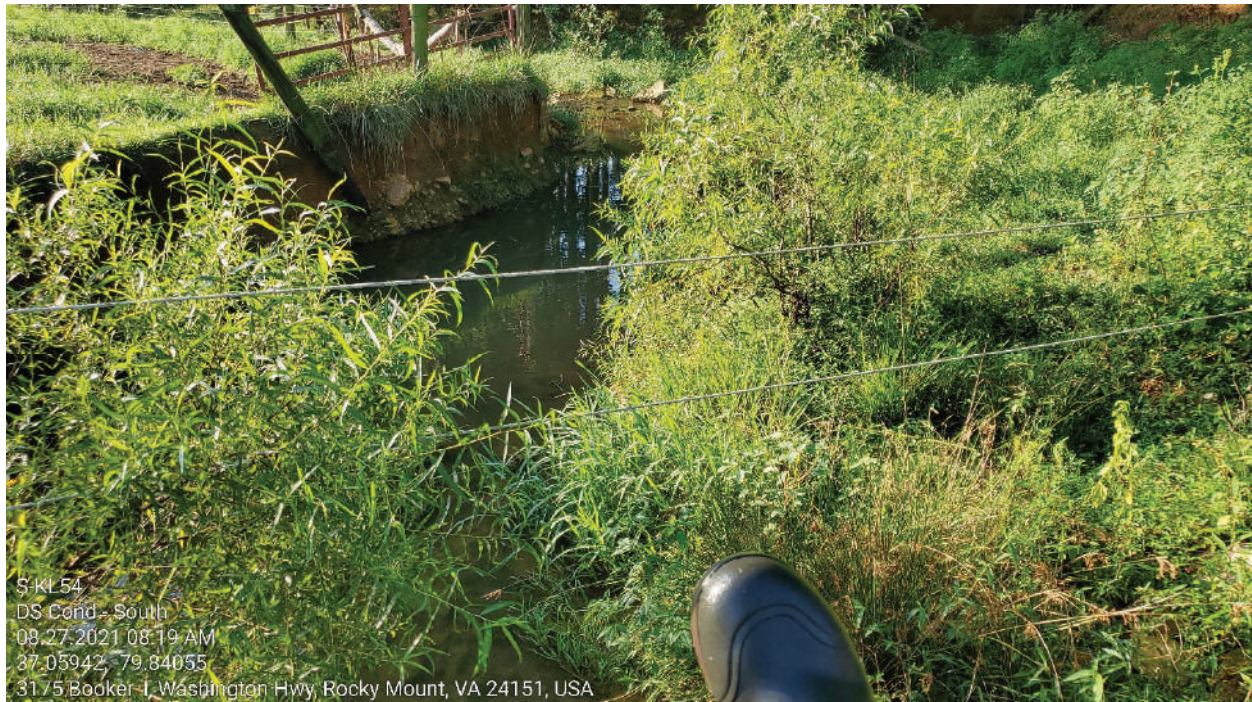
Photo Type: DS COND

Location, Orientation, Photographer Initials: Downstream at ROW/LOD looking S downstream, DW

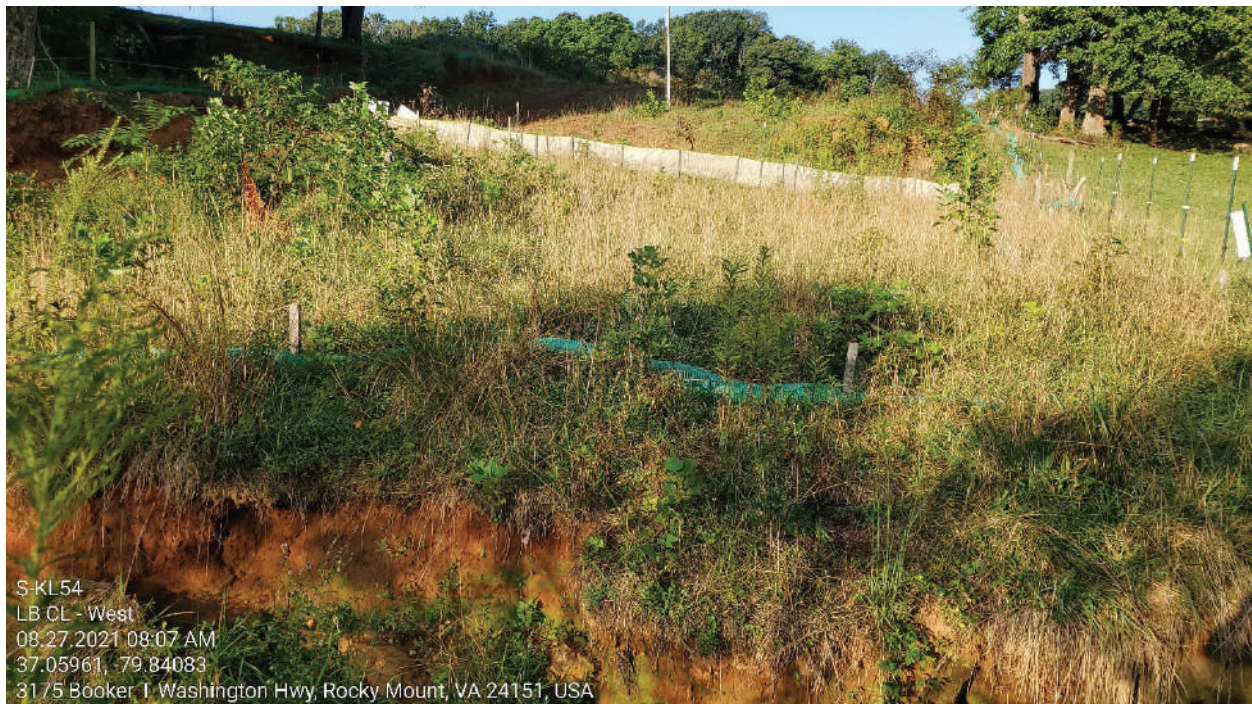
Photo Type: LB CL

Location, Orientation, Photographer Initials: On thalweg at pipe centerline looking W at right streambank, DW

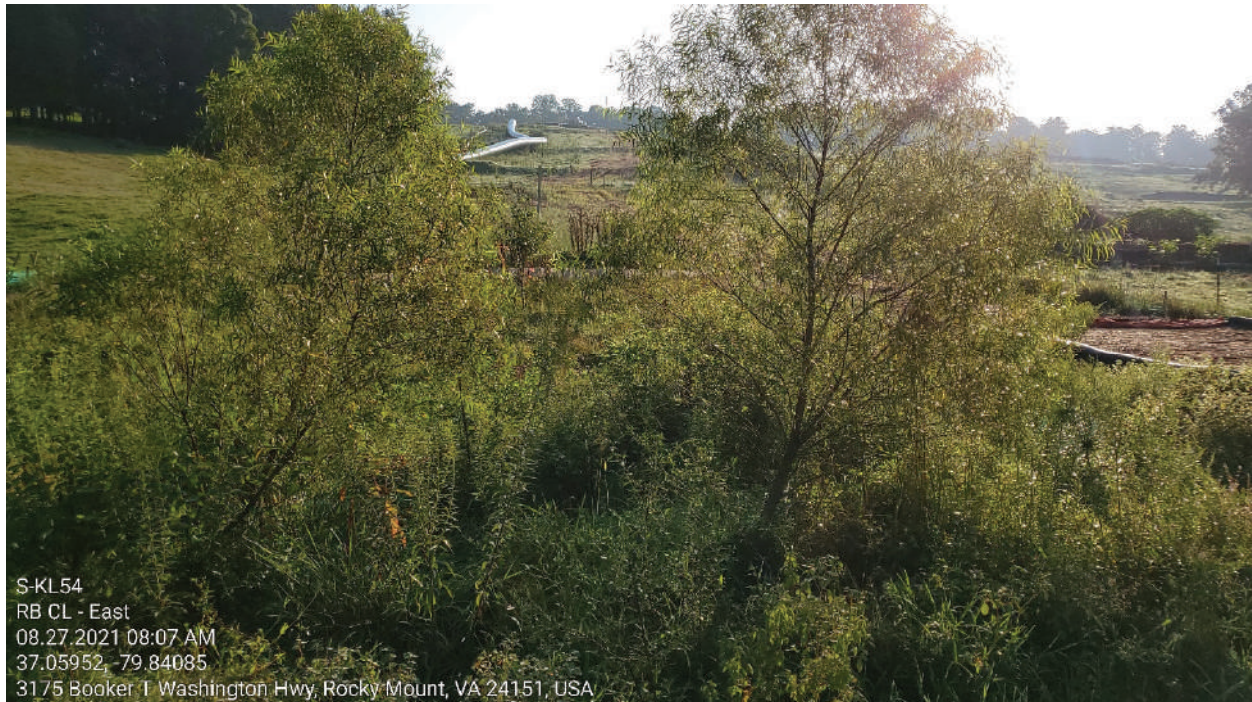
Photo Type: RB CL

Location, Orientation, Photographer Initials: On thalweg at pipe centerline looking E at left streambank, DW

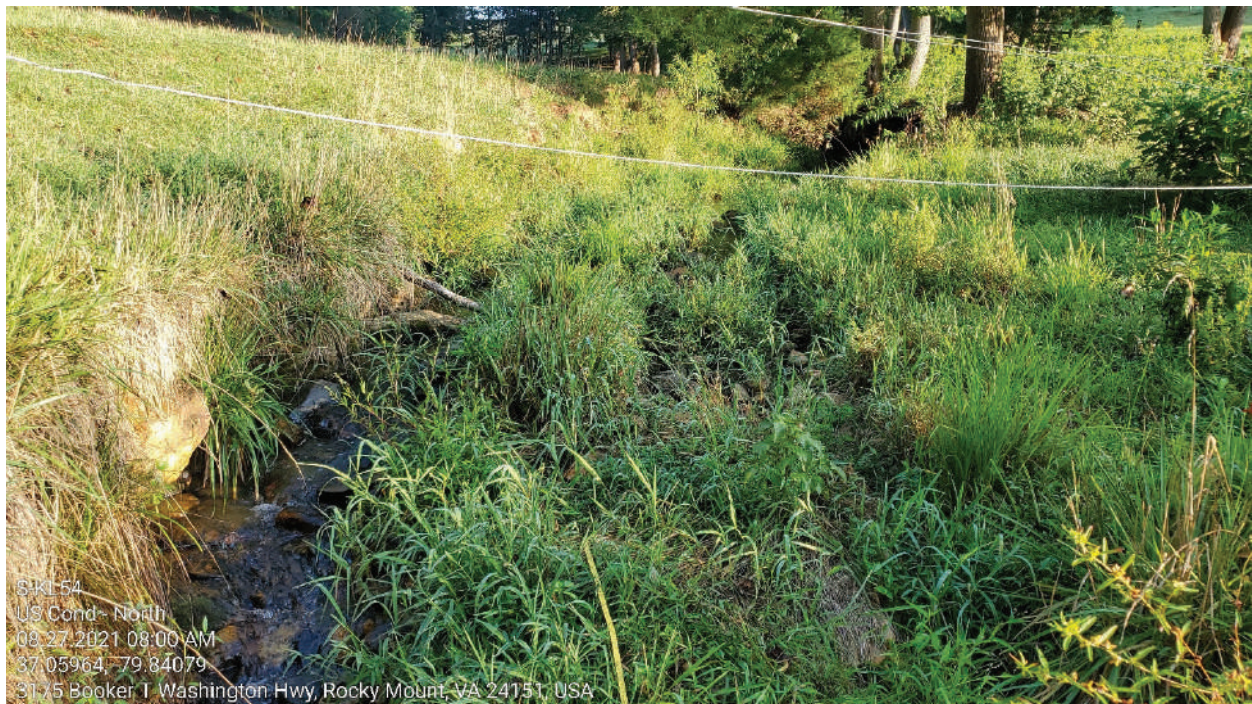
Photo Type: US COND

Location, Orientation, Photographer Initials: Upstream at ROW/LOD looking N upstream, DW

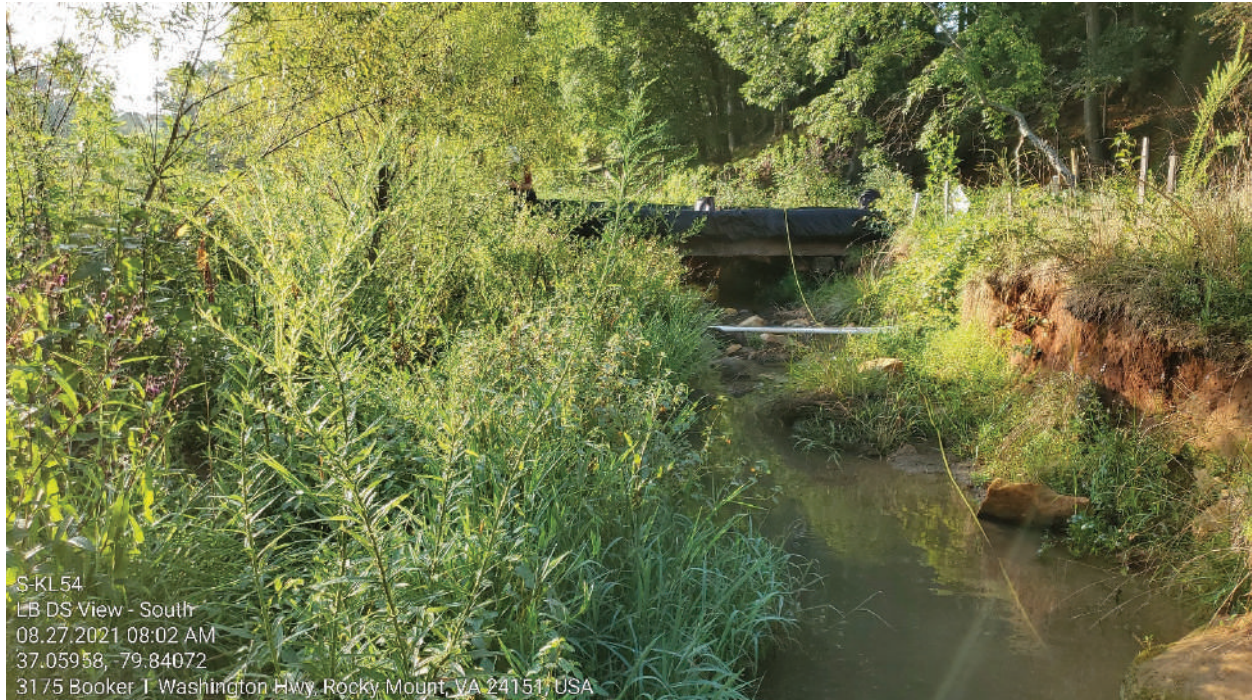
Photo Type: LB DS VIEW

Location, Orientation, Photographer Initials: Upstream at ROW/LOD on left bank looking S downstream, DW

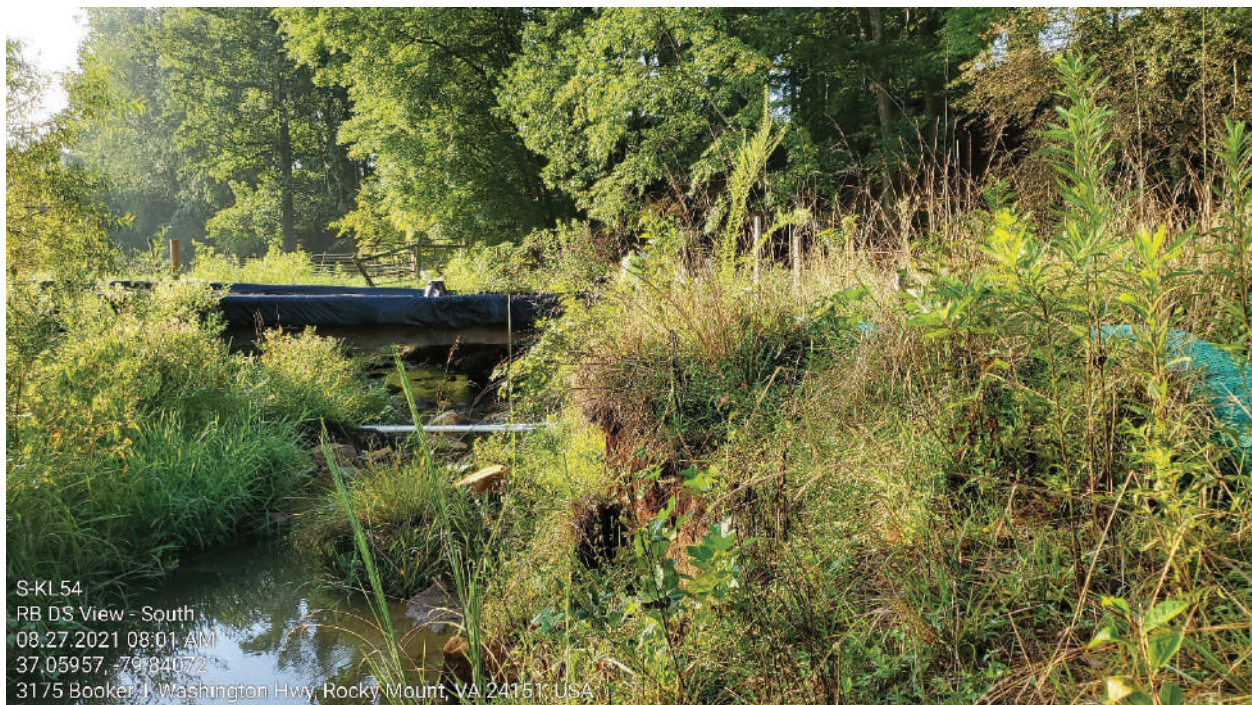
Photo Type: RB DS VIEW

Location, Orientation, Photographer Initials: Upstream at ROW/LOD on right bank looking S downstream, DW

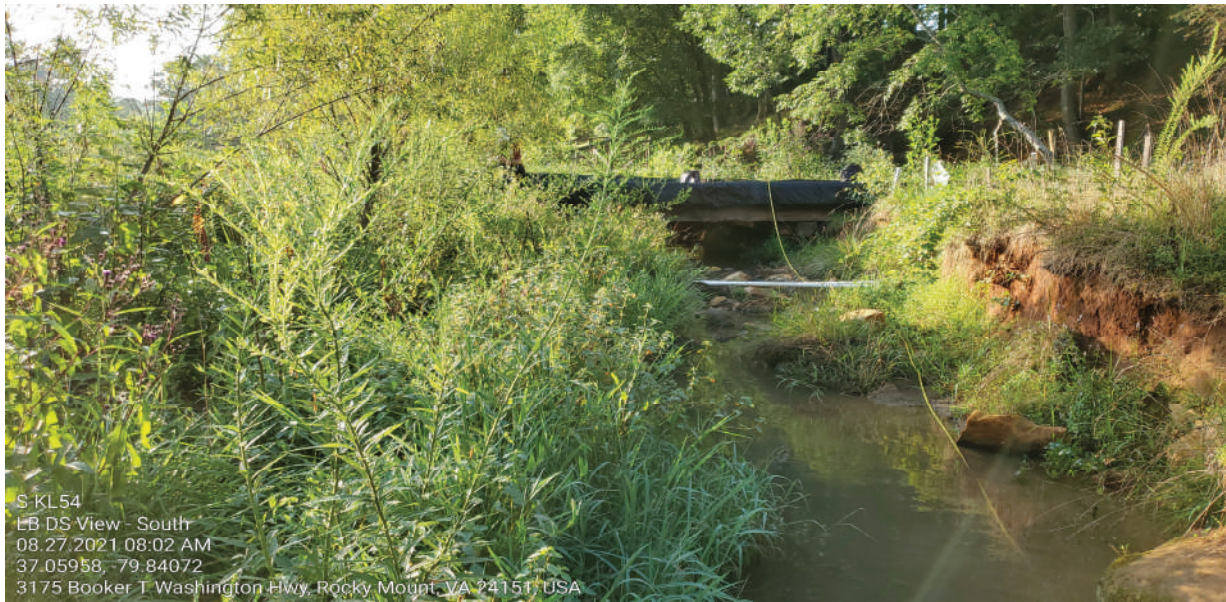
S-KL54  
LB DS View - South  
08.27.2021 08:02 AM  
37.05958, -79.84072  
3175 Booker T Washington Hwy, Rocky Mount, VA 24151, USA
