## Baseline Assessment – Stream Attributes

### Reach S-EF26 (Timber Mat Crossing) Perennial Spread I Pittsylvania County, Virginia

## Spread I Stream S-EF26 (Timber Mat Crossing) Pittsylvania County

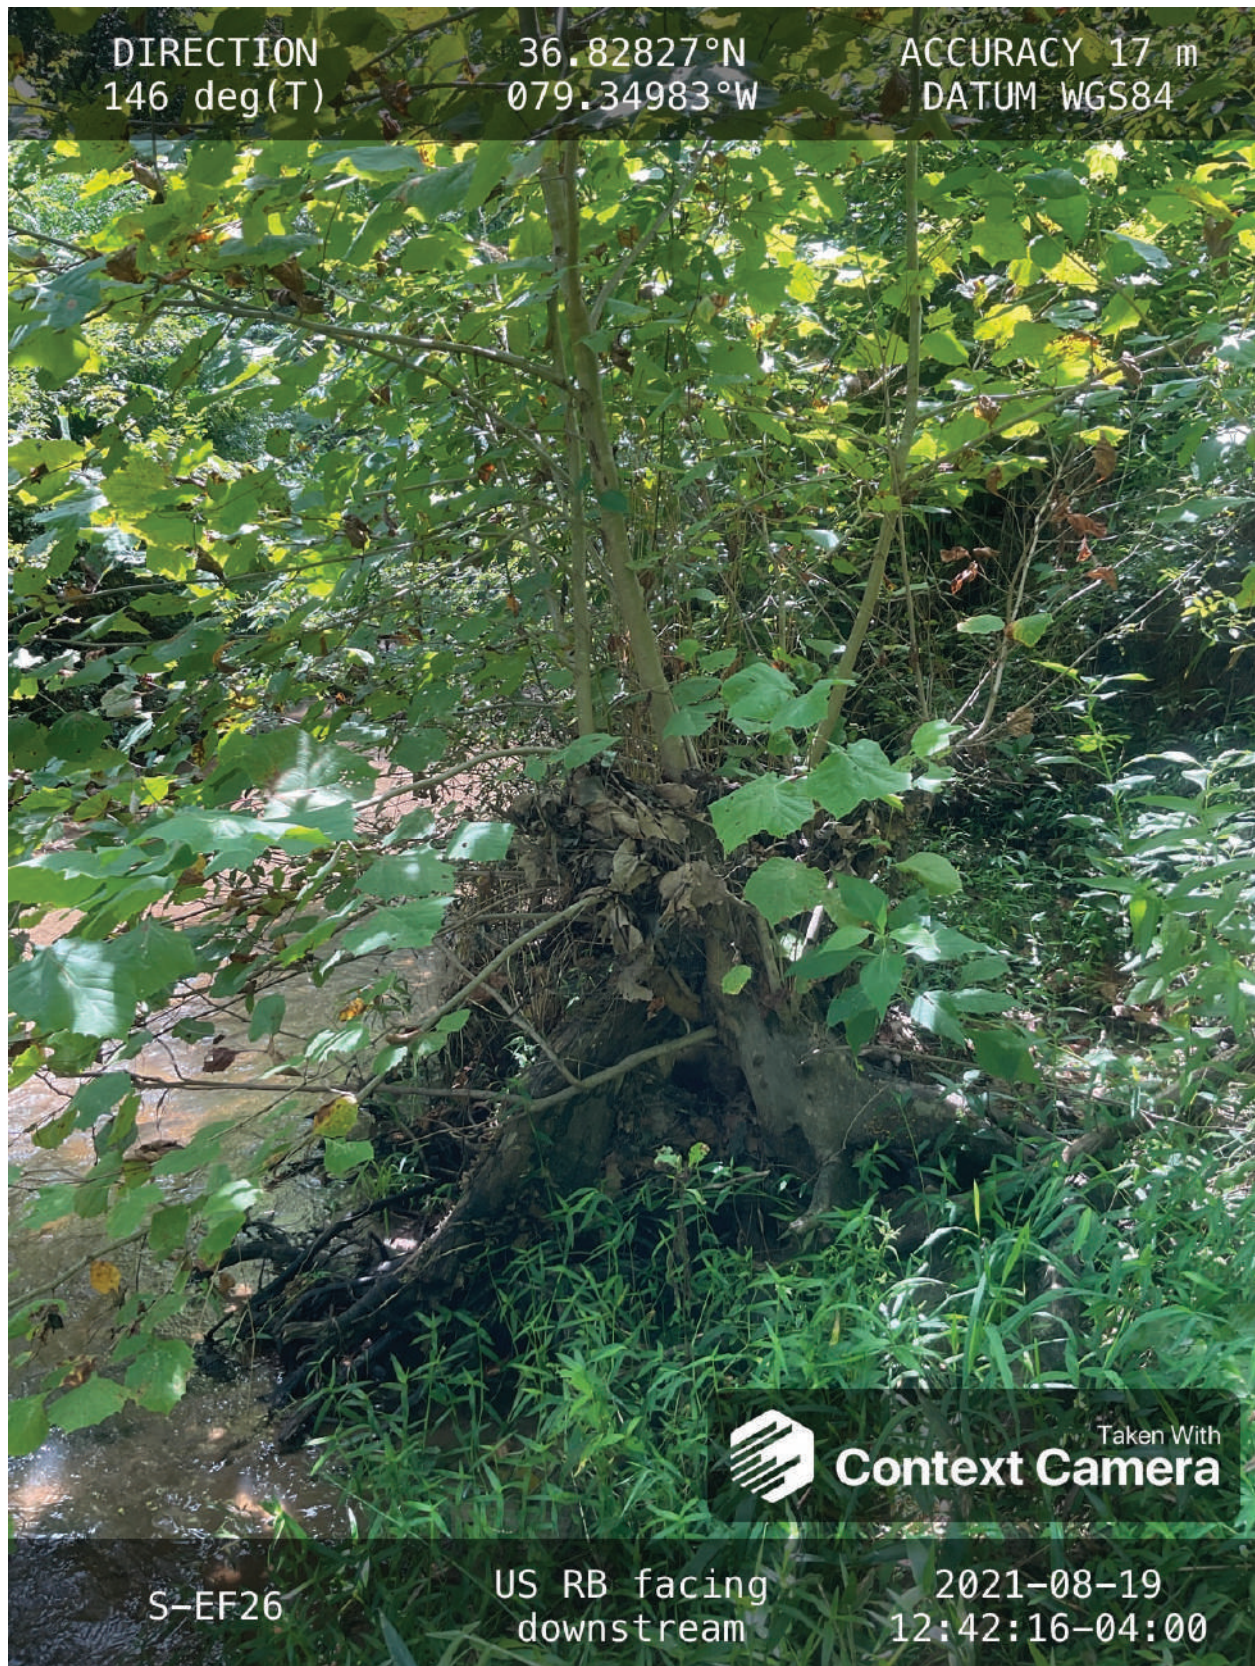
Photo Type: US RB facing downstream

Location, Orientation, Photographer Initials: Downstream at S-EF26 looking SE upstream, DW

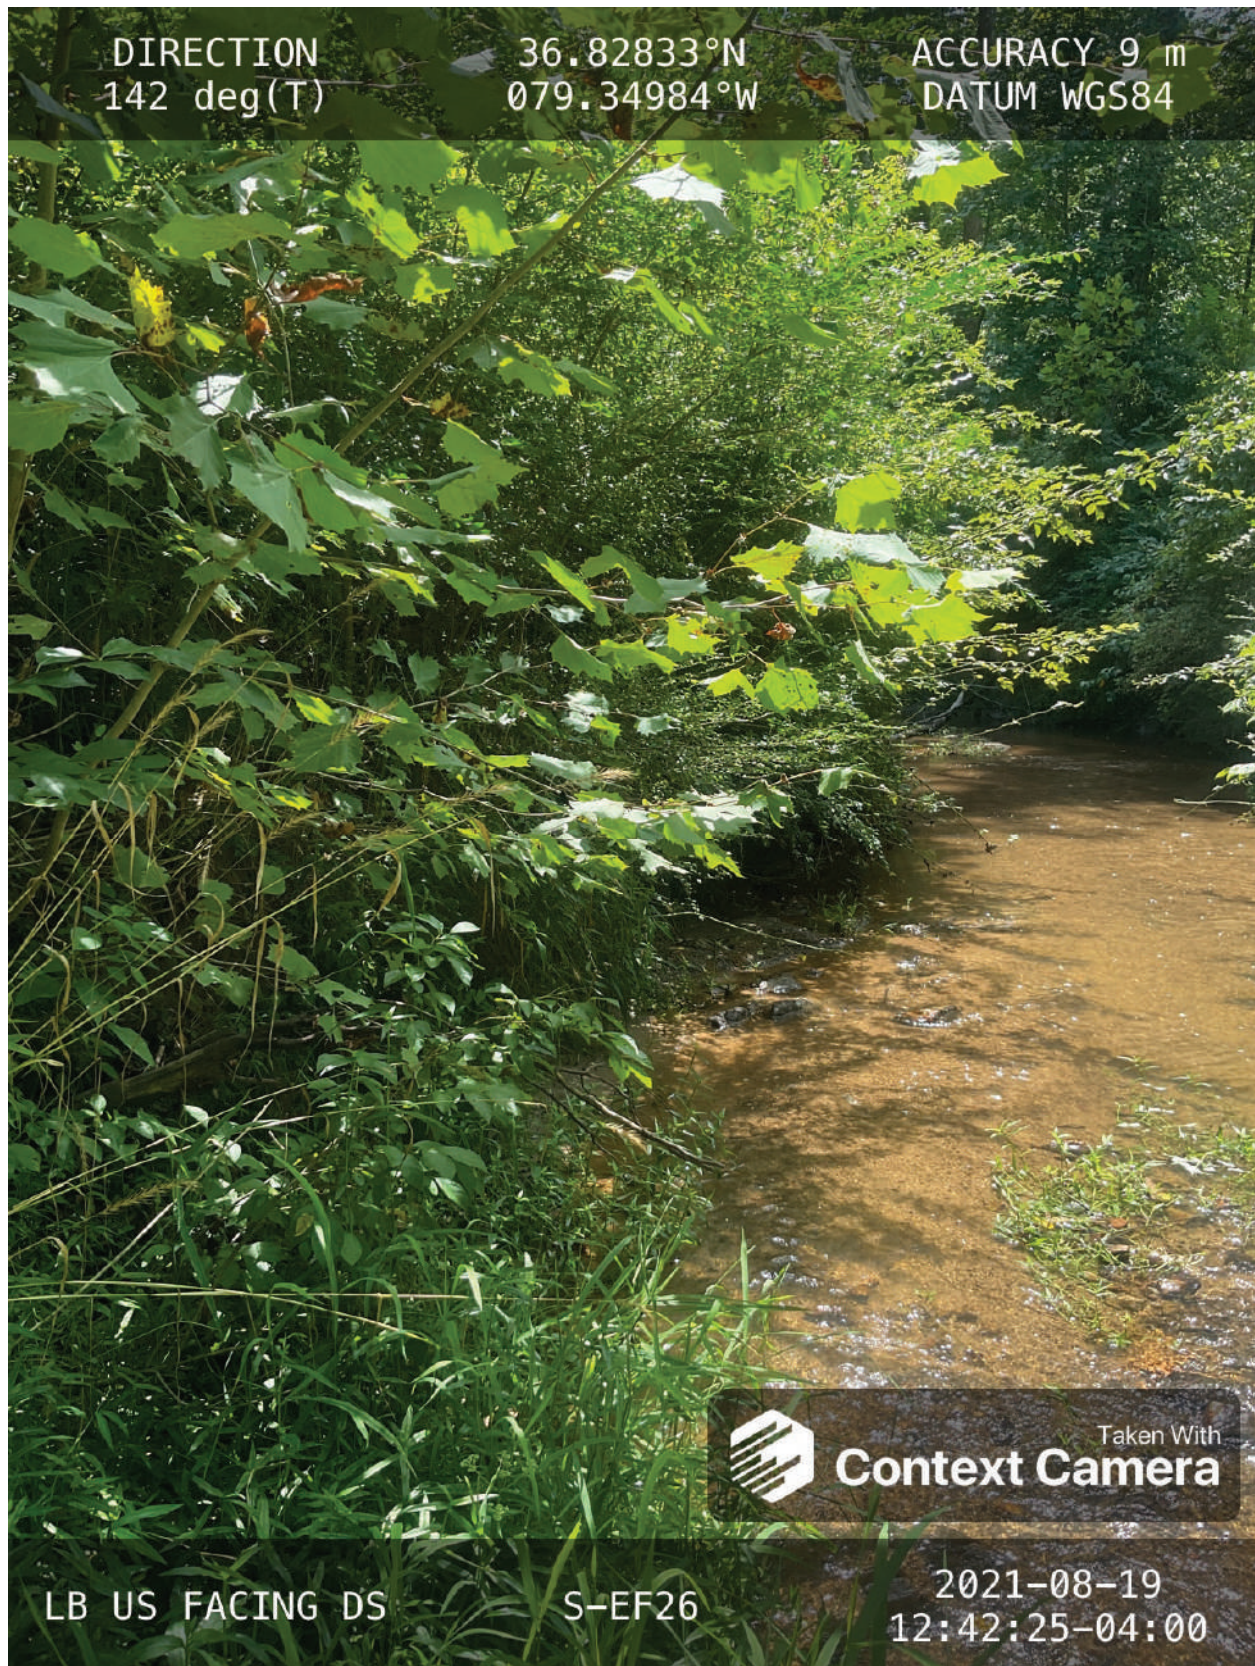
Photo Type: LB US facing DS  
Location, Orientation, Photographer Initials: Downstream at S-EF26 looking SE downstream, DW

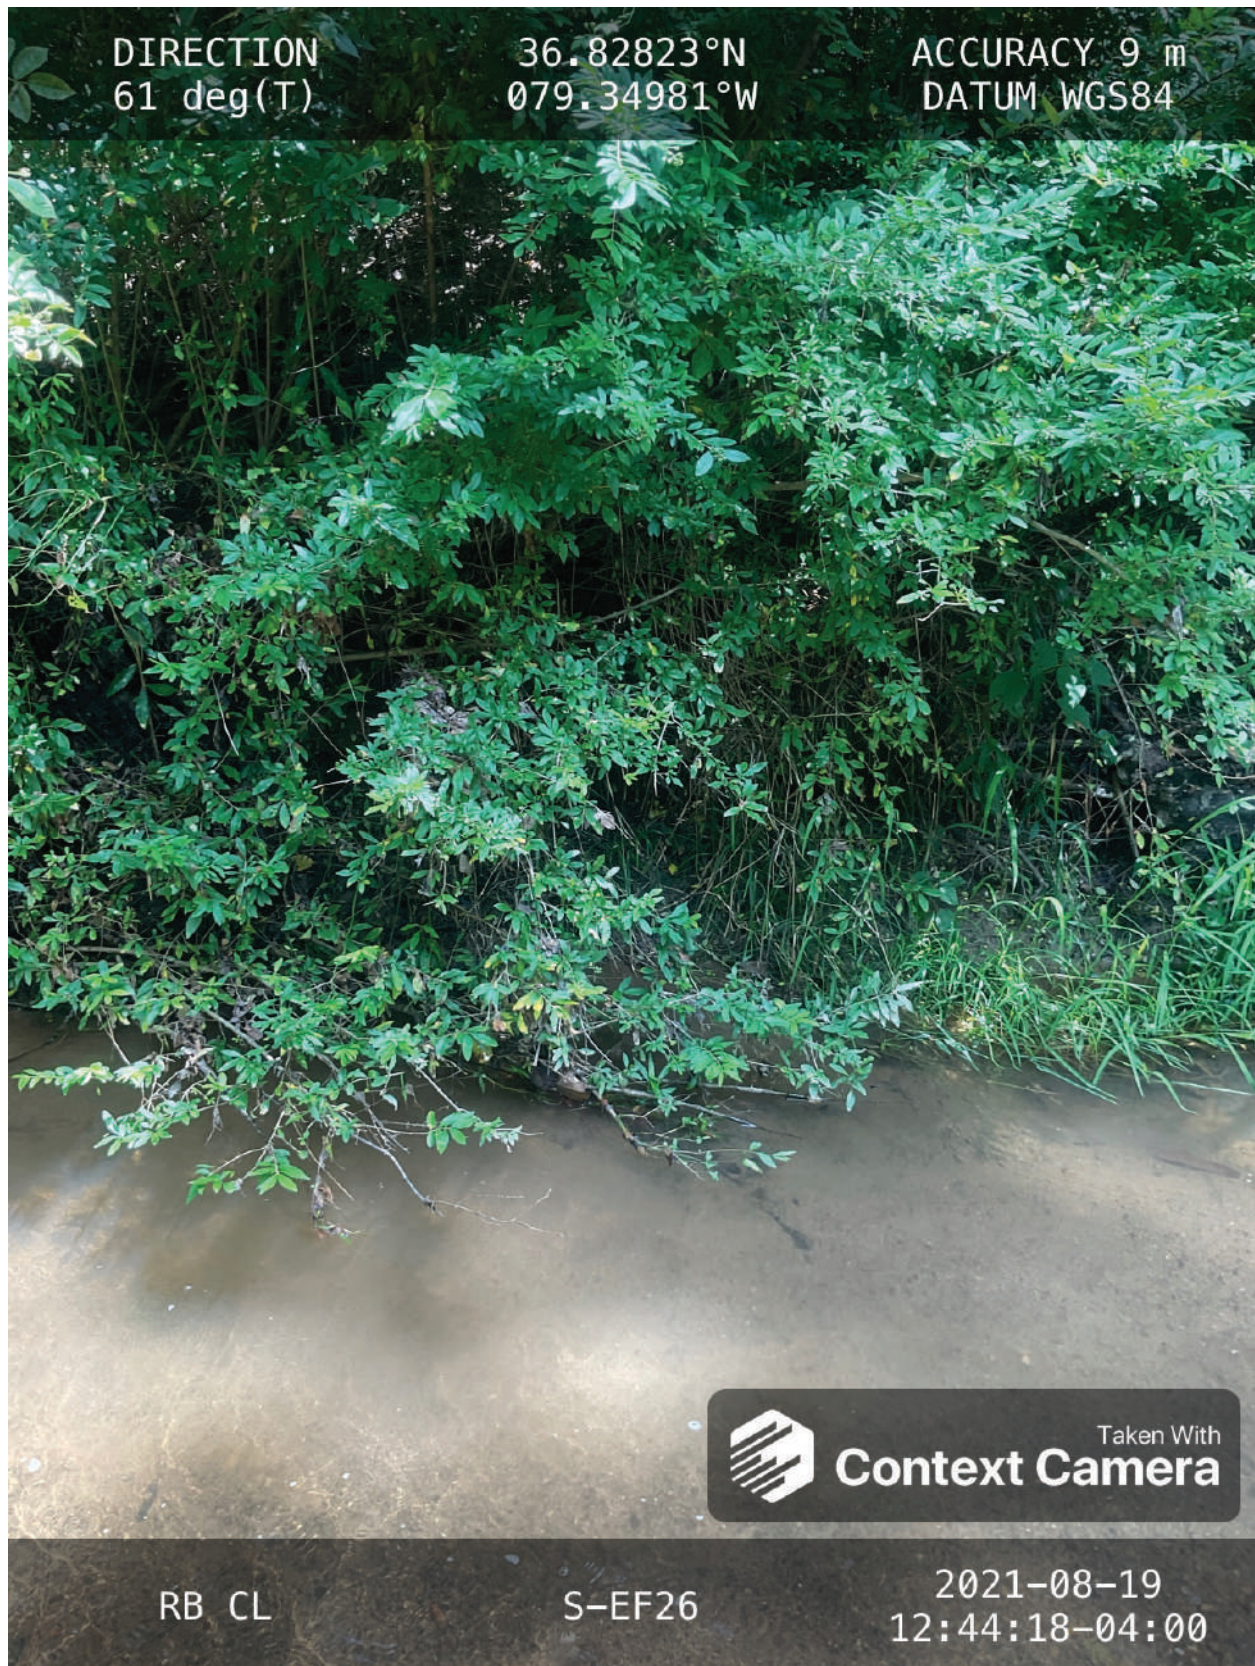
Photo Type: RB CL

Location, Orientation, Photographer Initials: On thalweg at S-EF26 pipe centerline looking E at right streambank,  
DW

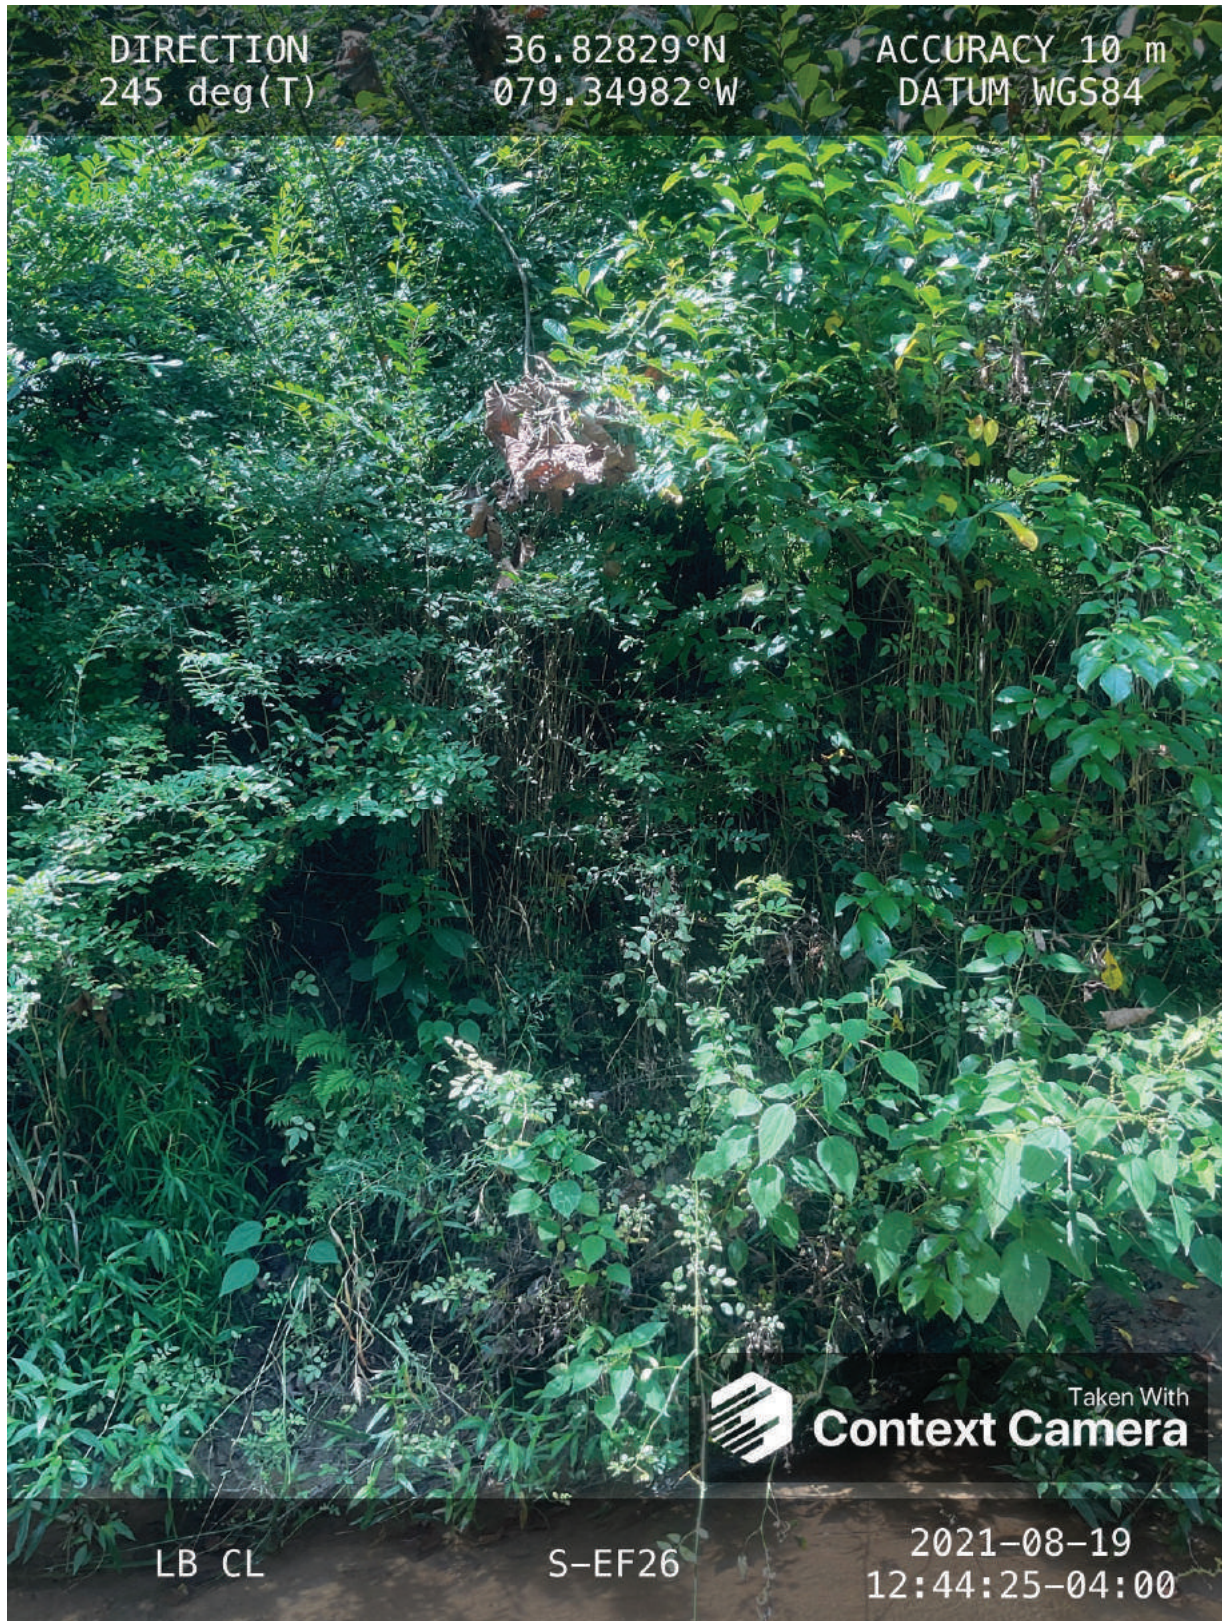
Photo Type: LB CL

Location, Orientation, Photographer Initials: On thalweg at S-EF26 pipe centerline looking W at left streambank, DW

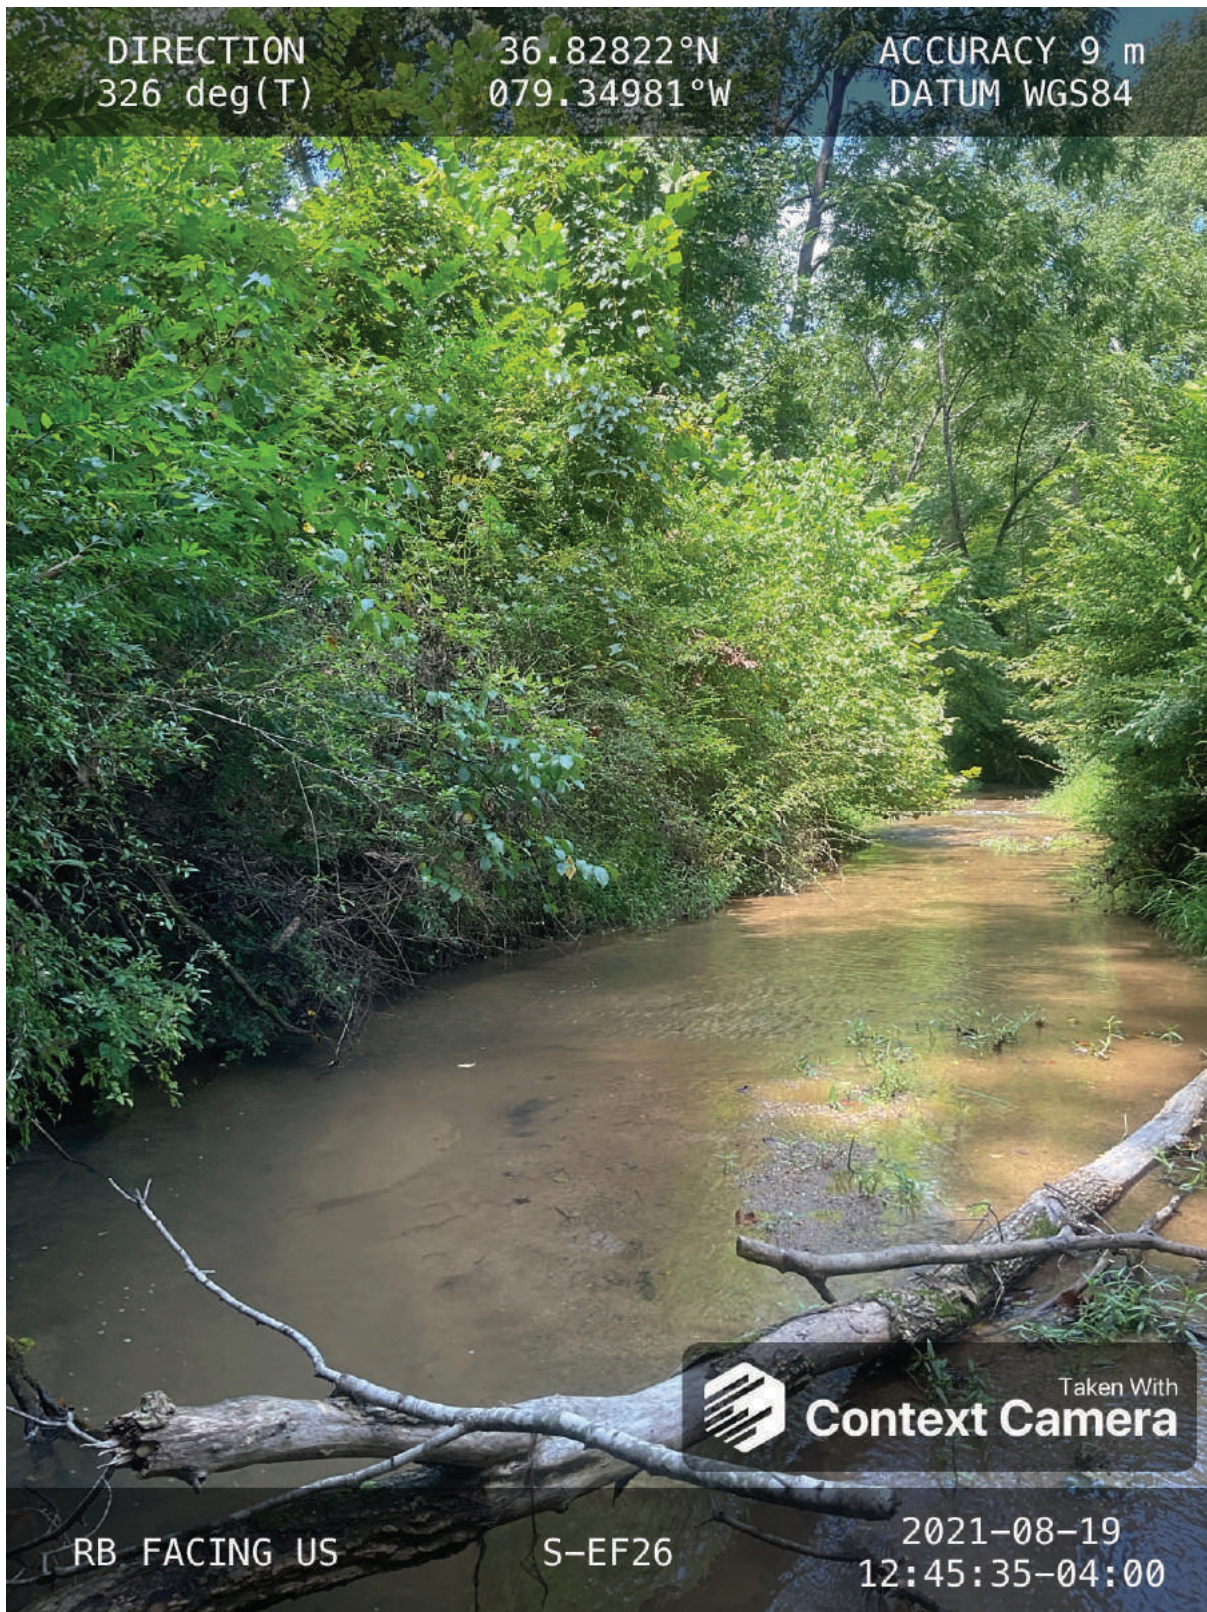
Photo Type: RB facing US  
Location, Orientation, Photographer Initials: Downstream at S-EF26 looking N upstream, DW

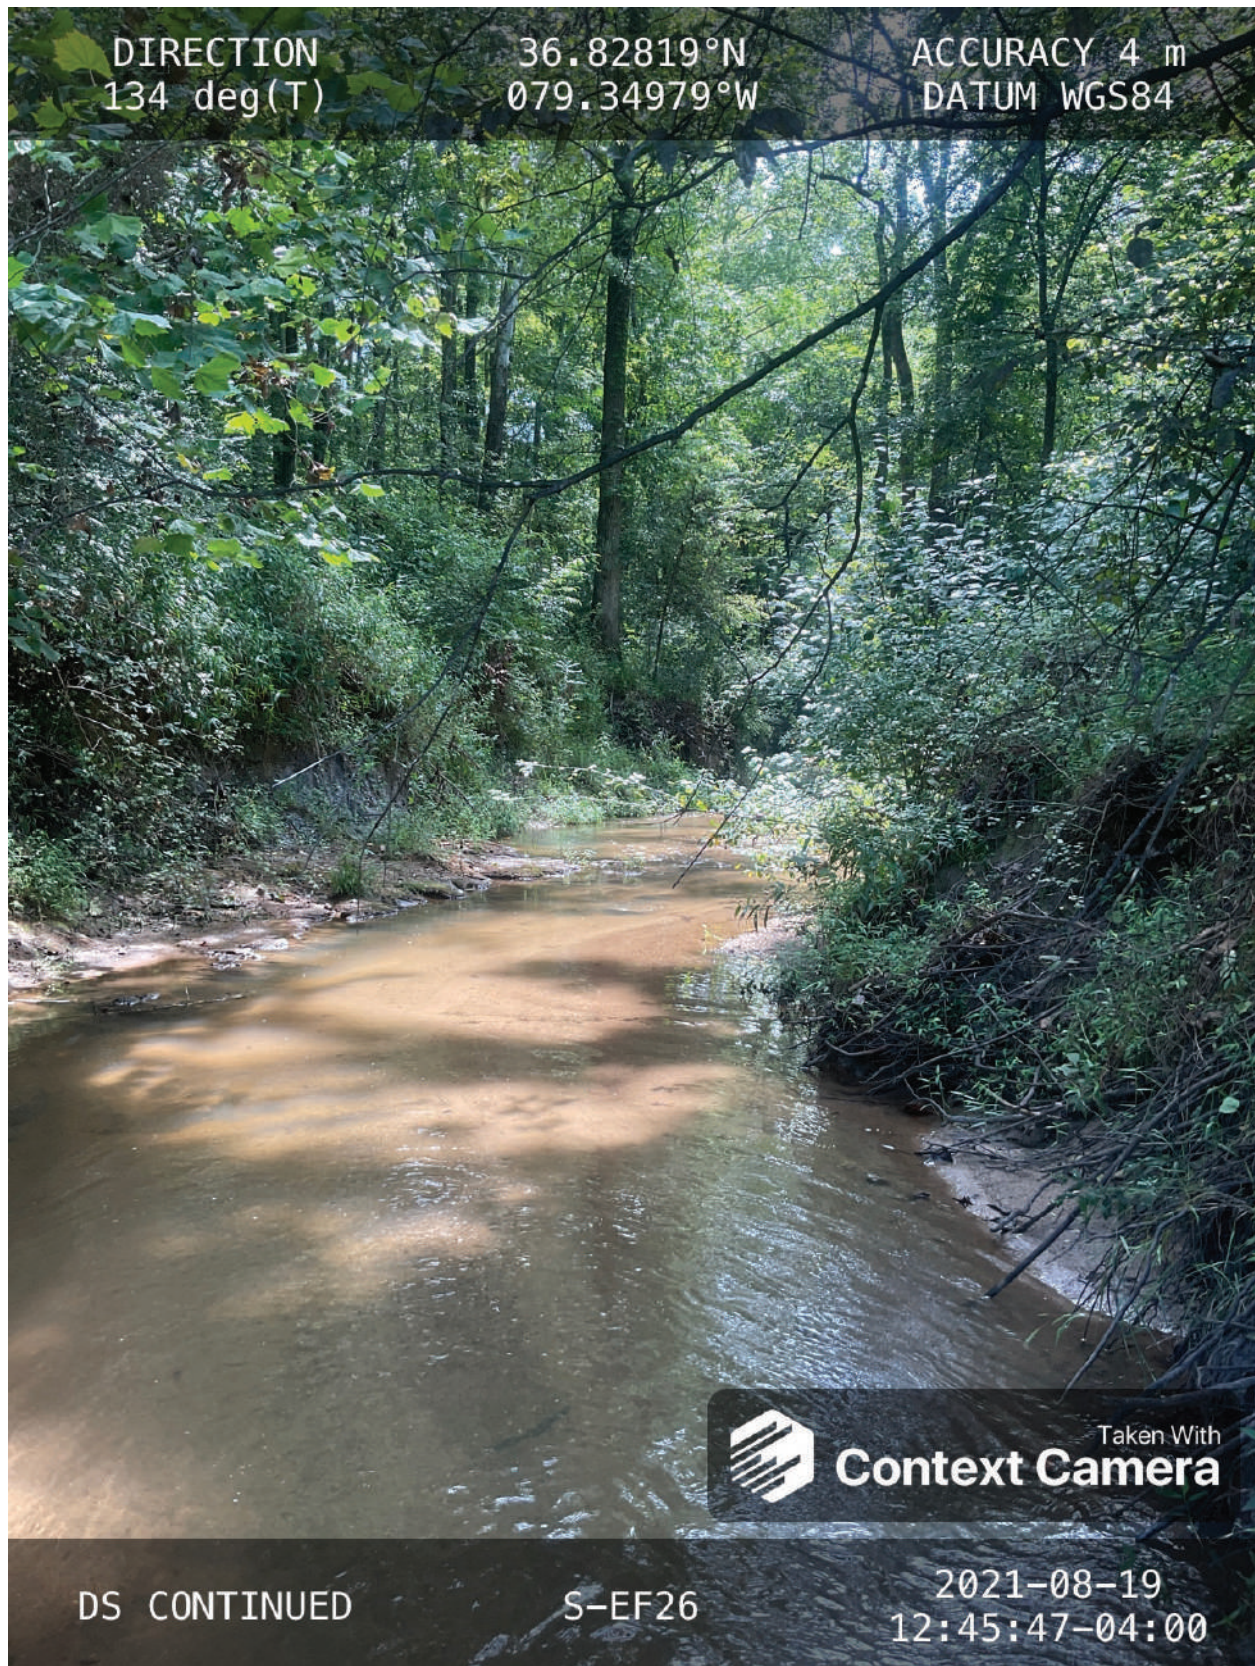
Photo Type: DS VIEW

Location, Orientation, Photographer Initials: Downstream at S-EF26 looking SE downstream, DW

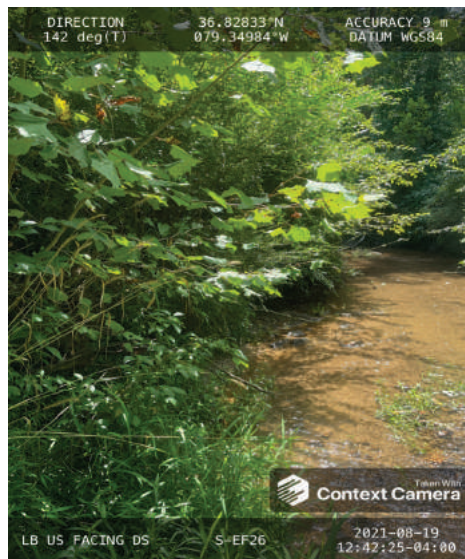
### INSERT PHOTOS:

**CAPTION.** Assessment is limited to areas within the temporary ROW.
