Trouble shooting guide for tablet coatings

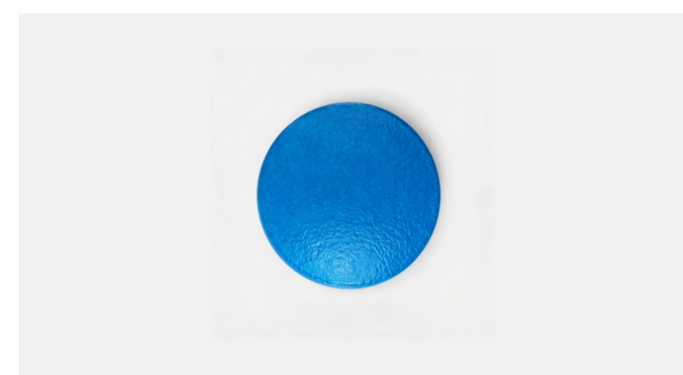
Orange peel / Roughness

Rough, orange-like film surface

- High viscosity/solid content
- High spray rate
- Low atomization air pressure
- Poor spray gun performance
- Dispersion sedimentation

- Reduce viscosity of coating suspension
- Optimize atomizing air pressure
- Reduce spray rate
- Optimize spray gun

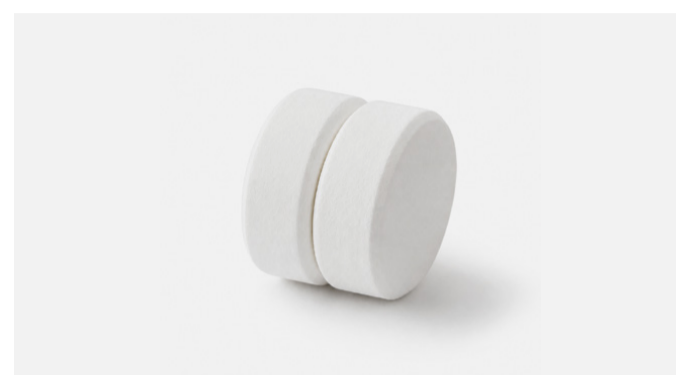
Twinning

Two or more tablets stick together

- Insufficient drying
- Low atomization air pressure
- Spray gun too close to bed
- Slow pan speed
- High spray rate
- Flat surface tablet
- Excessive tacky coating formulation

- Increase drying capacity
- Increase atomization air pressure
- Increase gun to bed distance
- Increase pan speed to reduce dwell time
- Decrease spray rate
- Add edge curvature to tablet
- Use less tacky coating system

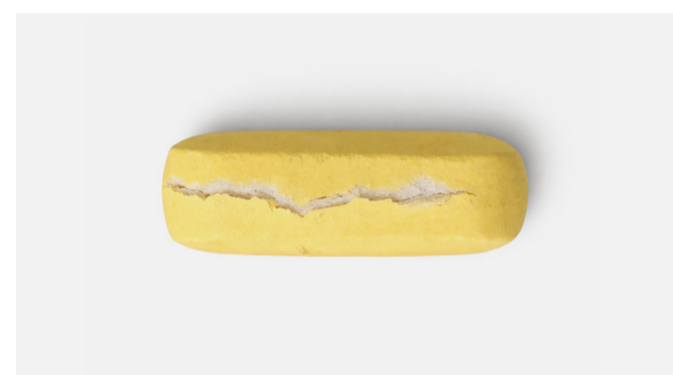
Film cracking

Cracks on coated surface

- Poor plasticization; non-flexible film
- Expansion of tablet core
- Inadequate compression coating hold time
- Expansion of core due to heating
- Expansion of core due to water absorption

- Reduce thermally expandable excipients
- Extend hold time between compression and coating
- Avoid high tablet blend temperature
- Improve drying capabilities of coating process

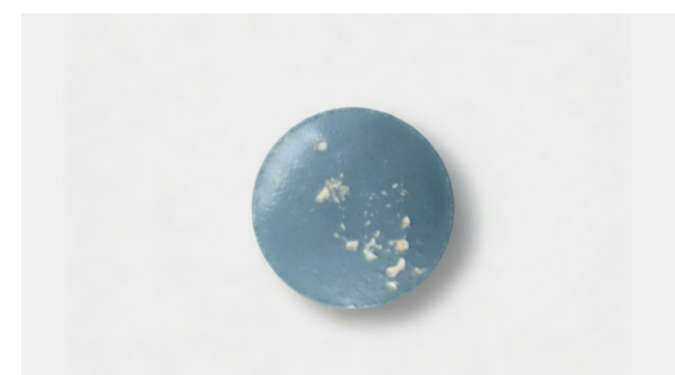
Picking and sticking

Surface damage after sticking

- Poor film adhesion
- Low solid coating formulation
- Too high spray rate
- Drying temperature too low
- Slow pan speed
- Low atomization air pressure

- Use high adhesion film coating formulation
- Use high solid film coating formulation
- Reduce spray rate
- Increase drying temperature
- Increase pan speed
- Increase atomization air pressure

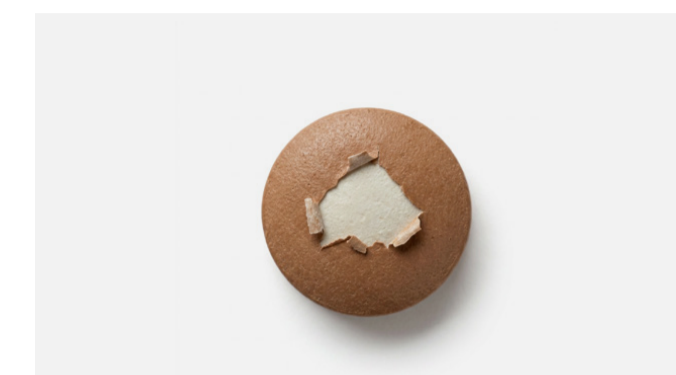
Film peeling

Coating peels off

- Core tablet erosion
- Low film strength coating
- Overheated tablet core
- Excessive attrition
- Insufficient core porosity

- Improve tablet core formulation
- Reduce pre-warming temperature and time
- Reduce pan speed
- Increase tablet core porosity

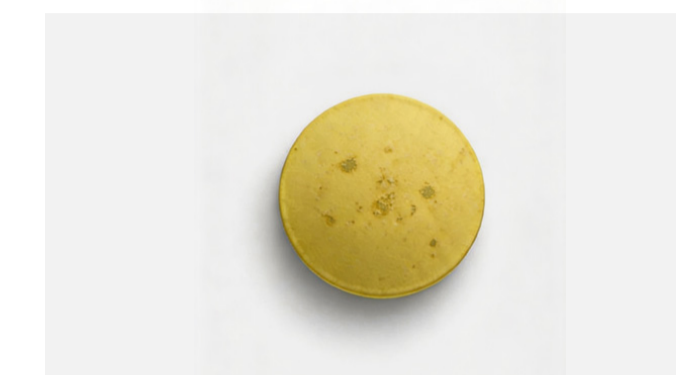
Scuffing

Grey-black marks on tablet surface

- Large and elongated shaped tablet
- High TiO₂ content
- Slow pan speed
- Longer coating process
- Underloaded coating pan

- Change tablet shape
- Reduce TiO₂ level
- Shorten coating time
- Increase pan speed
- Increase pan load

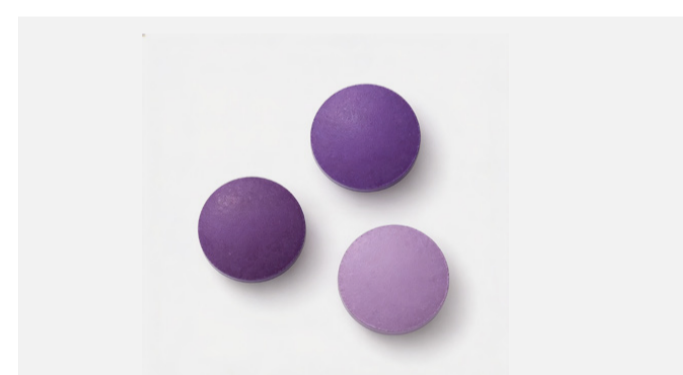
Colour variation

Uneven tablet shades

- Low opacity (hiding power) of film coating
- Too high solid concentration of coating formulation
- Low or High pan loading
- Low film coat weight gain
- Too low pan speed
- Insufficient number of spray gun

- Coating system with increase hiding power
- Reduce solid concentration of coating formulation
- Optimize pan loading
- Increase film coat weight gain
- Increase pan speed
- Increase number of spray gun

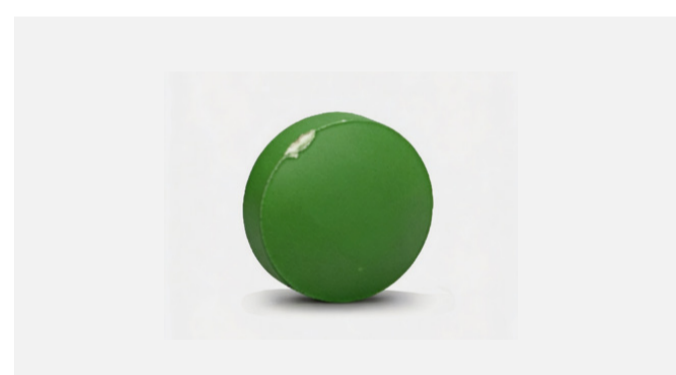
Edge erosion

Chipped or worn edges

- Poor film strength
- High core friability
- Too sharp tablet edges
- Worn tablet tooling
- Low spray rate
- Inappropriate baffle design according to tablet shape
- Under loaded pan
- Too high pan speed

- Reformulate core to reduce brittleness
- Change core shape and design
- Replace tablet tooling
- Increase spray rate
- Change baffle design
- Fill pan to correct volume
- Reduce pan speed

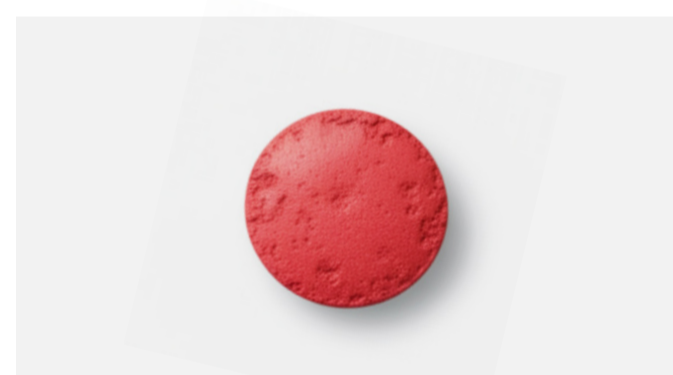
Tablet surface erosion

Surface wear during tumbling

- Low film strength
- Too low solid concentration of coating suspension
- Hygroscopic tablet core
- High core friability
- Logo placement and design
- Too low spray rate
- Too high pan speed

- High strength film coating
- Increase coating suspension solid concentration
- Reduce hygroscopic core material
- Reformulate core with improve friability
- Change logo design and placement
- Increase spray rate
- Decrease pan speed

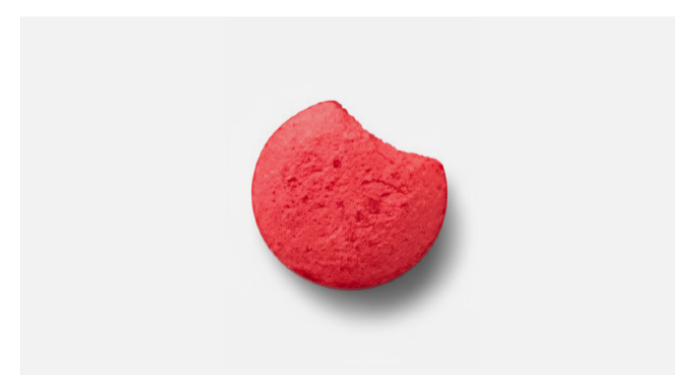
Tablet breakage

Tablets break apart

- Tablets are too soft or too brittle
- Poor tablet shape
- Too high pan speed
- Inappropriate baffle design
- Too low spray rate
- Under loaded pan

- Consider reformulating core
- Change tablet shape
- Reduce pan speed
- Change baffle design
- Increase spray rate
- Fill the pan at optimum volume

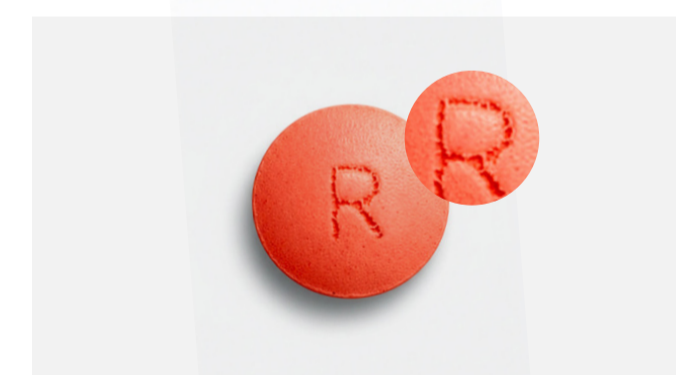
Logo bridging

- Low adhesion film coating
- Poorly plasticized film coating
- Poor logo design
- Low adhesion core ingredients
- Dispersion sedimentation
- Spray rate too high
- Too low atomization pressure

- Use high-adhesion coating
- Use optimally plasticized film coating
- Use appropriate logo design
- Use high adhesion core ingredients
- Decrease spray rate
- Increase atomization air pressure

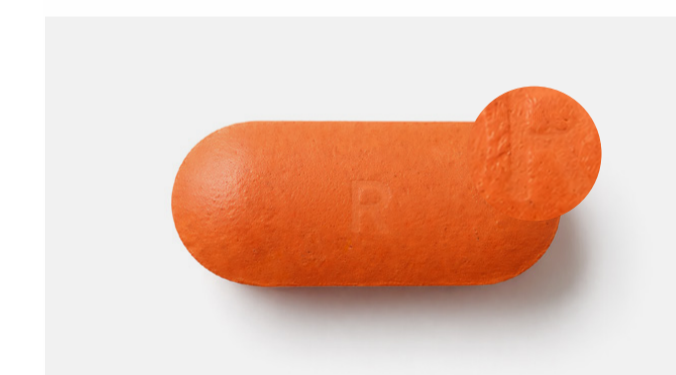
Logo filling

Filling of logo

- High solid content/Viscosity
- Low plasticizer
- High spray rate
- Low/high atomizing air pressure
