Wind Turbine Services

Blade X-Ray Inspection

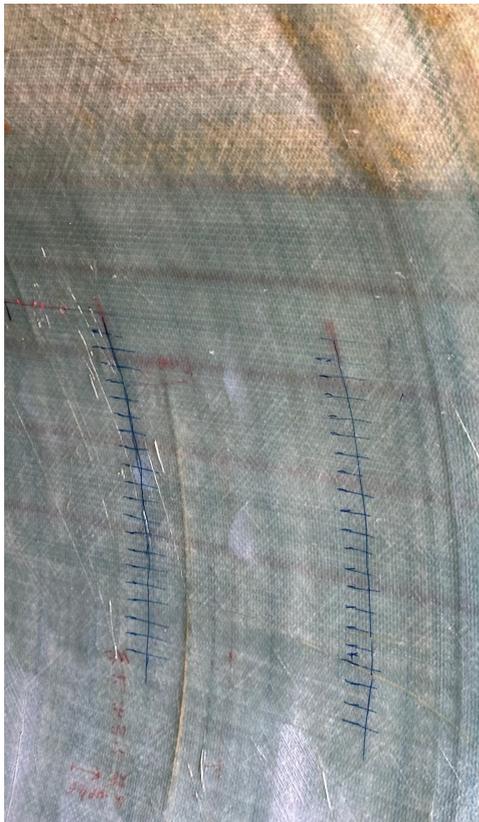
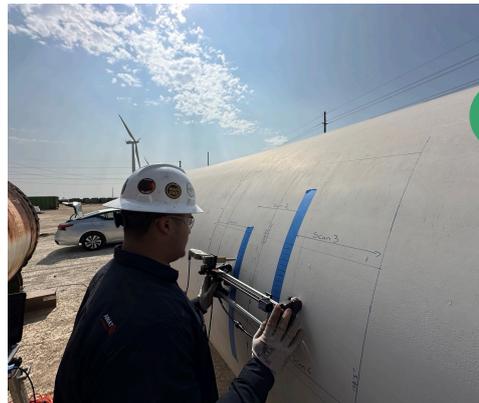
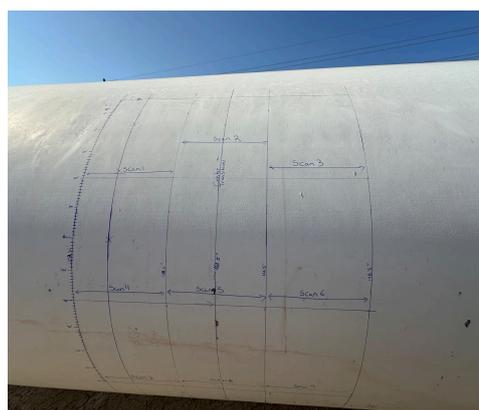
- Initially, Aurora proposed using Phased Array Ultrasonic Testing (PAUT) on the blade's exterior, which required rope access...
- However, PAUT is a time-intensive and delicate process. Instead, Aurora suggested performing X-ray inspections from the interior of the blade...
- This method proved to be safer, faster, and more effective for on site inspections, successfully identifying the internal defects.
