TOWN OF BRADFORD - PILOT

In May 2024, the Town of Bradford implemented a targeted pilot program to assess the effectiveness of catch basin inserts in intercepting pollutants at source within the stormwater network. A total of **32 EnviroPod™ LittaTrap™** units were installed at identified hotspot locations, with a focus on capturing trash and litter entering downstream infrastructure, including stormwater management ponds.

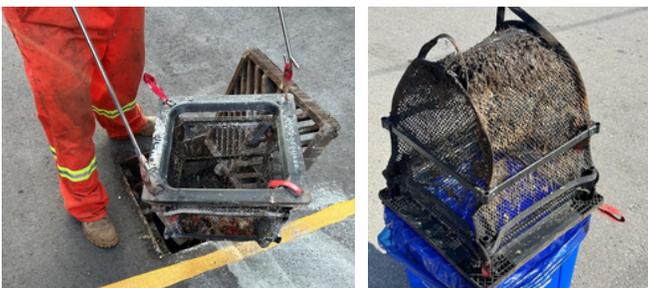
LittaTrap™ removed from catch basin then emptied into the bin.
