Featured Technical Topic Summary

FGI Monthly Members Meeting

TOPIC: Your Liner is Leaking, What Should You Do?

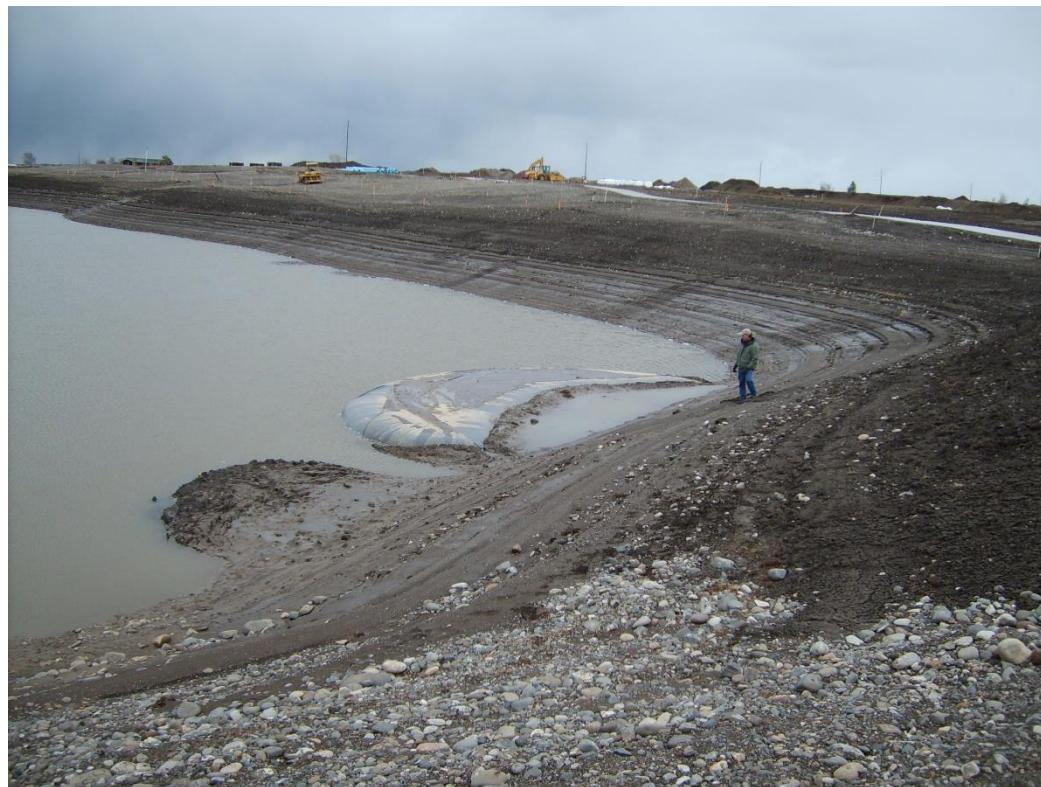
- Pat Elliott's photo of displaced soil cover from the top of a PVC geomembrane because of leakage from a nearby leaking irrigation channel, leakage from irrigation channel caused increase in groundwater, which raised the geomembrane so problem not in the pond

- If geomembrane bubbles up due to groundwater increase, the bubble(s) is large and flat so can for identifying cause
- If geomembrane bubbles up due to gas pressure, gas bubbles are smaller and more circular than due to groundwater

- After the irrigation canal was lined with a geomembrane, the nearby pond continued to perform well because the groundwater returned to its initial level

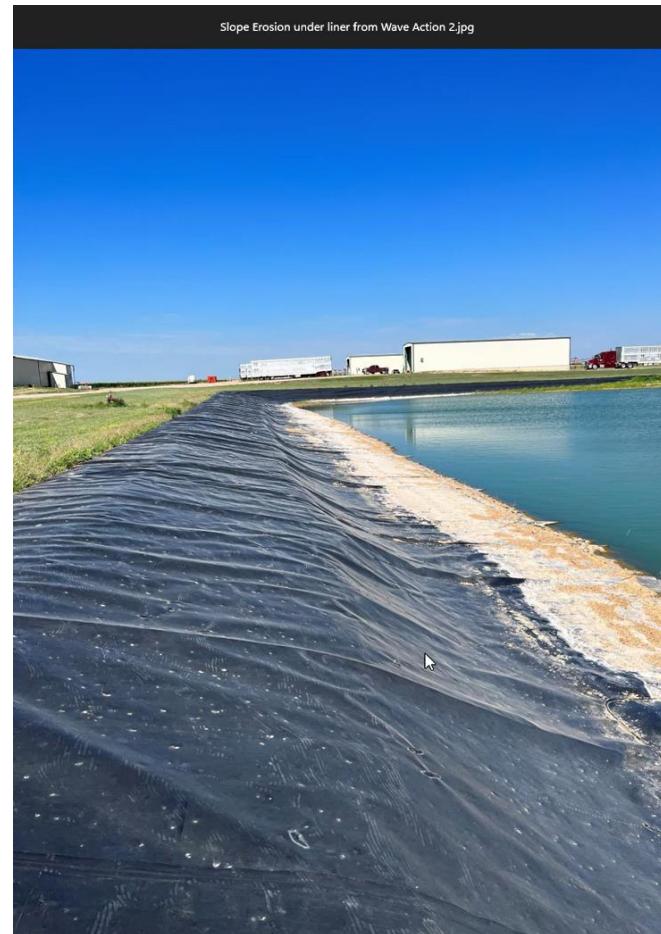
- Neil Nowak of GLA shared the following two photos:
- First photo shows a leaking 5 acre pond seven years after installation – sediments from brine and wind blown sand covered most of the geomembrane after draining the pond
- Second photo shows the leak after a leak location survey was able to locate it even with sediment on top of geomembrane

WYOMING - SEDIMENTS IN POND BOTTOMS AFTER REMOVAL OF WATER FOR LINER REPAIRS; POND OPERATIONAL 7 YEARS. WATER WAS 13,000 PPM TO 66,000 PPM TDS.

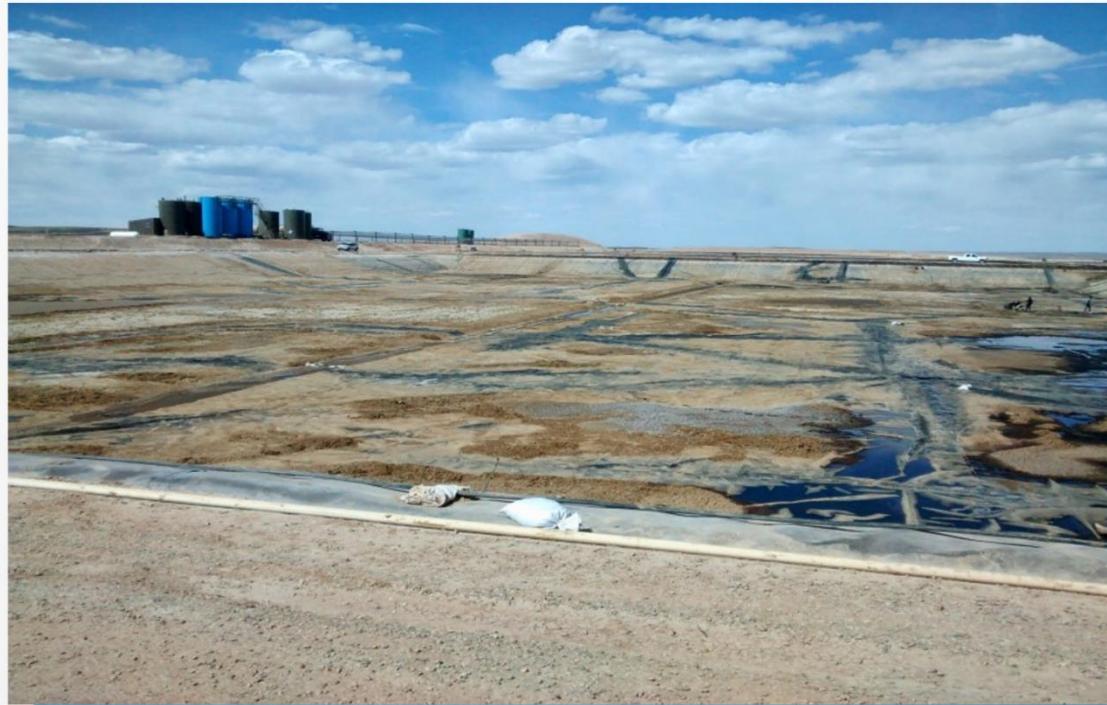
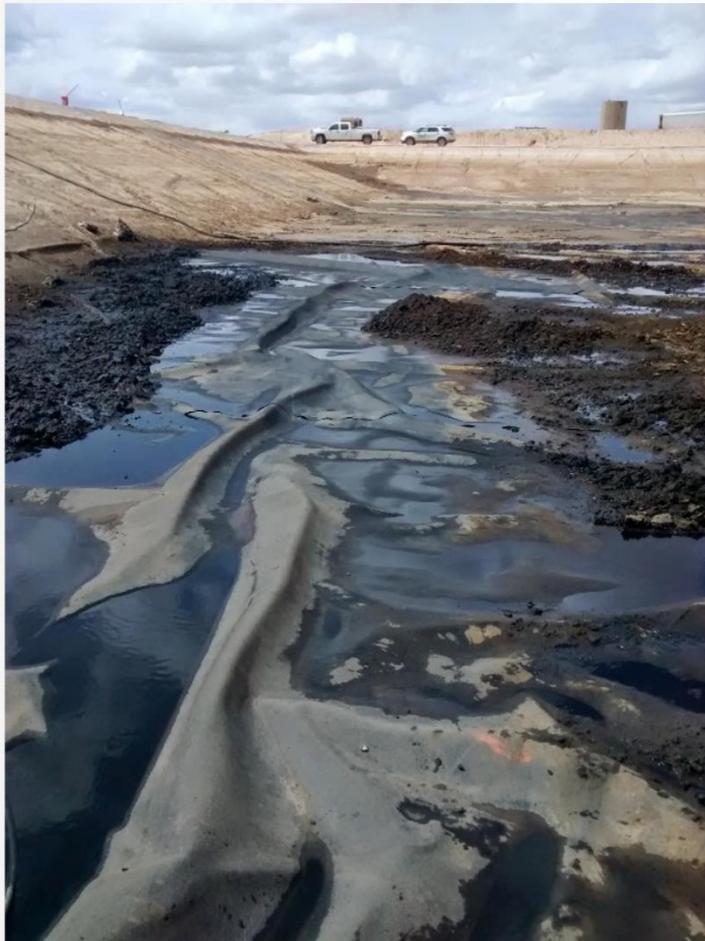
SEDIMENTS REMOVED BY HAND
USING SHOVELS AND POWER
WASHER, THEN WHEELBARROW
THE SEDIMENTS TO THE TOP OF
THE POND. LOAD THE DRIED
SEDIMENTS IN WASTE TRUCKS FOR
DISPOSAL AT AN OILFIELD WASTE
LANDFILL.
