**Emnor Mechanical Inc.**  
20 Depew Street  
Hamilton, Ontario  
L8L 7H8

## REPAIR OF GEAR PUMP

Scope of work was to manufacture new gears, repair the damage to the housing and shafts

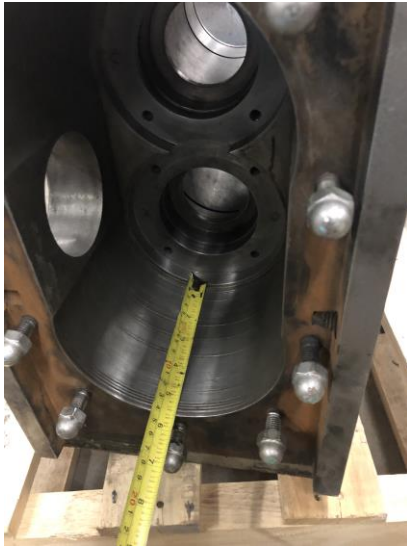
Worn Housing

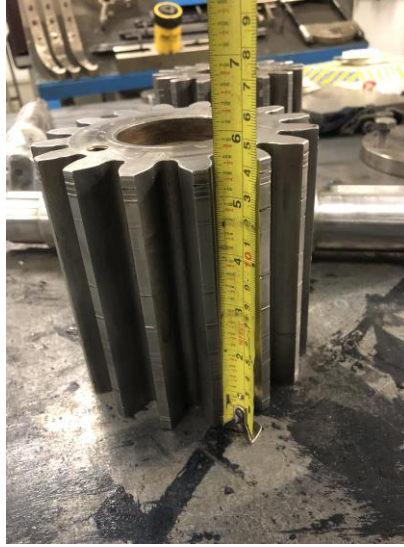
Worn Gear

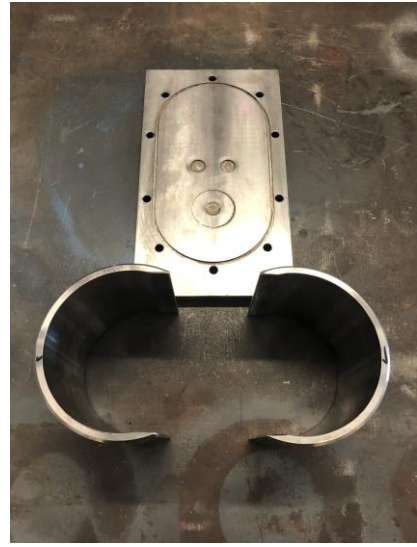
Sleeves for Bores

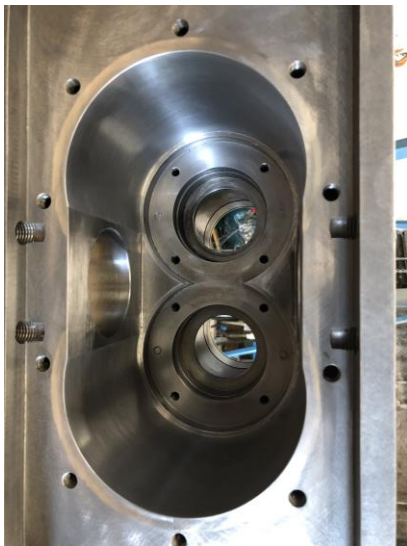
Sleeves Welded Into Housing

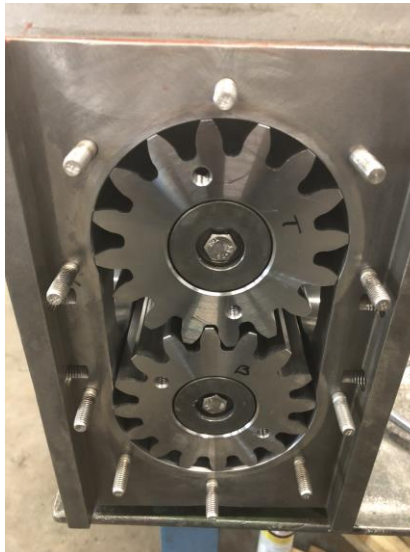
New Gears Installed

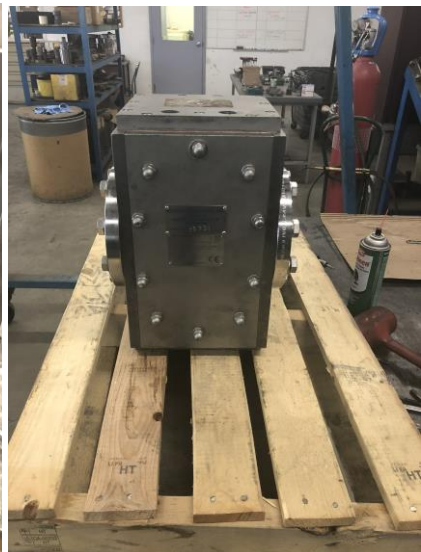
Assembled Pump
