**Emnor Mechanical Inc.**  
20 Depew Street  
Hamilton, Ontario  
L8L 7H8

## REPAIR OF HIDROSTAL SUBMERSIBLE PUMP

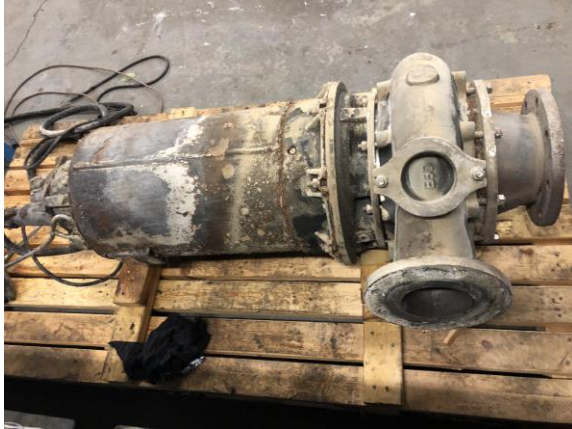
Pump as Received

Scope of work was to manufacture a new cooling jacket, machine the suction cone and impeller, repair bearing housing bore, recondition the motor and mechanical seals.

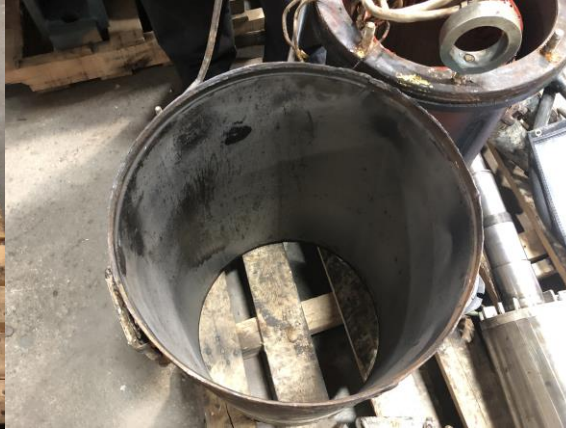
Damaged Cooling Jacket

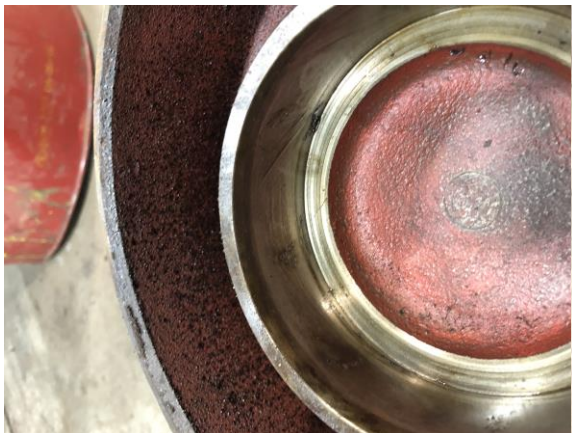
Damaged Bearing Housing Bore

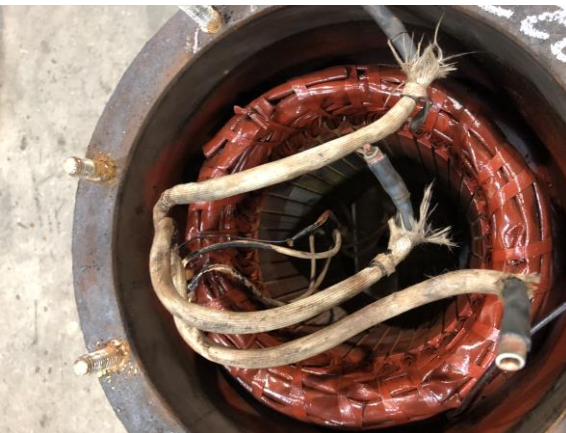
Damaged Motor

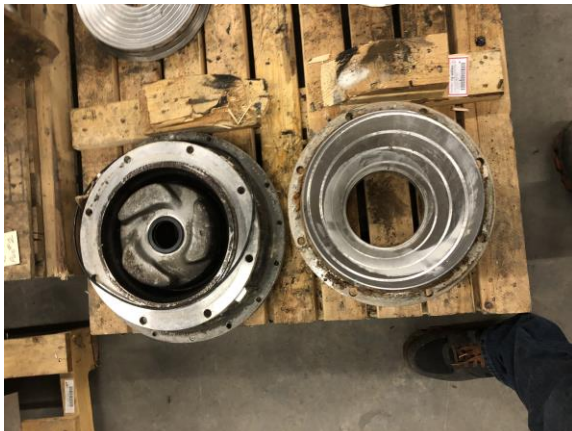
Cone Wear

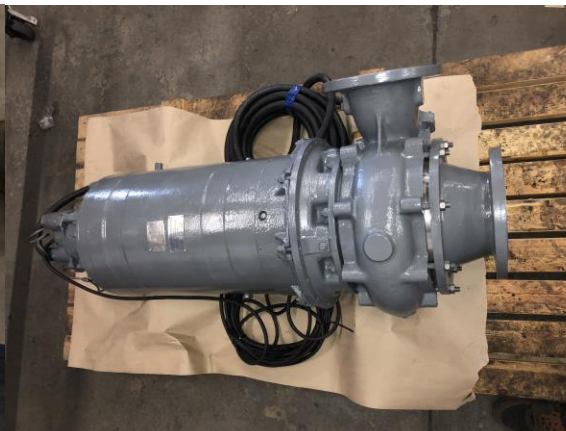
Completed Repair
