**Emnor Mechanical Inc.**  
20 Depew Street  
Hamilton, Ontario  
L8L 7H8

Repair 14X14X22 Volute

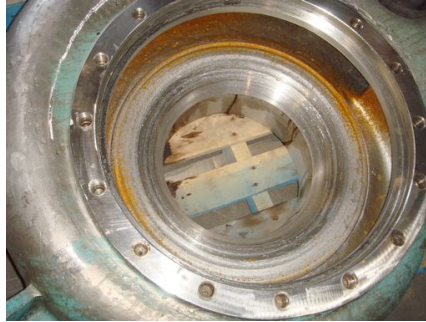
Worn Volute

The above volute was repaired at considerable savings to new. The suction side plate and volute were tungsten carbide coated for extended life in an abrasive application. Please contact Emnor to discuss repair procedures that will save money and increase pump life.

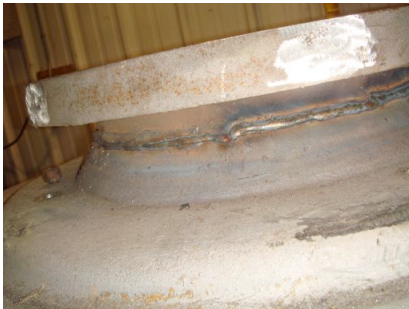
Flange Weld

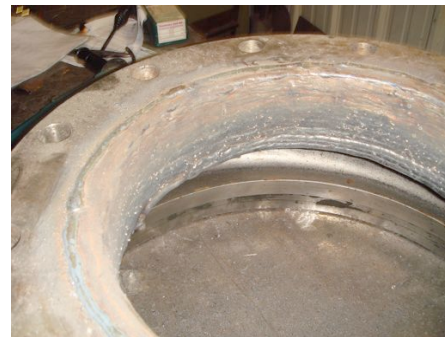
Welded

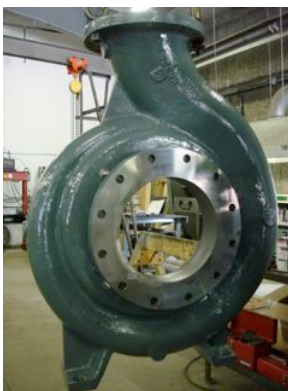
Finished

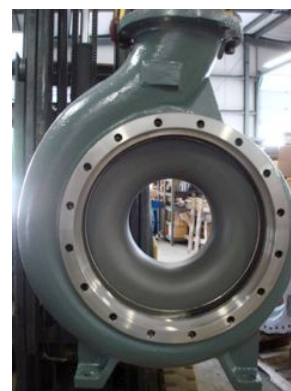
Finished with new plate
