Electrical Inspection Report

Site: 24 Fawcett Street, Dunedin.

Carry out Visual Electrical Inspection of the above site including Mains Supply, Distribution Boards, Metering, Wiring, Earthing and Switchgear.

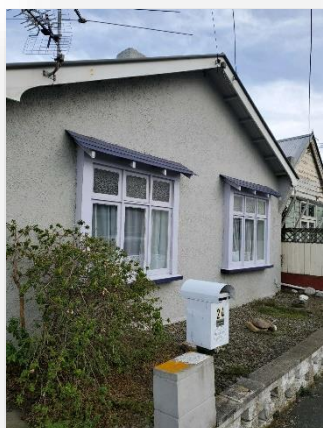
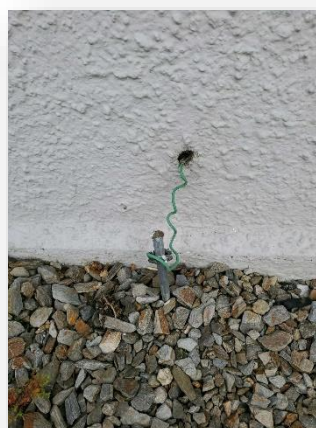
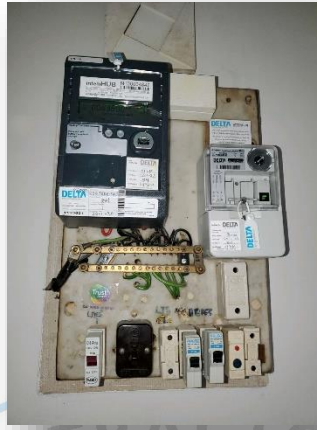
comments/recommendations	grade
13 Switchboard type:	Fixed Panel Surface Mount	B
13 *This panel is impregnated with asbestos. It is compliant but would recommend to replace		
14 Overload protection: Circuit Breakers	4 Circuit Breakers	A
14 Overload protection: Fuse Carriers	3 Fuse Carriers	B
15 Electric shock protection: RCD'S		
16 Main Switch	Yes	A
17 Neutral & Earth Bar	with link	A
18 Switchboard wiring	Yes	A
19 Switchboard fireproofing		
20 Meterbox
