EP-Stage 1B VR Test

ST1-5949

VR1 Inspection

## C. Stage 1b inspection and test

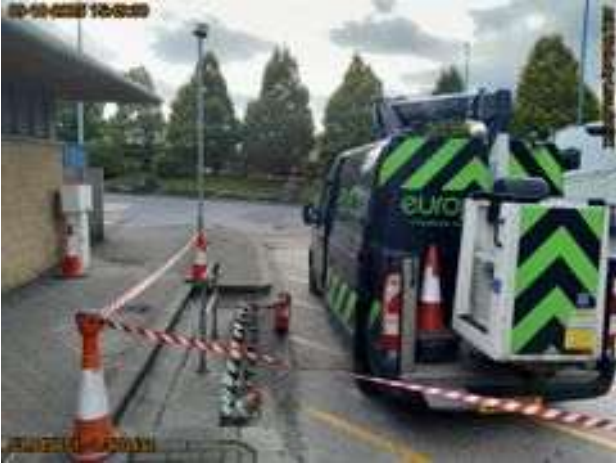
| Answer | Comments |
|---|---|
| Take a Picture of your safe working area on the forecourt include fire ex, gas monitor and barriers | |
| Site setup complete correctly | Yes |

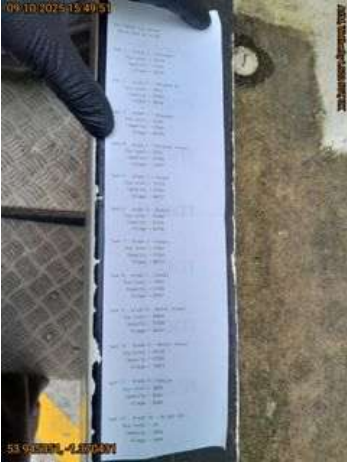
| Answer | Notes |
|---|---|
| Take a picture of the gauge print out | |
| Does the print out match the tank to pump plan and labels? | Yes |

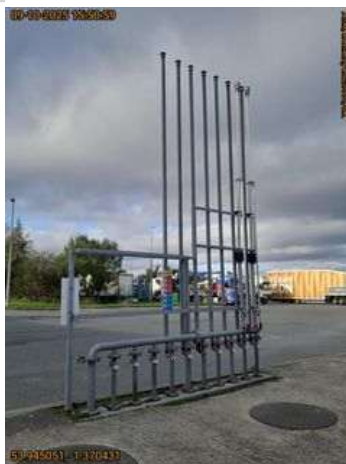
Take a photo of the Vent  
stack

Where is the manifold

Low

located?

How many Pvs? 2

Is the vent warning sign in place? Yes

Are vent tags in place? Yes

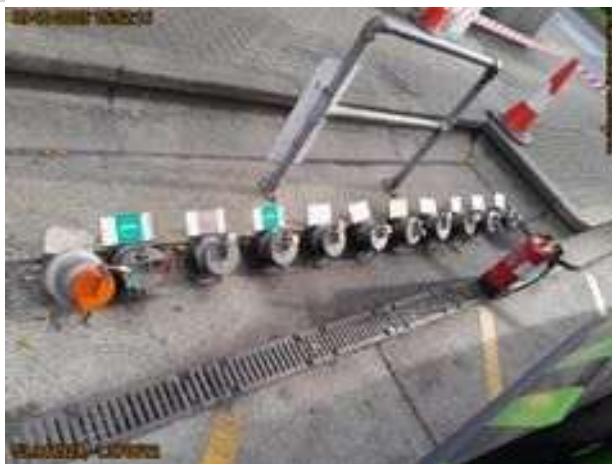
Take a photo of the Fill Points

Are the labels clean? Yes

Check cap seals STATEMENT READ - Check all spirit and diesel cap o,ring seals and replace as required

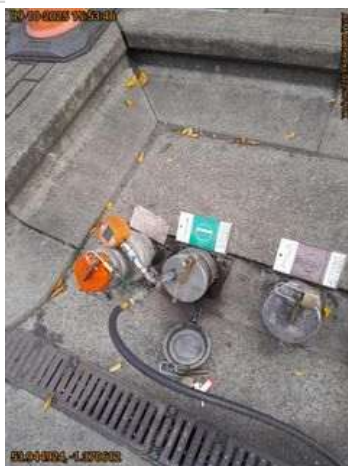
Take a photo of your test rig on the fill points testing drop tube seals

Is the vent system sound  
and undamaged?

Yes

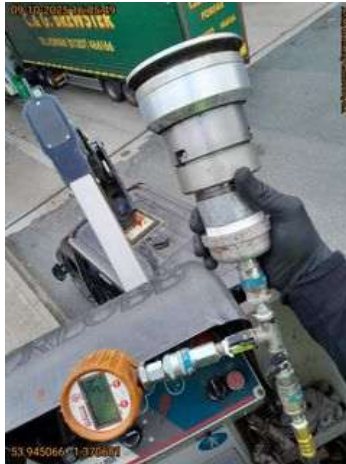
Take a photo of the Pvs on  
test from the cherry picker  
bucket.

Are the pvs operating  
correctly?

Yes

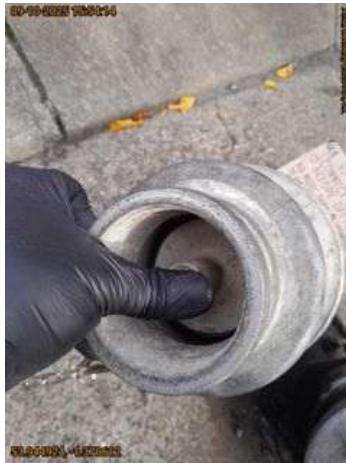
Is the vr hook adapter free  
and operational?

Yes

Take a photo of the VR  
adaptor and flame arrestor

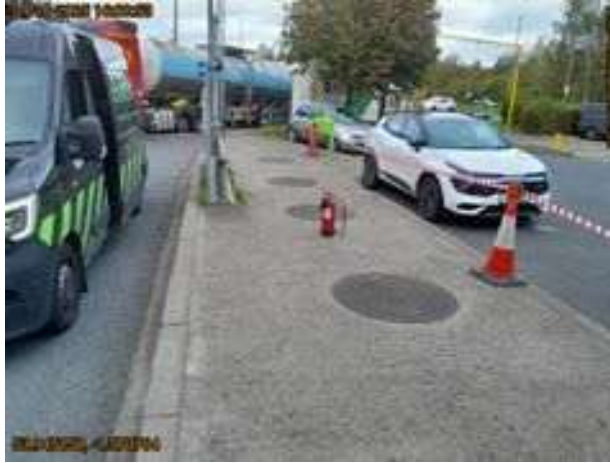
Please take a picture of your setup around chambers

Details the size(s) and type of the manhole cover (Eg. Fibrelite 860 x 860)

980mm x 980mm fibrelite

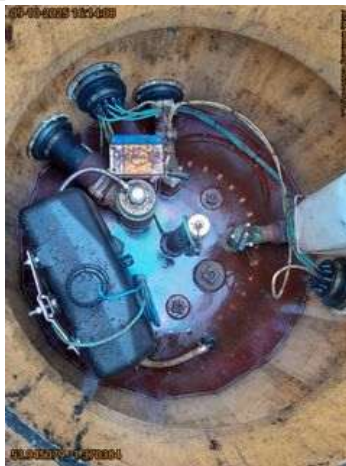
8

Take a photo of the current manhole chamber

1200mm

Yes

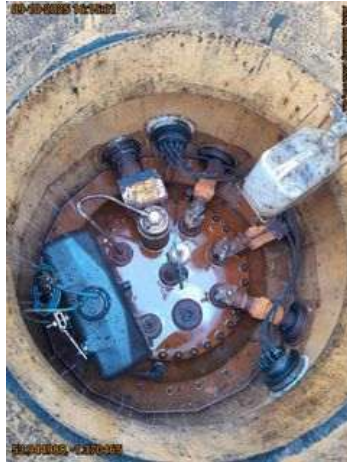
What is the tank number? 7

Take a photo of the current manhole chamber

How deep is the manhole chamber 1200mm

Are the tank labels visible with no damage Yes

Does the chamber contain water over fixtures and fittings? No

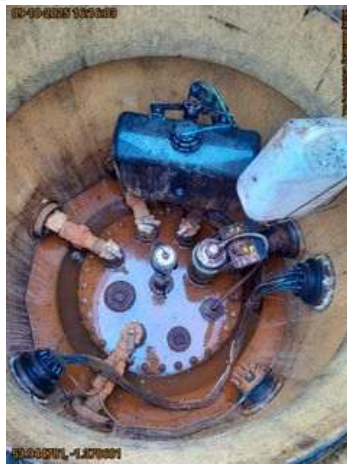
5

Take a photo of the current manhole chamber

How deep is the manhole chamber 1200mm

Yes

No

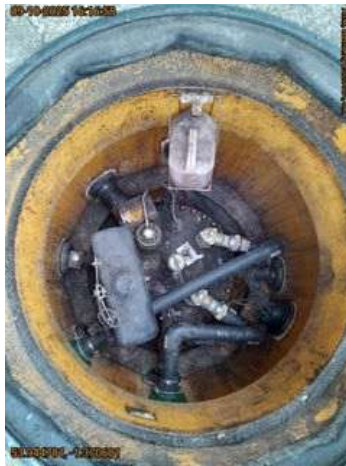
Take a photo of the current  
manhole chamber

1200mm

Yes

No

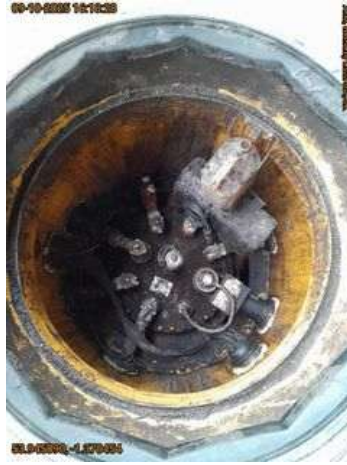
Take a photo of the current manhole chamber

1400mm

Yes

No

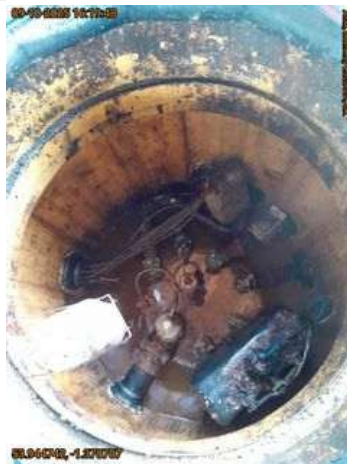
3

Take a photo of the current manhole chamber

1400mm

Capacity labels in bad condition

Yes

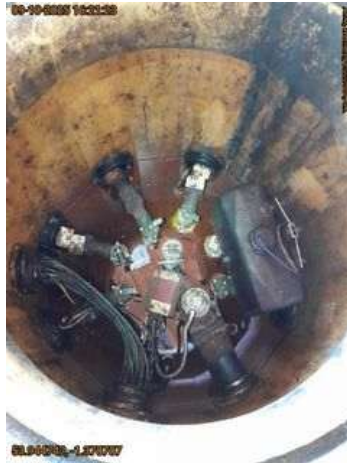
What is the tank number??? 2

Take a photo of the current manhole chamber

How deep is the manhole chamber 1400mm

Are the tank labels visible with no damage Capacity labels in bad condition

Does the chamber contain water over fixtures and fittings? Yes

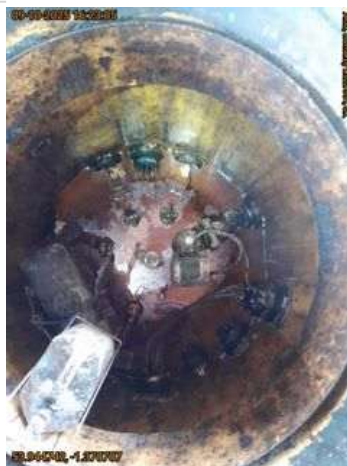
What is the tank number?? 1

Take a photo of the current manhole chamber

| How deep is the manhole chamber | 1450mm |
| Are the tank labels visible with no damage | Capacity labels in bad condition |
| which of the "This Tank Is Manifolde", Grade and Capacity labels are missing? | Capacity labels for tank 1, tank2 ,tank3 in bad condition |
| List any issues found or observations | Capacity labels for tank 1, tank2 ,tank 3 in bad condition |
