# Intelligent Camera Lens Assembly

with Active Alignment and a Single Optical Test Line for Different Products

### Camera Lens Assembly with Active Alignment and Optical Test Line

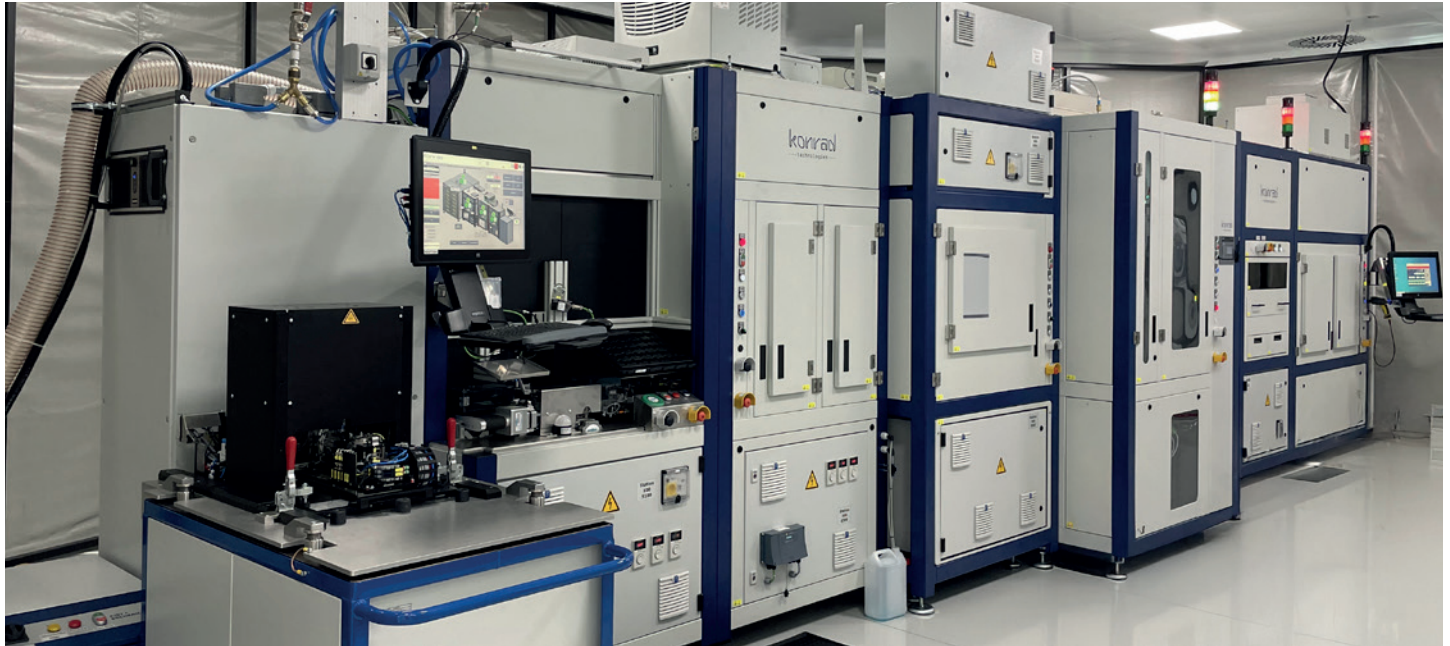
For the camera module assembly 6 fully automated stations were developed: Loading/Unloading, Plasma, Dispensing, Alignment, Oven, Optical Tester. Each station has its dedicated functions:

The line was developed for automated assembly, gluing, alignment, heating, plasma, optical testing, calibration and is a fully automated chain from assembly to optical test, from parts to OK DUT.
