Scan Data

Metadata		Condition Areas	
Scan ID	190400	Cracked Area	0 ft²
Inspection Date	2025-04-29	Deteriorated Area	0 ft²
GPS Coordinates		Panel Area	96 ft²
Accessibility Grade	5	Percent Deteriorated	0%
Access Description	No Significant Barriers to Access Found		
Material	Concrete		
Detectable Warning	Truncated Domes		
Length Inspected	16 ft		
Area Inspected	96 ft²

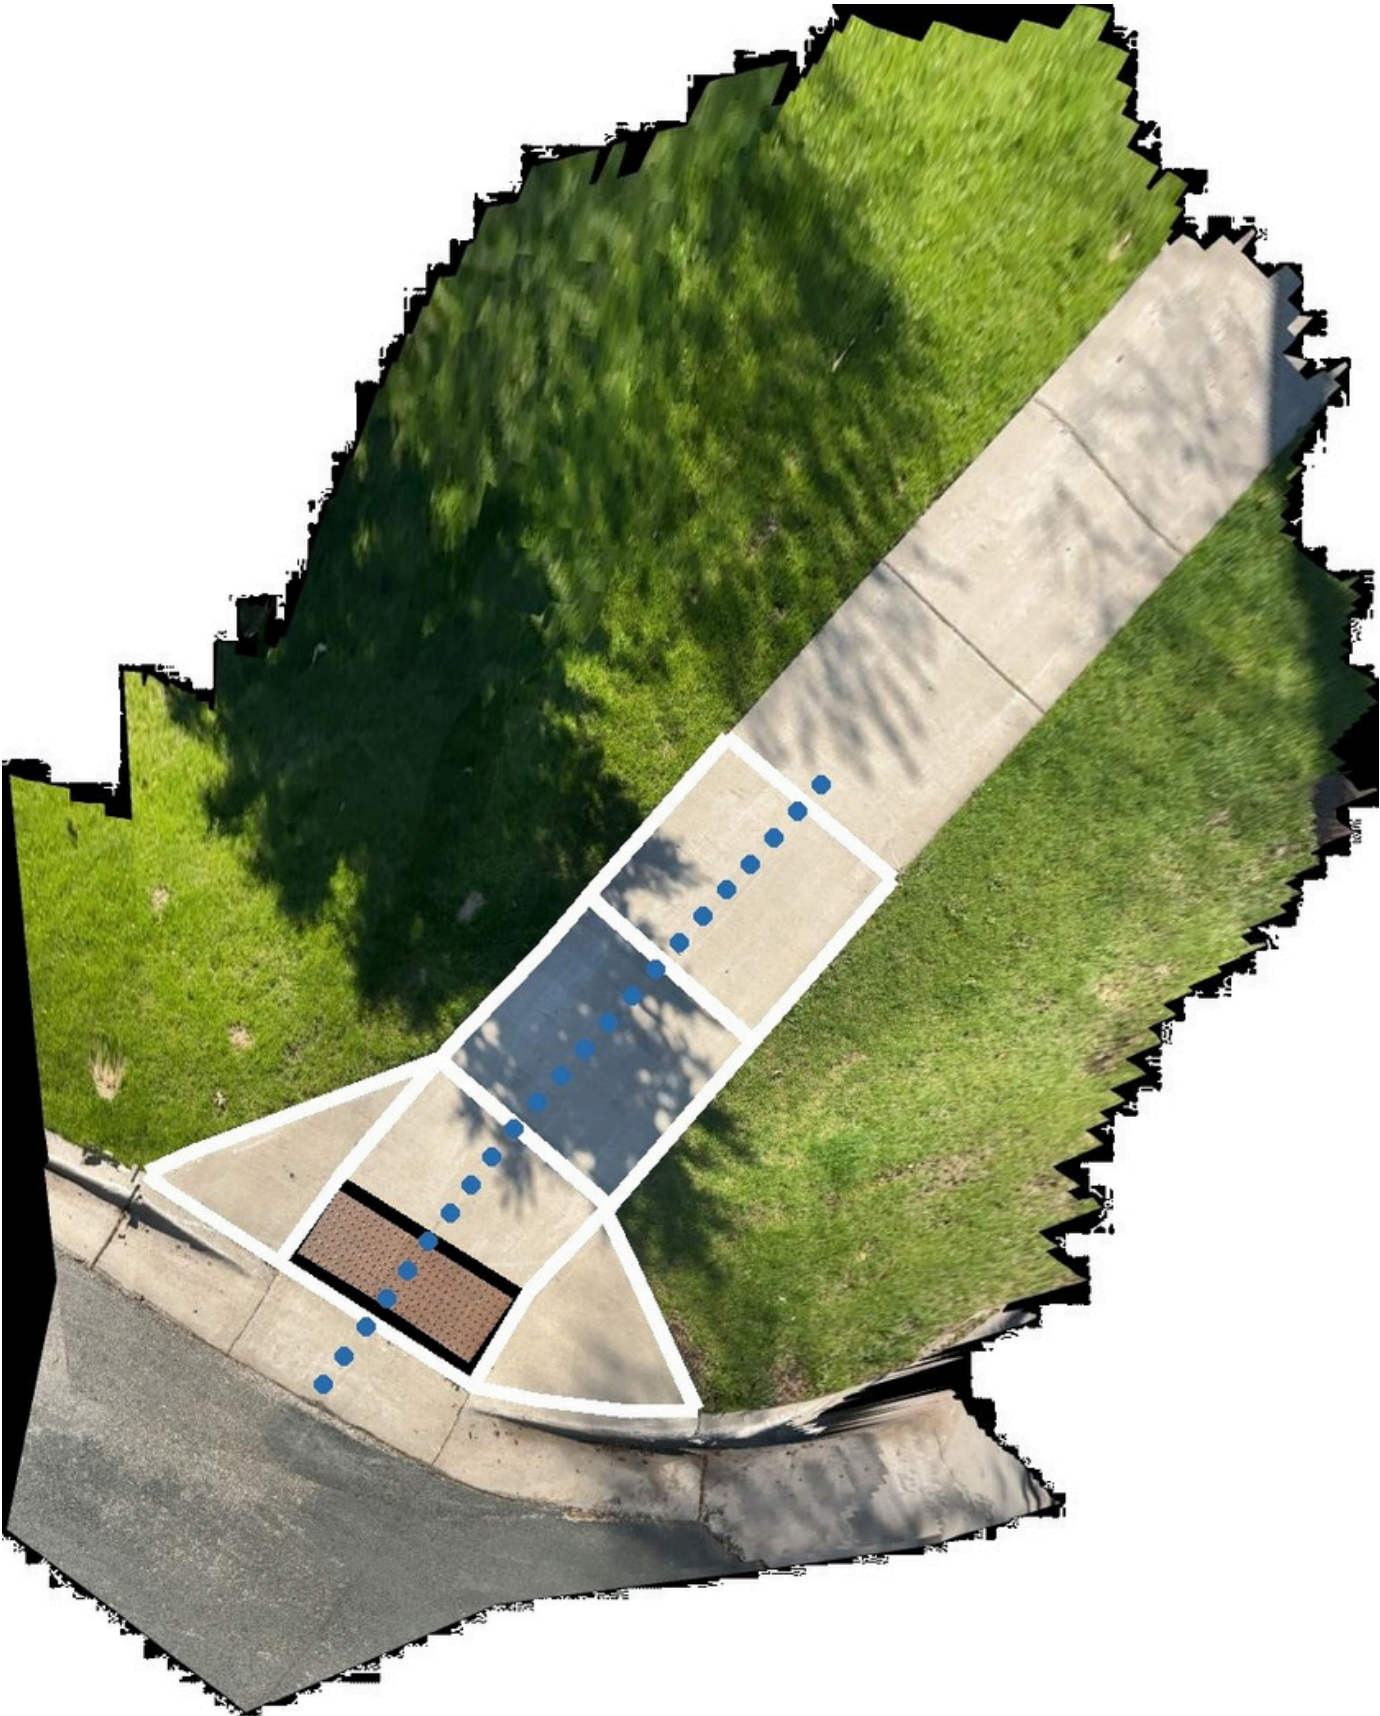
Accessibility Grade	5 out of 5
Access Description	No Significant Barriers to Access Found

Material	Concrete
Length Inspected	16 ft
Area Inspected	96 ft²

Detectable Warning	Truncated Domes
Percent Deteriorated	0%

Slopes & Measurements	
Average Cross Slope	1.4%
Max Cross Slope	1.9%
Average Running Slope	1.2%
Max Running Slope	2.6%
Average Width	60.1 in
Min Clear Width	58.5 in

Violations					
Cross Slope		Running Slope		Clear Width	
Extreme	0	Extreme	0	Extreme	0
Severe	0	Severe	0	Severe	0
Moderate	0	Moderate	0	Moderate	0
Minor	0	Minor	0	Minor	0
