Scan ID: 190304

Date: 2025-04-28

Accessibility Grade

Access Description

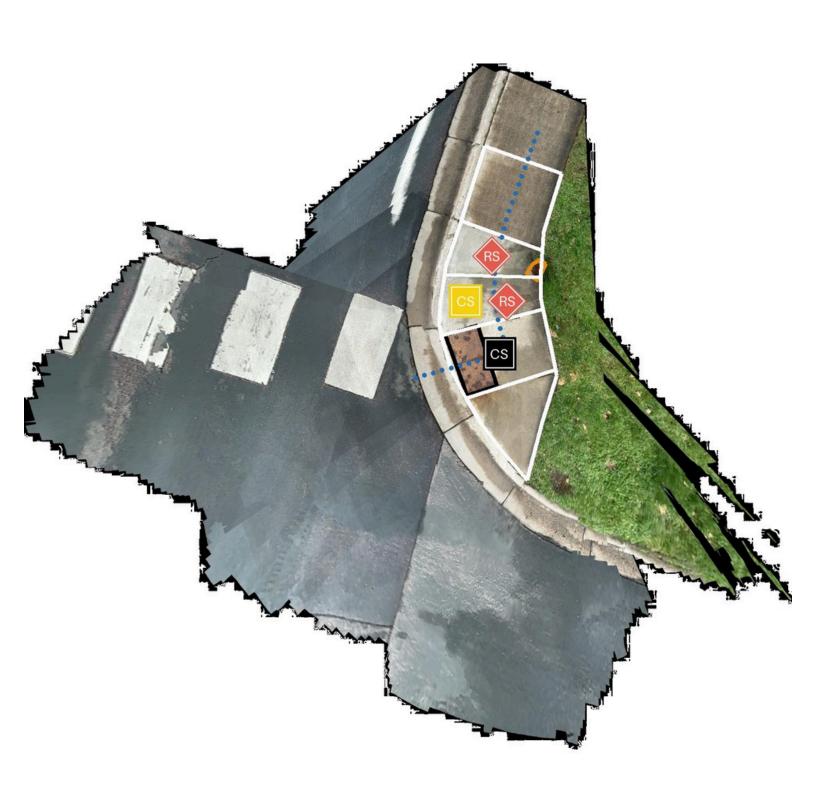
Slopes & Measurements			
Average Cross Slope	3.3%		
Max Cross Slope	7.8%		
Average Running Slope	8.9%		
Max Running Slope	10.9%		
Average Width	64.3 in		
Min Clear Width	58.4 in

Violations						
Cross Slope	Э	Running SI	Running Slope		Clear Width	
Extreme	1	Extreme	0	Extreme	0	
Severe	0	Severe	2	Severe	0	
Moderate	0	Moderate	0	Moderate	0	
Minor	1	Minor	0	Minor	0
