Drying Cabinets In-Place

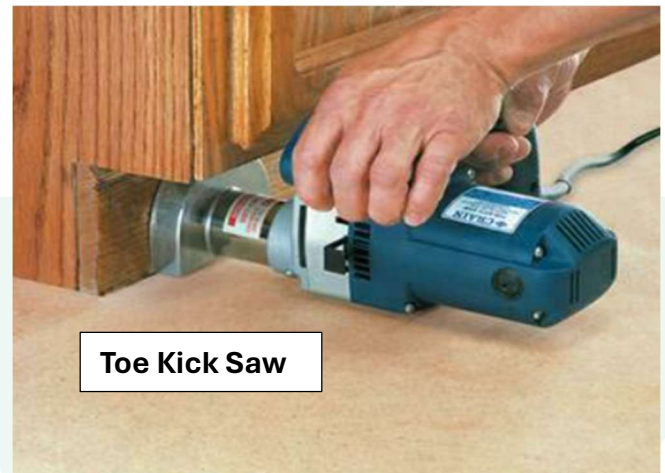
Toe Kick Saw

To dry cabinets in-place it will be necessary to remove the toe kicks to circulate air underneath the cabinets and possibly cut holes through drywall wall behind the cabinet, if the cabinets are installed on an interior wall, to access them from behind. Sometimes tenting hot, dry air from your dehumidifier will help raise vapor pressure differentials to dry and save the

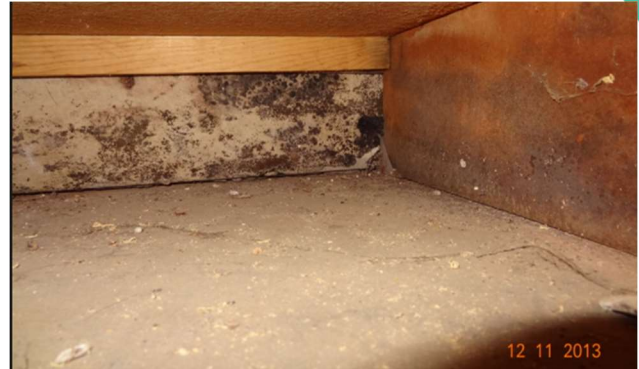
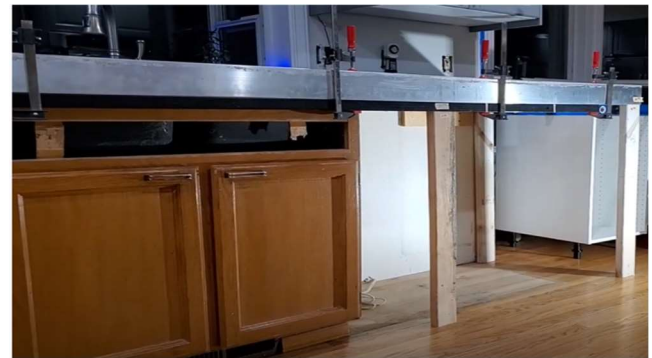
Moisture content readings can be taken under and behind cabinets with long probes attached to the restorer's moisture meter and small holes drilled inside the cabinets that can be repaired with wood putty upon completion. Photos of penetrating moisture meter readings are essential!
