Ceramic Tile, and Why I Don't Care if It's Wet!

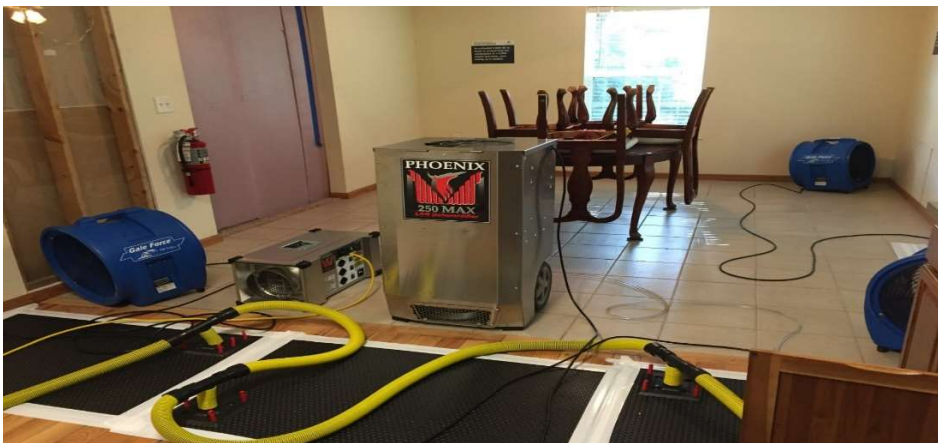
Accuserve IICRC approved ASD Disaster Recovery Learning Lab on the Clark State campus in Springfield, OH – kitchen/dining room after 125 floodings!

Beware that mold can grow on dirt and old soap scum so important that tile and grout is clean. At our IICRC approved ASD flood house in Ohio we installed ceramic tile over cement board over a plywood subfloor over a finished basement and a crawlspace and have now flooded it over 125 times with no issues. We even pulled up some cracked tiles a few months ago to replace them and no mold on wood or cement board underneath.
