## 3 RETAINING WALL

### 3.1 Definitions

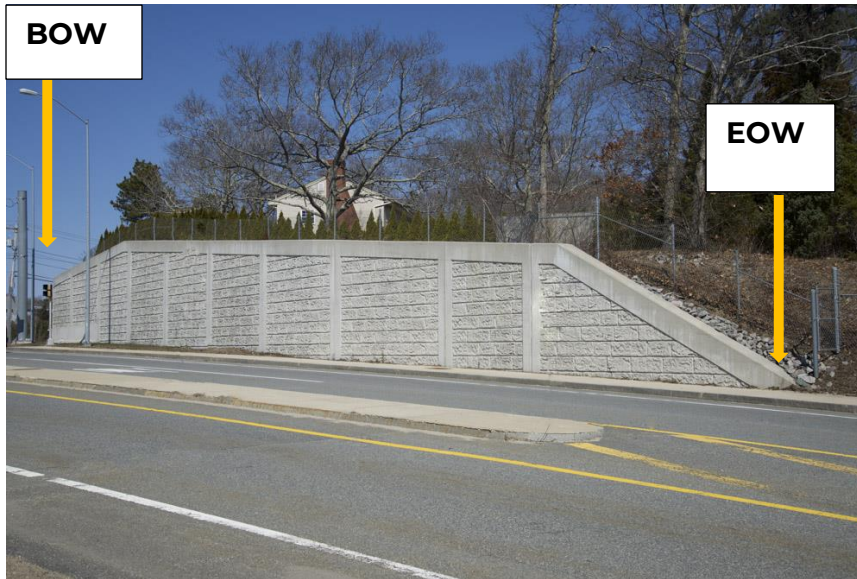
The wall facing inspection shall identify the facing type of material and the associated distresses with the facing type. Inspect the wall facing from the top of the wall (below any copings) to the top of the foundation or to the top of finished grade. Embedded and buried portions of walls are not subject to condition inspection since they are not visible.

**Figure 3-8: Typical wall facing inspection limits**

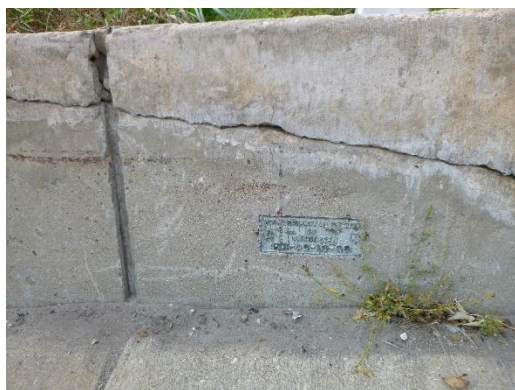
Concrete cracking can be either nonstructural or structural and can be caused by many different factors. Nonstructural cracking is most often related to volumetric changes in concrete caused by fluctuations in moisture content and/or temperature during curing or while in service. Nonstructural cracking is typically less than 1/8 inch wide. Structural related cracking is often related to loading on the concrete being beyond its tensile capacity. Concrete can also crack if the embedded reinforcing bars are corroding.

**Figure 3-9: Horizontal structural cracking**

Inspect the wall face for cracking and investigate whether any observed cracking is non-structural or structural in nature. Document the approximate location, orientation, width, and spacing of the cracking.

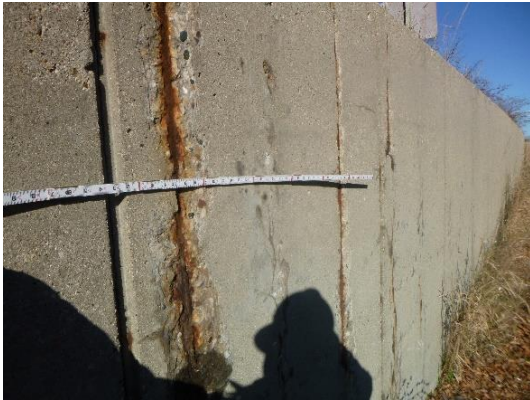
Inspect and document the extent and location of exposed reinforcing bar corrosion. Estimate the extent of any section loss.

**Figure 3-10: Corroded wall reinforcing**

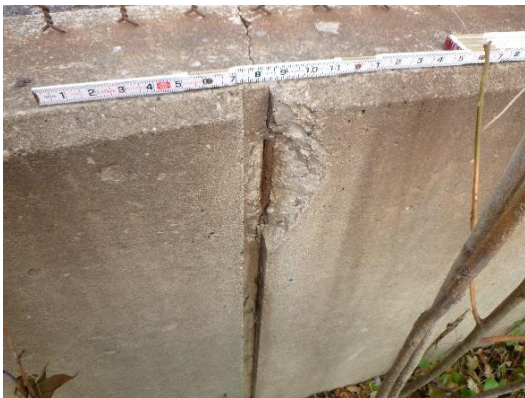
Concrete spalling is a surface failure in which concrete breaks off from the underlying concrete substrate. Like cracking, the spalling typically occurs when the steel reinforcing embedded within the concrete member undergoes corrosion. Spalling can also occur at expansion and contraction joints, at rustication and other ornamental non-structural features. It can also occur at cracks that have propagated due to wall deflection or impact damage.

**Figure 3-11: Concrete spall with corroded reinforcing**

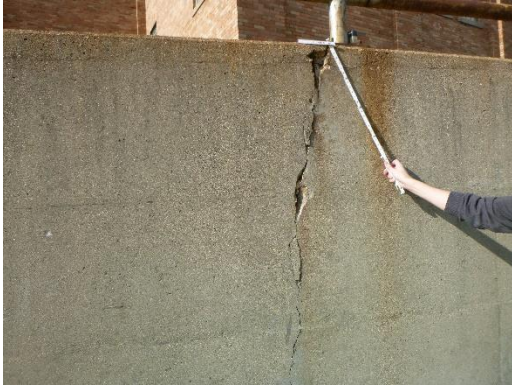
**Figure 3-12: Spalled and delaminated concrete**

Concrete delamination can be identified as a thin layer of concrete separation from its substrate. Unlike spalling, delaminated concrete does not break away but remains attached to the structure.

Inspect the wall for delamination and spalling. With a sounding hammer or other device, sound any areas that are exhibiting signs of distress to determine the limits of deterioration. Document the approximate location of delamination or spalling while indicating if reinforcement is exposed.

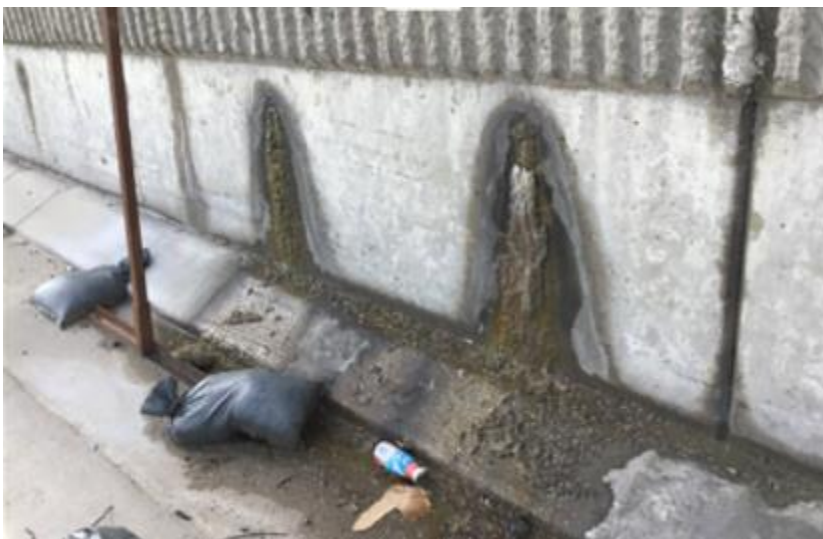
Damage occurs when the surface of concrete is unable to resist wear caused by rubbing and friction. As the outer paste of concrete wears on wall face, the fine and coarse aggregate are exposed, and abrasion and impact will cause additional degradation that is related to aggregate-to-paste bond strength and hardness of the aggregate. Abrasion of retaining wall faces is most often the result of wind or water-borne particles along the face of the wall.

**Figure 3-13: Retaining wall concrete abrasion**

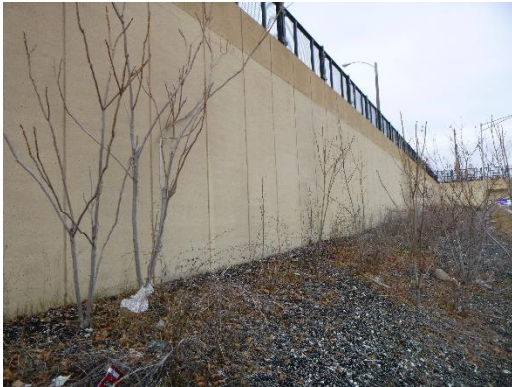
Inspect concrete surfaces for protective coating failure. Document the approximate location and extent of coating failure. Inspect concrete coating systems for wear due to UV exposure and other deterioration. Some failures are specific to the coating system, (i.e., epoxy systems) are subject to chalking, cracking, and flaking. Note the degree of effectiveness to which the concrete protection system is functioning.

**Figure 3-14: Semi-protective concrete protective coating**

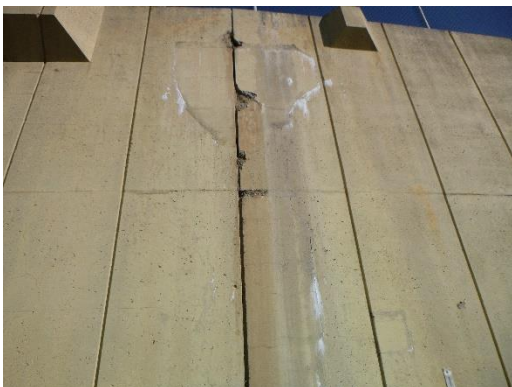
Efflorescence is caused when soluble salts and other dispersible water materials come to the surface of concrete and mortars. Efflorescence can be identified by the presence of a white powdery solid which appears on the surface of the concrete.

Inspect the wall for the presence of efflorescence, including surface white with built up or heavy build up with rust staining.

**Figure 3-15: Efflorescence accumulation**

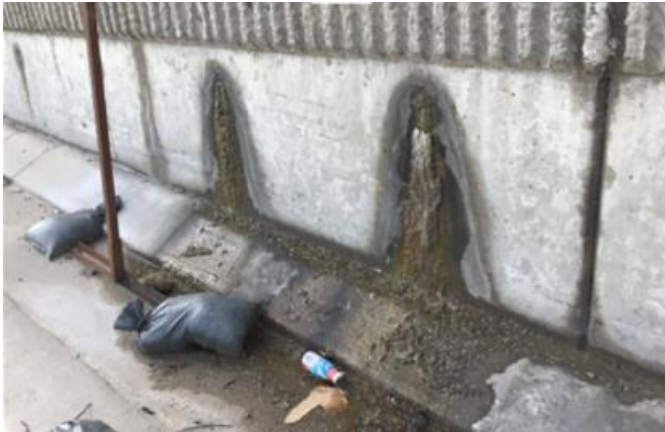
**Figure 3-16: Weep holes/wall drainage**

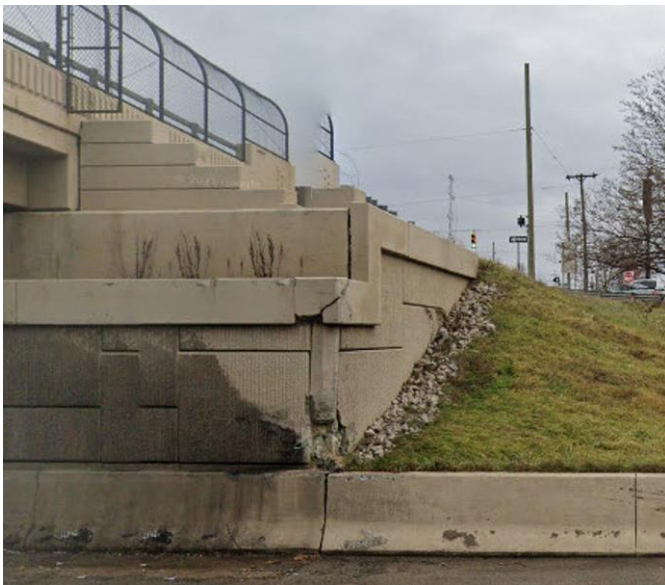
Inspect the wall system for vehicular impact damage. Document the location and degree of damage.

**Figure 3-17: Impact damage**

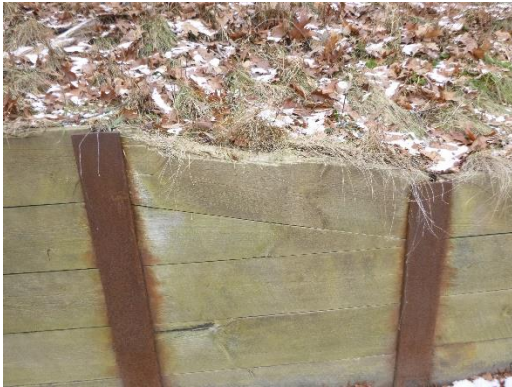
**Figure 3-19: Section loss at top of wall**

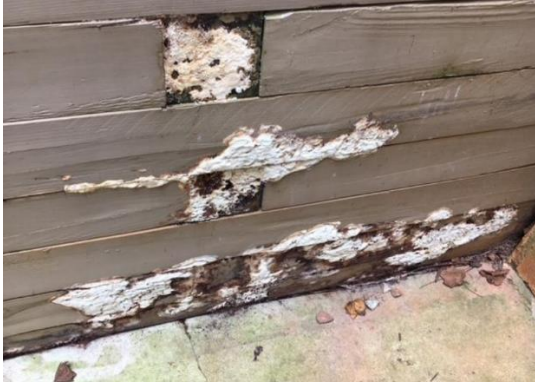
Timber members are also susceptible to drying and weathering, which often results in surface and through splits. Checks and splits in members can indicate a weakened member and create an entry for moisture to enter the element.

**Figure 3-20: Timber lagging splitting**

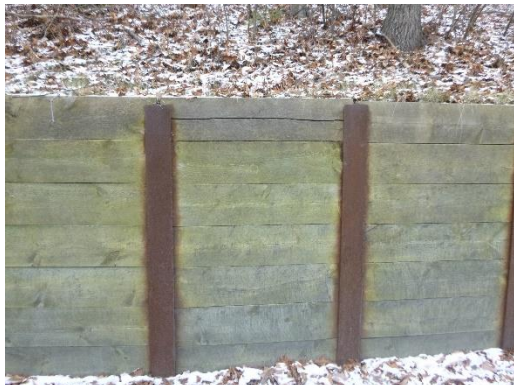
Checks and Shakes are natural and are present in most timber members. Inspect the wall for check or shakes. Document the approximate location and the length in respect to member depth.

Figure 3-21: Timber lagging is split along top

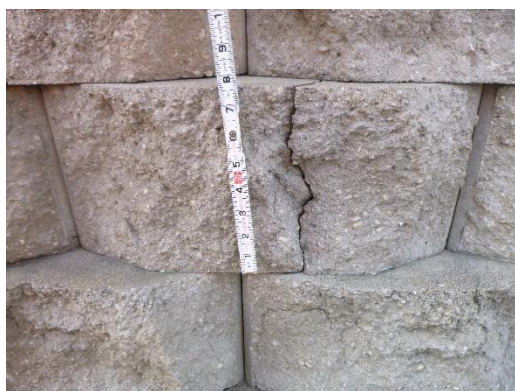
**Figure 3-22: Vertical split in modular block**

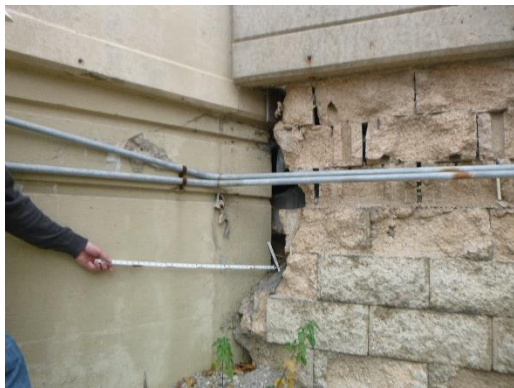
**Figure 3-23: Masonry breakdown**

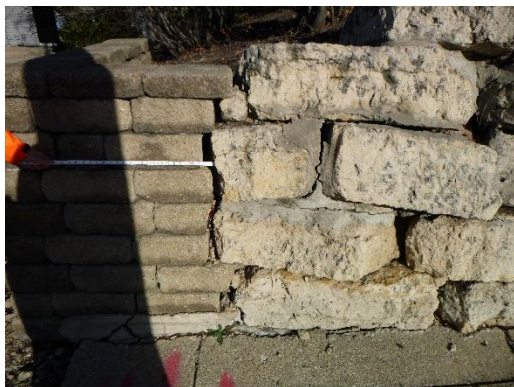
**Figure 3-24: Wall misalignment**

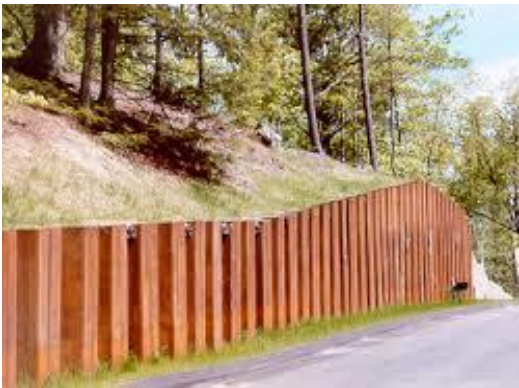
The Metal Facing element includes steel sheet piling, bin wall construction, corrugated metal panels and other constructions.

**Figure 3-25: Typical sheet pile wall**

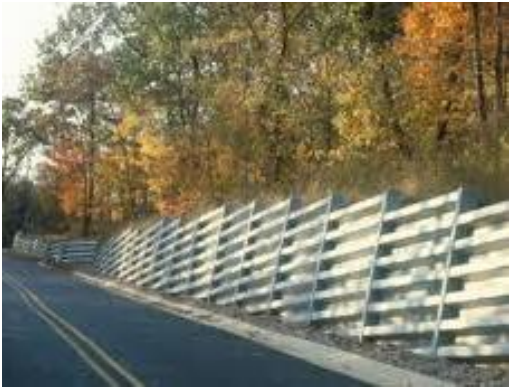
**Figure 3-26: Typical metal bin wall**

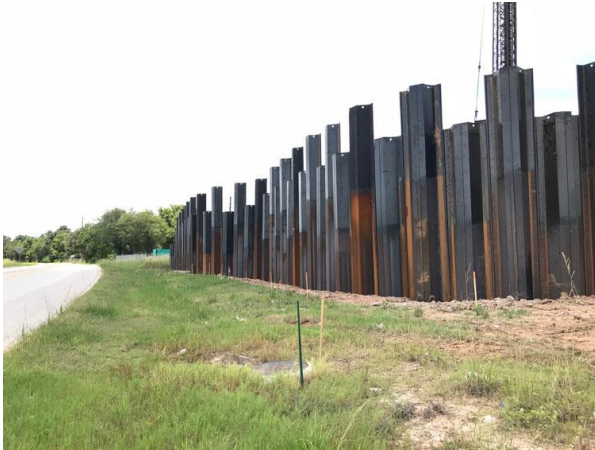
Inspect steel surfaces for protective coating failure. Note whether the failure is limited to the top application coat or to bare steel. Create Work Rec and document the approximate location, percentage, and extent of coating failure. Coating failure may be indicated by surface dulling, loss of pigment, exposure of bare metal, oxidation indicated by darkening of the coating, or peeling and curling of the protective coating.

**Figure 3-28: Steel protective coating missing**

Inspect steel coating systems for chalking, peeling, curling, and oxide color. Document on the location and extent of any observed deterioration to coating systems present.

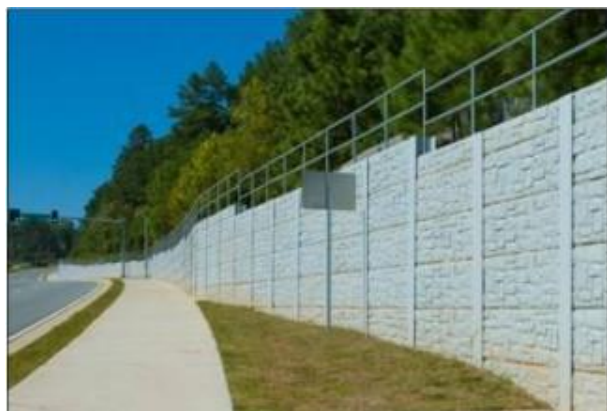
**Figure 3-29: Soldier pile wall with precast lagging (note: anchors not shown)**

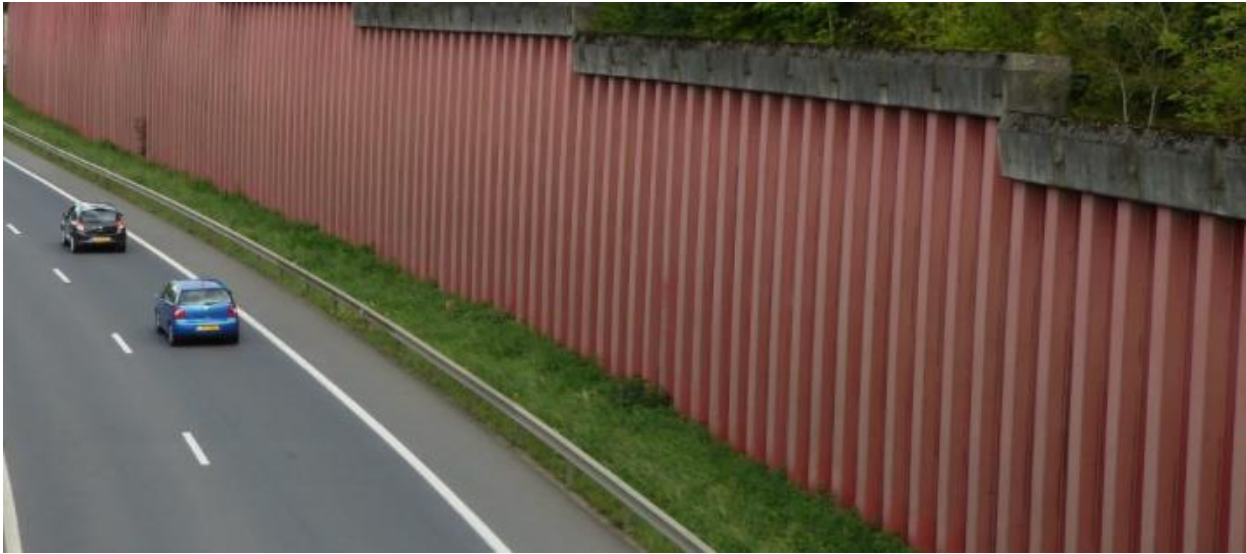
Ground anchors are also used in continuous wall systems, such as sheet-pile walls, tangent or secant pile walls, slurry walls, or soil mixed walls. Unlike soldier pile and lagging walls, continuous walls act as both vertical and horizontal wall elements. Because of the relative continuity of these wall systems, the design also takes the water pressure behind continuous walls into account.

**Figure 3-30: Typical continuous wall**

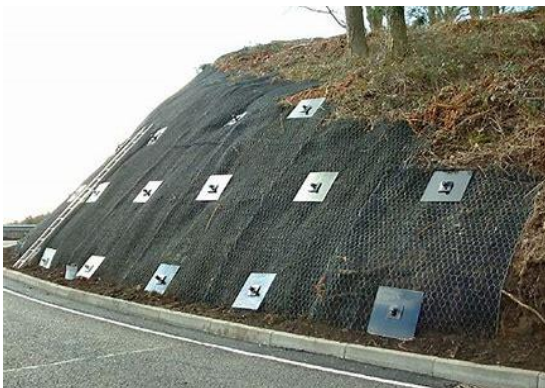
Soil nails are reinforcing, passive elements that are drilled and grouted horizontally in the ground to support excavations in soil or in soft and weathered rock. Unlike ground anchors that are post-tensioned, soil nails contribute to the stability of the earth-resisting systems mainly through tension as a result of the deformation of the retained soil or weathered soil mass. Soil nails also transfer loads to the surrounding ground through shear stresses (i.e., bond stresses) along the grout-ground interface. As with any passive system, some movement of the wall is expected to engage the nails.

**Figure 3-31: Typical soil nail wall**

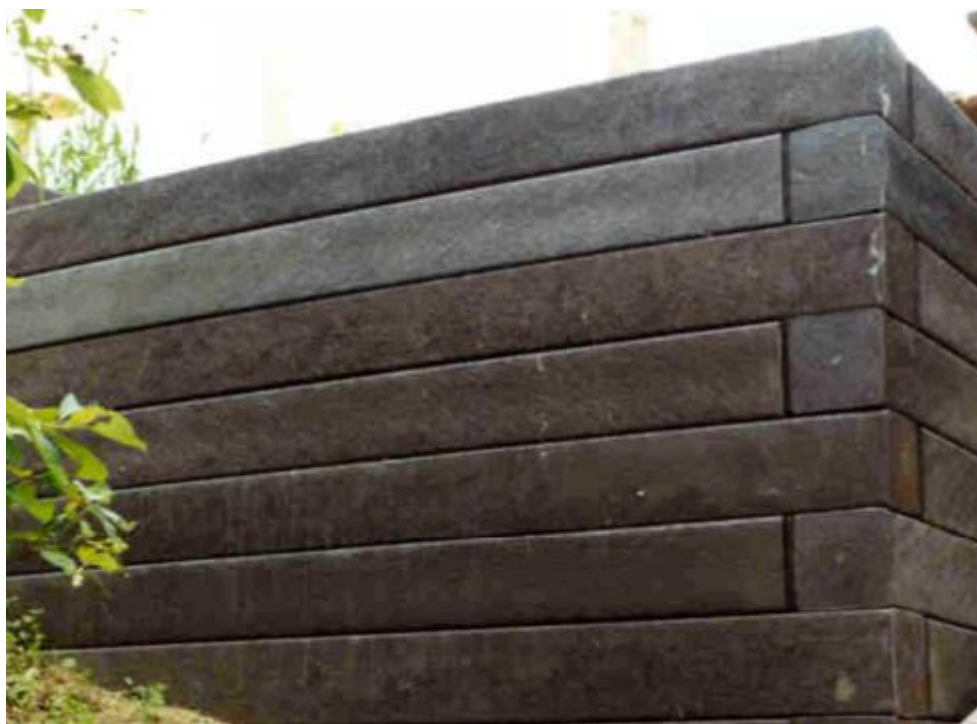
Composites come in a variety of forms including plastic lumber, which is typically formed from recycled high-density polyethylene (HDPE) plastic, vinyl sheet piling, and integrated hybrid composites of plastic and steel. Plastics can exhibit ultraviolet deterioration, material incompatibility, corrosion damage, and overstress damage. Plastics will typically exhibit discoloration when undergoing ultraviolet deterioration. The material may also begin to fray when under constant sunlight.

**Figure 3-34: Plastic/vinyl lumber wall**

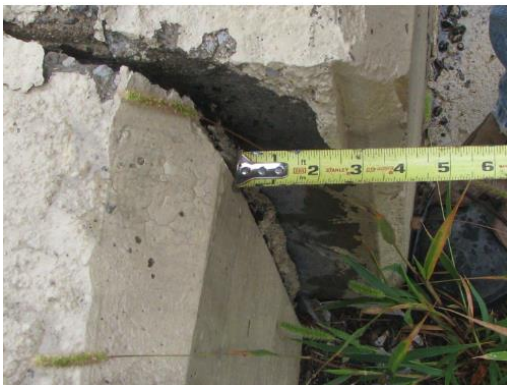
**Figure 3-35: Wall displacement**

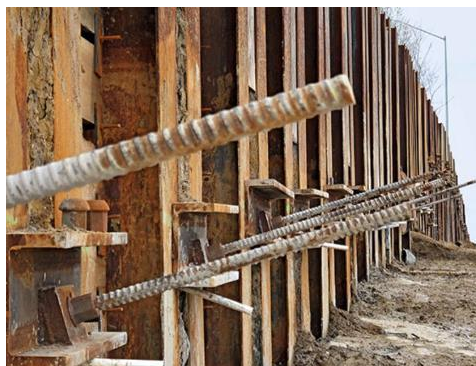
Examine anchorage systems, including anchor seals or other fasteners, at connection to the wall for material distress. Signs of distress may include distortion, areas of cracking, spalling, leakage stains, and loss of seal adhesion. Note any corrosion of bars or other anchorage hardware. Identify any damage, looseness or excessive projection of bars or anchorage hardware such as nuts, wedges, collars, or plates. Rotations of anchored retaining walls are often preceded by punching shear or cracking around the area of the anchor attachment to the stem.

Corrosion protection for ground anchor tendons includes either one or more physical barrier layers which protect the tendon from the corrosive environment. The barrier layers include anchorage covers, corrosion inhibiting compounds, sheaths, encapsulations, epoxy coatings, galvanization, and grouts. Inspect the visible portions of the anchors, including tie rods, bolts, or nuts for signs of corrosion and section loss. Document the location and extent of corrosion and section loss in the inspection report.

**Figure 3-36: Wall anchor**

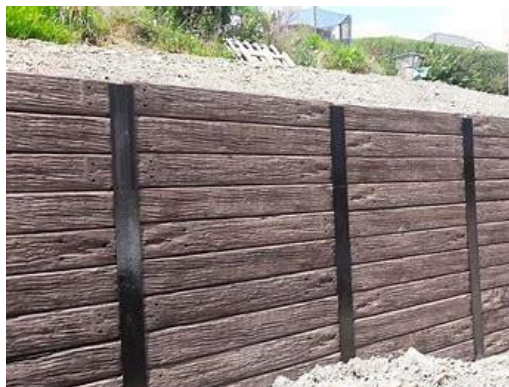
**Figure 3-37: Vertical support steel**

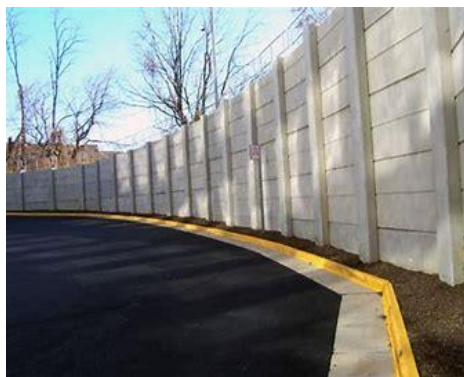
Vertical Support/Column Concrete includes all prestressed and reinforced concrete columns/posts regardless of size, shape, or protective system. Inspect concrete elements for delamination, spalling, cracking, efflorescence, exposed reinforcing or prestressing strands and other deterioration. Additionally, inspect the element for evidence of distortion or buckling and misalignment including but not limited to rotation.

**Figure 3-38: Vertical support concrete**

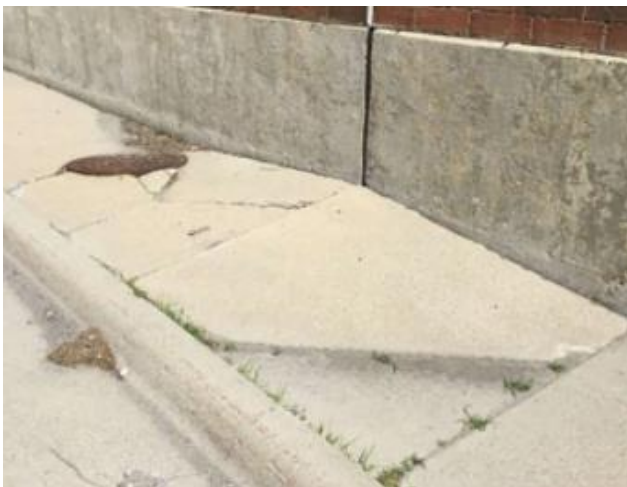
Vertical movement can occur in the forms of uniform settlement or differential settlement. Depending on the magnitude of the settlement realized, uniform settlement will have limited impact on the structural stability of the wall; however, overtopping of the wall may occur if the settlement is significant. Differential settlements, on the other hand, may lead to serious problems in the wall. Differential settlements may cause the opening of joints or cause wall cracking or transverse tipping. The most common causes of vertical movement consist of soil bearing failure; soil consolidation; erosion; and foundation material deterioration.

**Figure 3-41: Wall settlement**

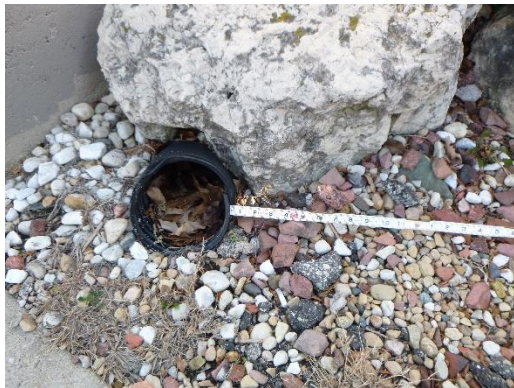
**Figure 3-42: Drainage outlet is partially clogged with leaves and debris**
