12 HIGH MAST LIGHTING TOWER (HMLT)

12.1 Definitions

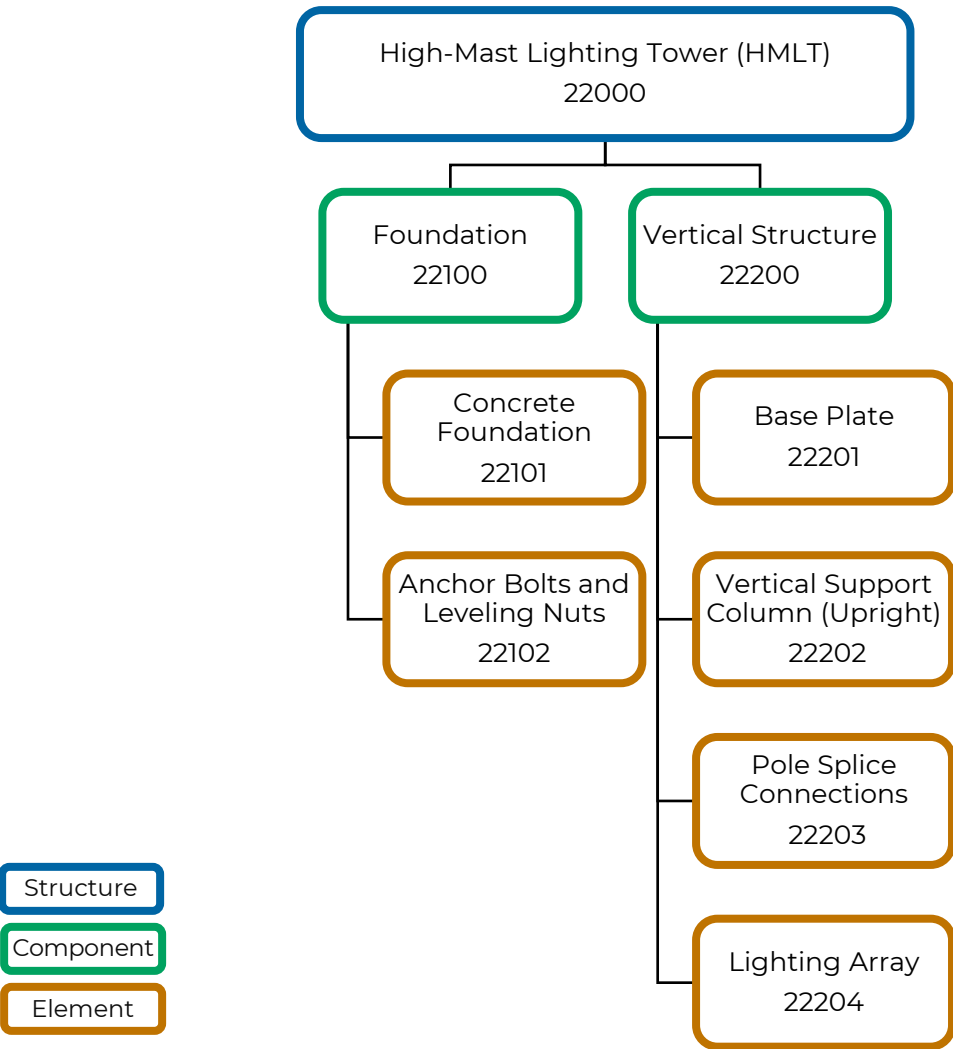
Figure 12-1: Rating structure for High-Mast Lighting Tower

See Section 1.7 for discussion on component ratings, element ratings, and condition states. A representation of the rating structure is provided in Figure 12-1. A sketch of a typical HMLT with components and elements is shown in **Error! Reference source not found.**

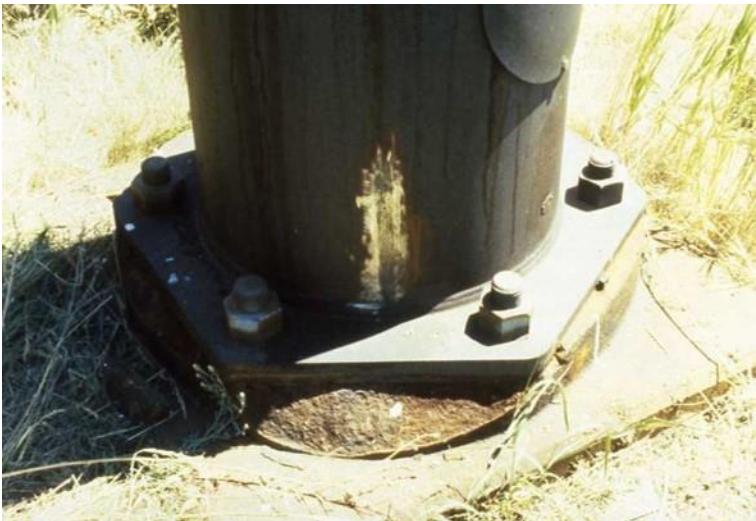
Figure 12-4: HMLT concrete foundation, spalling deterioration

The foundation stabilizes and secures the entire structure. The purpose of inspection is to identify and record any minor to severe deficiencies throughout the lifespan of the foundations. Inspect the condition of the concrete foundation, noting any cracking, spalling, voids, impact damage, and general deterioration. Typical issues include cracking throughout the foundation, spalling, chipping, delaminated or broken sections of the foundation, exposed aggregate and rebar, and soil erosion around the foundation.

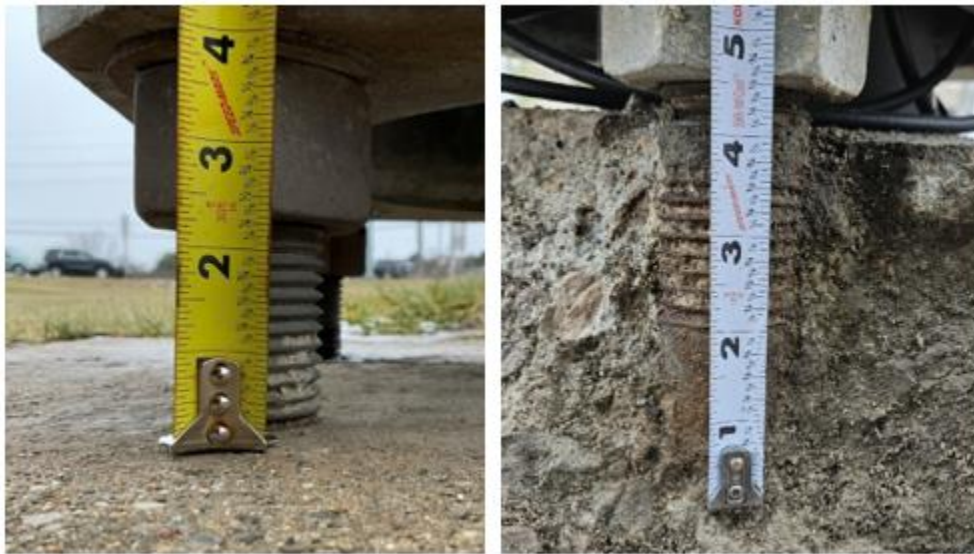
Figure 12-5: Standoff measurement for a sound foundation (left) and standoff measurement with foundation concrete deterioration (right)

Visually inspect the base looking for missing or damaged anchor bolts or nuts connected to the foundation. Note any damage or corrosion and any bolt that shows signs of bending. Check for any gaps between the nuts, washers, and base plate. Check for excessive standoff distance between the underside of the leveling nut and the top of the foundation (or the top of sound concrete in cases of foundation deterioration).

The standoff distance is an indication of whether or not the anchor rods are subjected to bending moment stress. For double-nut connections, if the clearance between the bottom of the leveling nuts and the top of the concrete foundation is less than or equal to one bolt diameter, bending stresses in the anchor bolts can be disregarded (AASHTO LRFD Specifications for Structural Supports, sec. 5.16.3.1). Any distance greater than one bolt diameter may be cause for concern.

- d. Standoff distance more than twice the bolt diameter, where bending of anchor bolts is evident
- e. Multiple loose bolts in an anchor bolt connection

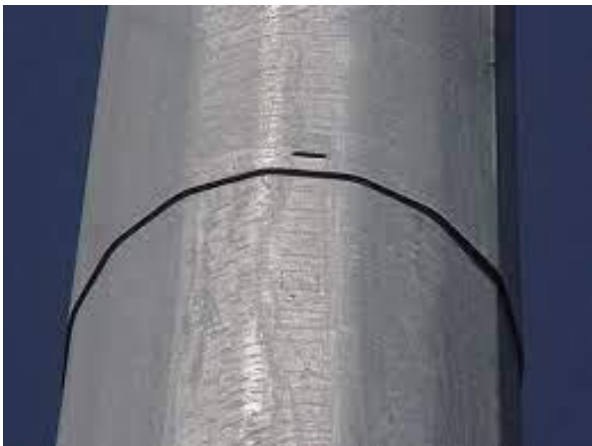
Figure 12-7: HMLT pole splice

Typical issues include weld discontinuities, galvanizing damage, or flange connection gaps. Note any gaps between steel in the spliced connections or cracked welds. Gusset, lacing, or stiffener plates may be present; note any cracks or corrosion in these plates. If plates are present at the connections, record any bolting components that are missing, deteriorated, or damaged. Record any signs of corrosion.

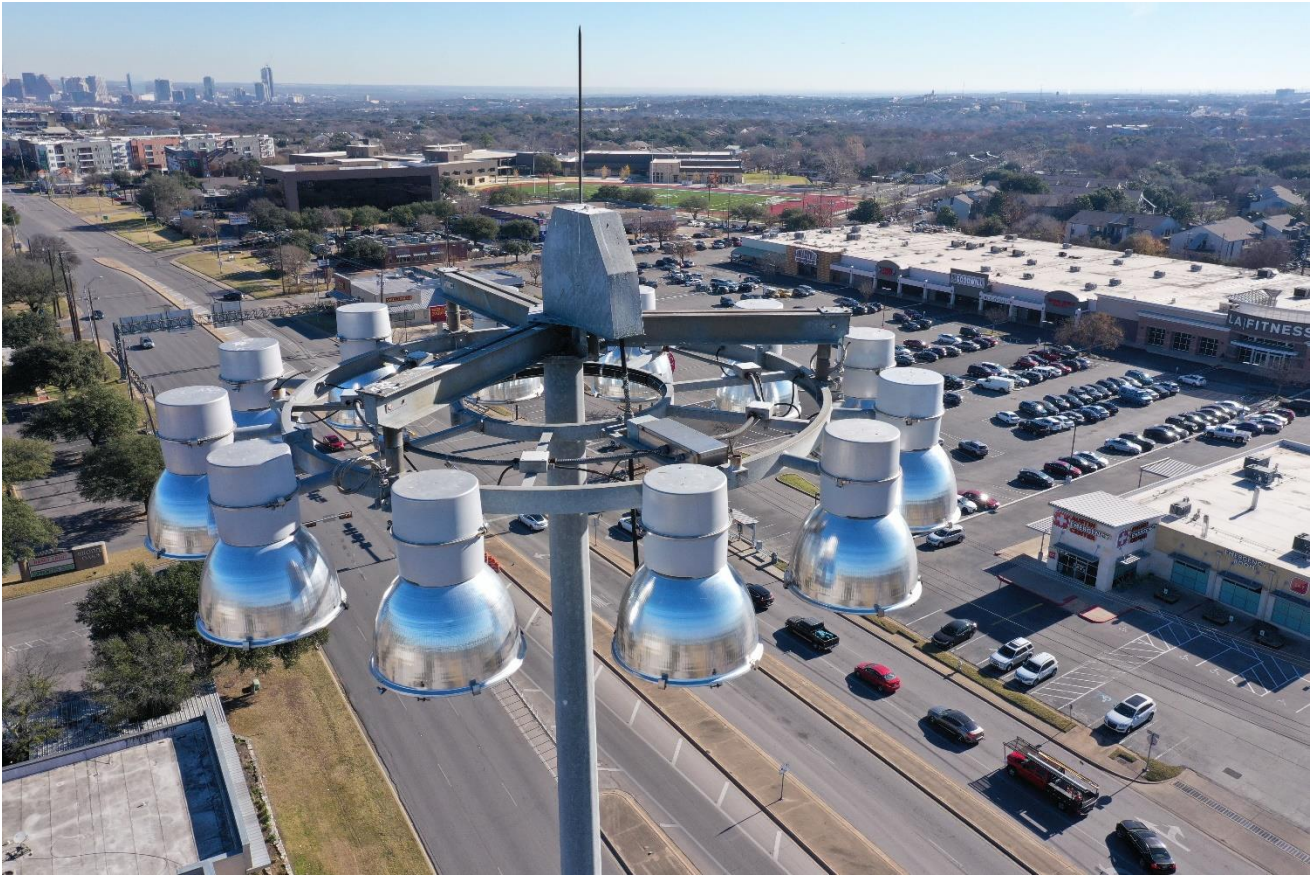
Figure 12-8: HMLT lighting array, as seen from a UAS

Lighting arrays are comprised of many different parts including structural framing, brackets, luminaires, wiring and electrical connections/hardware. The arrays should be visually inspected for weld defects or cracks, corrosion, coating damage, hardware issues, etc.
