## 3 RETAINING WALL

### 3.1 Definitions

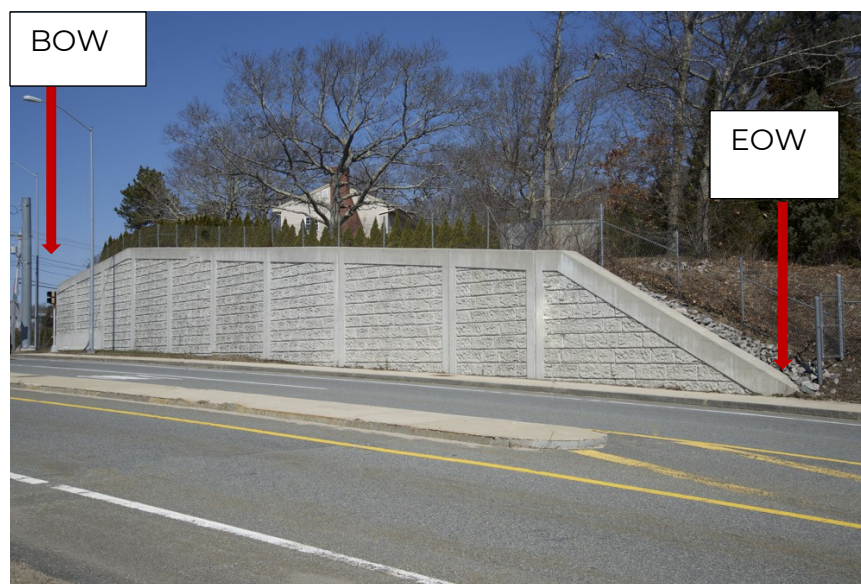
**Figure 3-8: Typical wall facing inspection limits**

MSE panels and concrete panels/blocks or masonry blocks. Barriers and coping at the top of the wall, however, do not count as part of the wall face area.

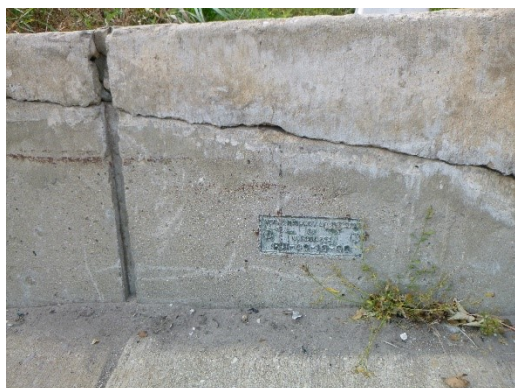
**Figure 3-9: Horizontal structural cracking**

Inspect the wall face for cracking and investigate whether any observed cracking is non-structural or structural in nature. Document the approximate location, orientation, width, and spacing of the cracking.

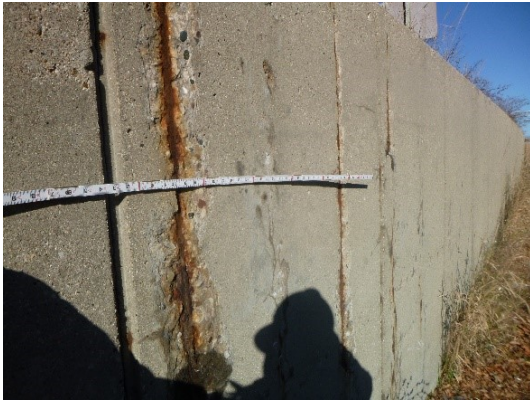
**Figure 3-10: Corroded wall reinforcing**

Inspect and document the extent and location of exposed reinforcing bar corrosion. Estimate the extent of any section loss.

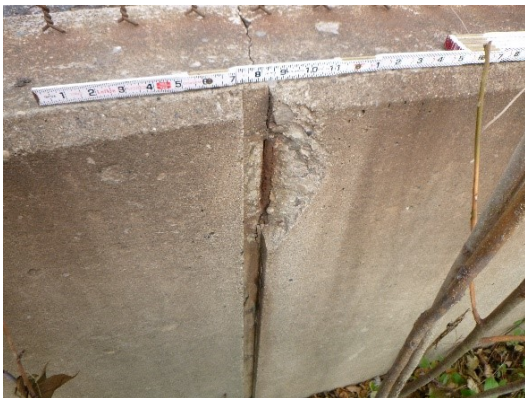
**Figure 3-11: Concrete spall with corroded reinforcing**

Concrete spalling is a surface failure in which concrete breaks off from the underlying concrete substrate. Like cracking, the spalling typically occurs when the steel reinforcing embedded within the concrete member undergoes corrosion. Spalling can also occur at expansion and contraction joints, at rustication and other ornamental non-structural features. It can also occur at cracks that have propagated due to wall deflection or impact damage.

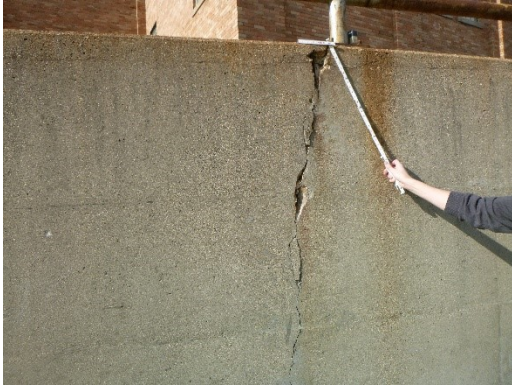
**Figure 3-12: Spalled and delaminated concrete**

Concrete delamination can be identified as a thin layer of concrete separation from its substrate. Unlike spalling, delaminated concrete does not break away but remains attached to the structure.

Inspect the wall for delamination and spalling. With a sounding hammer or other device, sound any areas that are exhibiting signs of distress to determine the limits of deterioration. Document the approximate location of delamination or spalling while indicating if reinforcement is exposed.

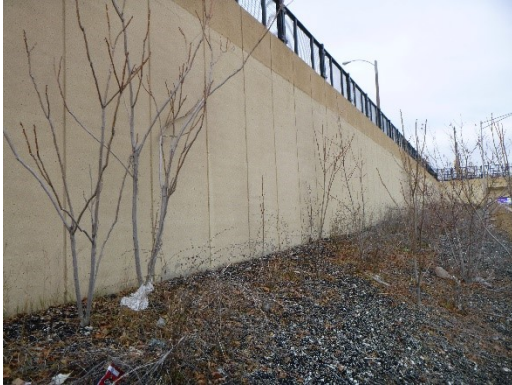
**Figure 3-14: Semi-protective concrete protective coating**

Inspect concrete surfaces for protective coating failure. Document the approximate location and extent of coating failure. Inspect concrete coating systems for wear due to UV exposure and other deterioration. Some failures are specific to the coating system, (i.e., epoxy systems) are subject to chalking, cracking, and flaking. Note the degree of effectiveness to which the concrete protection system is functioning.

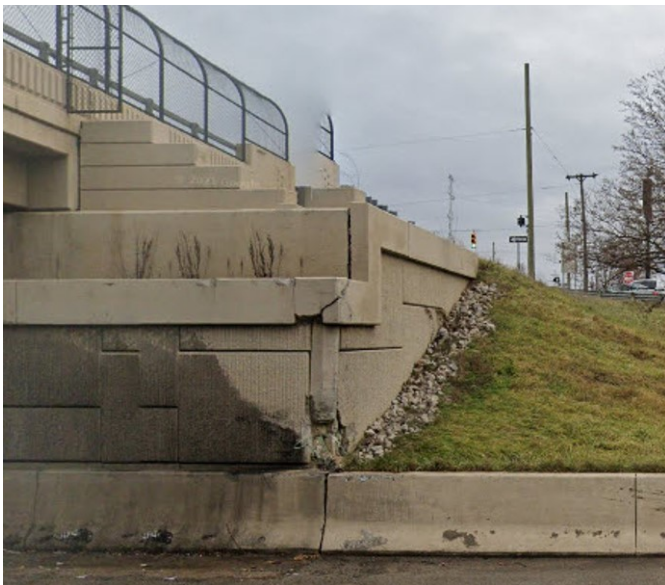
**Figure 3-17: Impact damage**

Inspect the wall system for vehicular impact damage. Document the location and degree of damage.

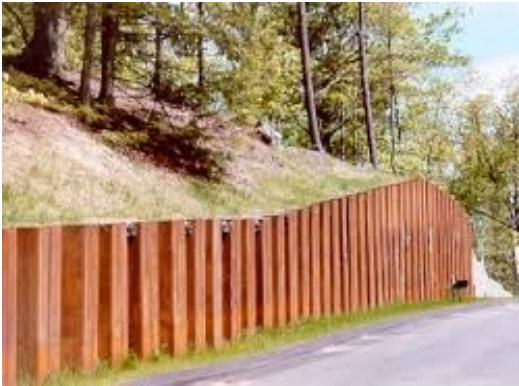
**Figure 3-26: Typical sheet pile wall**

The Metal Facing element includes steel sheet piling, bin wall construction, corrugated metal panels and other constructions.

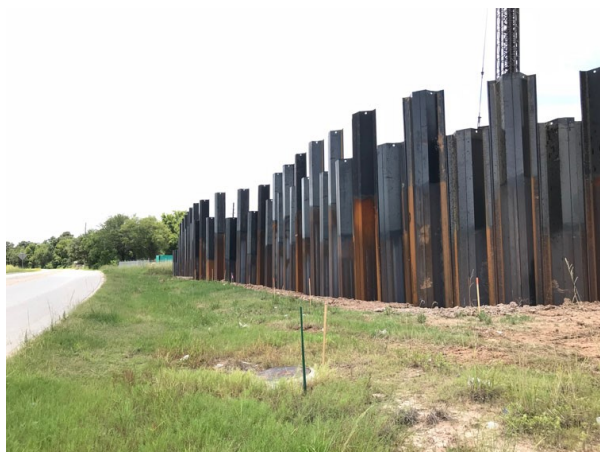
**Figure 3-29: Steel protective coating missing**

Inspect steel surfaces for protective coating failure. Note whether the failure is limited to the top application coat or to bare steel. Create Work Rec and document the approximate location, percentage, and extent of coating failure. Coating failure may be indicated by surface dulling, loss of pigment, exposure of bare metal, oxidation indicated by darkening of the coating, or peeling and curling of the protective coating.

Inspect steel coating systems for chalking, peeling, curling, and oxide color. Document on the location and extent of any observed deterioration to coating systems present.

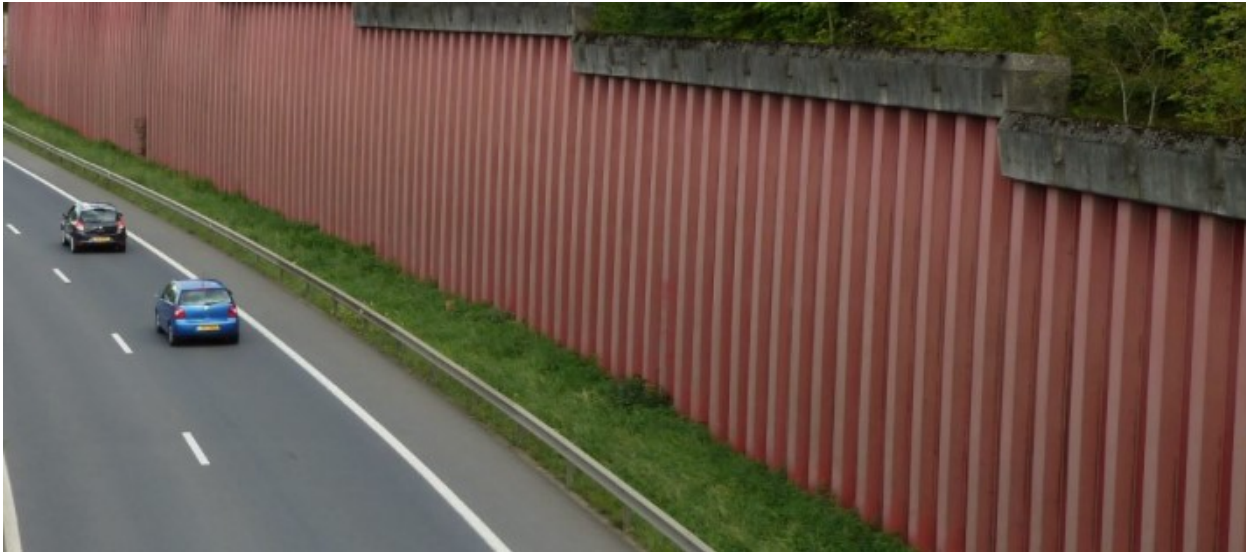
**Figure 3-31: Typical continuous wall**

Ground anchors are also used in continuous wall systems, such as sheet-pile walls, tangent or secant pile walls, slurry walls, or soil mixed walls. Unlike soldier pile and lagging walls, continuous walls act as both vertical and horizontal wall elements. Because of the relative continuity of these wall systems, the design also takes the water pressure behind continuous walls into account.

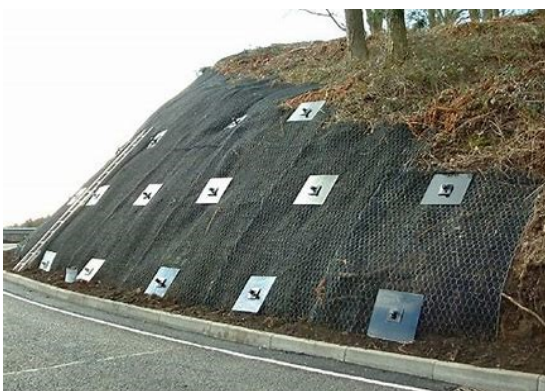
**Figure 3-32: Typical soil nail wall**

Soil nails are reinforcing, passive elements that are drilled and grouted horizontally in the ground to support excavations in soil or in soft and weathered rock. Unlike ground anchors that are post-tensioned, soil nails contribute to the stability of the earth-resisting systems mainly through tension as a result of the deformation of the retained soil or weathered soil mass. Soil nails also transfer loads to the surrounding ground through shear stresses (i.e., bond stresses) along the grout-ground interface. As with any passive system, some movement of the wall is expected to engage the nails.

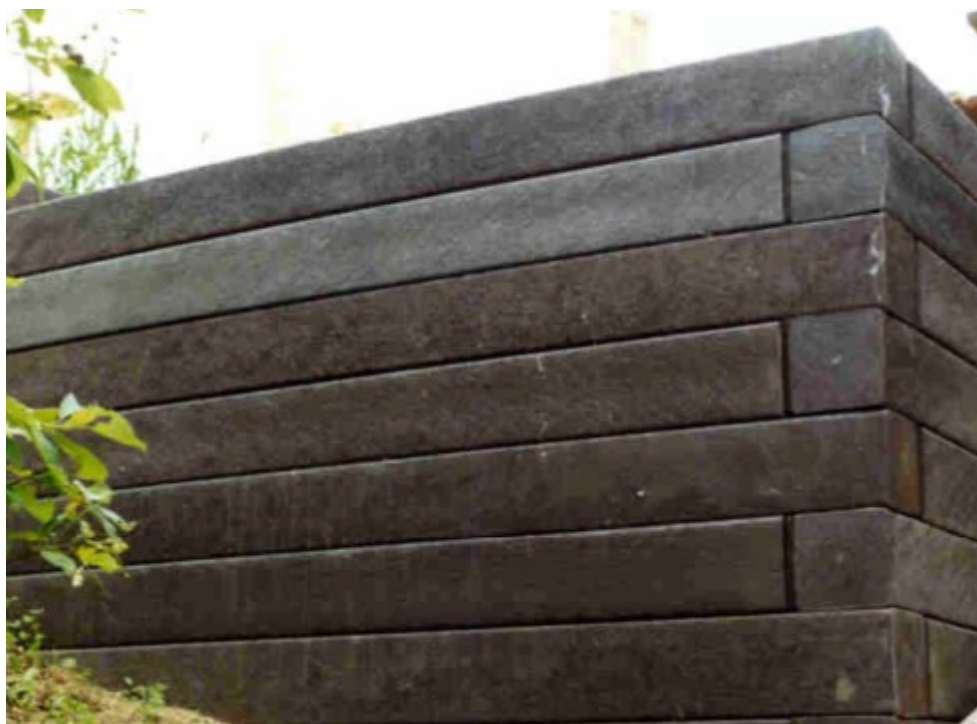
**Figure 3-35: Plastic/vinyl lumber wall**

Composites come in a variety of forms including plastic lumber, which is typically formed from recycled high-density polyethylene (HDPE) plastic, vinyl sheet piling, and integrated hybrid composites of plastic and steel. Plastics can exhibit ultraviolet deterioration, material incompatibility, corrosion damage, and overstress damage. Plastics will typically exhibit discoloration when undergoing ultraviolet deterioration. The material may also begin to fray when under constant sunlight.

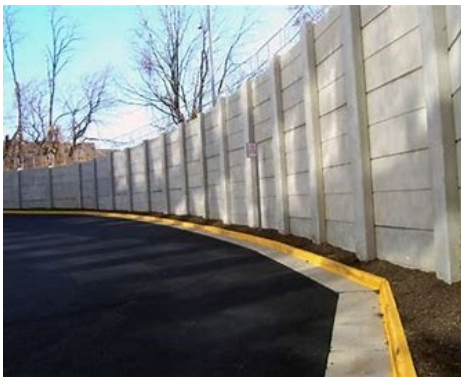
**Figure 3-39: Vertical support concrete**

Vertical Support/Column Concrete includes all prestressed and reinforced concrete columns/posts regardless of size, shape, or protective system. Inspect concrete elements for delamination, spalling, cracking, efflorescence, exposed reinforcing or prestressing strands and other deterioration. Additionally, inspect the element for evidence of distortion or buckling and misalignment including but not limited to rotation.

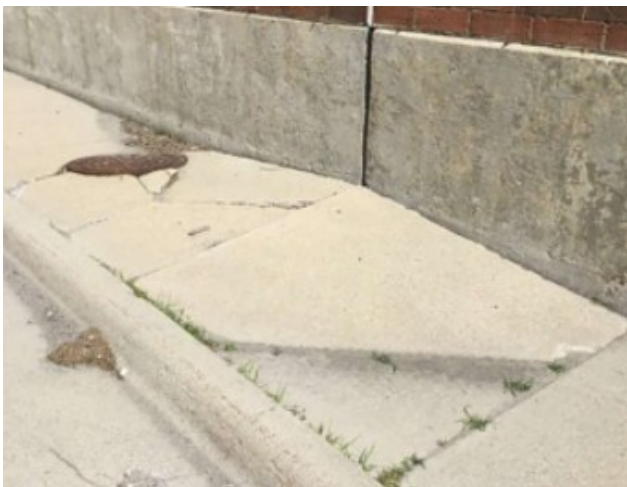
**Figure 3-42: Wall settlement**

Vertical movement can occur in the forms of uniform settlement or differential settlement. Depending on the magnitude of the settlement realized, uniform settlement will have limited impact on the structural stability of the wall; however, overtopping of the wall may occur if the settlement is significant. Differential settlements, on the other hand, may lead to serious problems in the wall. Differential settlements may cause the opening of joints or cause wall cracking or transverse tipping. The most common causes of vertical movement consist of soil bearing failure; soil consolidation; erosion; and foundation material deterioration.
