# **DRAFT Preliminary Repair, Rehabilitation, and Replacement Options for Consideration for Culverts Report**

Prepared by HNTB Corporation

December 2023

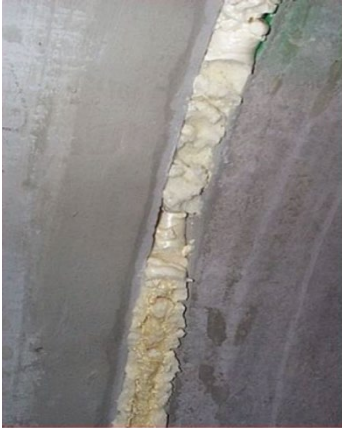
**Figure 1: Internal Side of a Chemically Grouted RCP**

Chemical grouting is used to internally seal joints in structurally sound structures. This type of repair is not suitable for longitudinal or circumferential cracks or broken/crushed pipes. Materials used for chemical grouting include acrylamide gel, polyurethane foam, urethane gel, acrylic gel, and acrylate gel. Figure 1 shows a separation joint of an RCP that has been chemically grouted with polyurethane foam (Caltrans 2014).

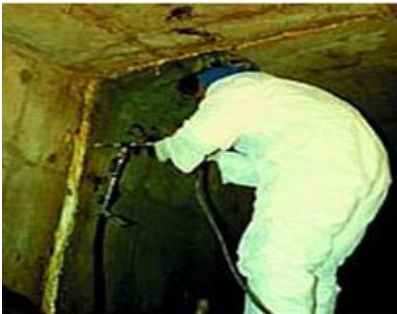
**Figure 2: Internal Grouting through Human Entry**

Internal grouting with human entry involves filling internal cracks and joint voids using a specially formulated mix that aims to enhance the culvert's integrity and to minimize inflow and infiltration. This non-structural renewal method is suitable for larger-sized culverts, specifically those exceeding 30 inches in diameter (Figure 2). Traditional grout mixes use cement, while chemical grout finds widespread application for addressing leaking joints below the groundwater table. Traditional grout mixes involve the use of cement, while chemical grout, favored for treating leaking joints, encompasses several types of compounds. These chemical grouts effortlessly mix with water during application, ensuring excellent penetration into wet joints, cracks, and surrounding soils. They are available in various forms, including expanding polyurethane foam, which expands to fill the crack, gel, or in conjunction with a carrier medium such as oil-free oakum. (Peralta, et al. 2016).

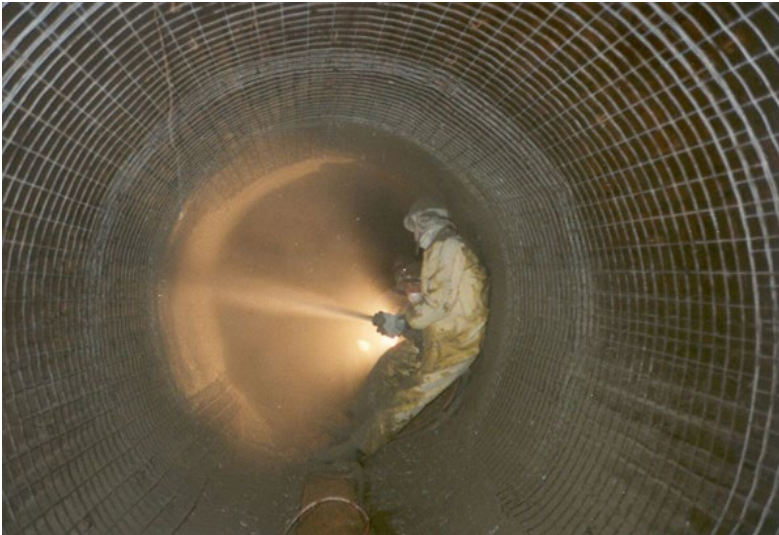
**Figure 4: Internal Shotcreting through Human Entry**

Internal shotcreting involves manually spraying concrete at a high velocity through a pneumatic hose to fix surface issues in large diameter RCP and CMP culverts (Peralta, et al. 2016). This method can be applied as either a non-structural or semi-structural renewal technique, as indicated by the Portland Cement Association (PCA 2015). Figure 4 shows human entry shotcreting.

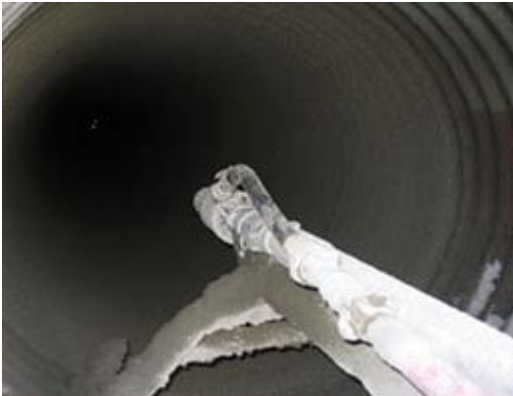
**Figure 5: Robotic Shotcreting**

Robotic shotcreting involves the movement of a remote-controlled robot on a track that is equipped with CCTV cameras and a rotary applicator to enable the flow of concrete to the point of defect in the culvert (Figure 5). Robotic shotcreting can be used as either a non-structural or semi-structural renewal method.

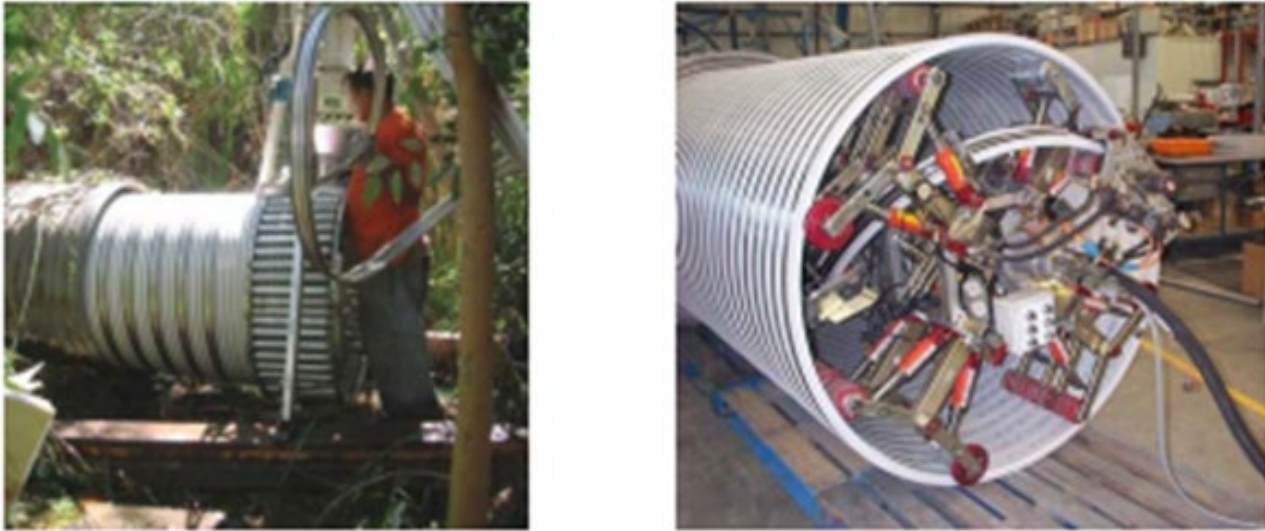
**Figure 8: Spirally Wound Liner: Stationary (left) and Mobile (right) Winding Machines**

Spiral winding is classified as either stationary or mobile. In the stationary method, the winding machine is positioned at one end of the culvert. While in the mobile approach, a circular machine with hydraulic rams moves along the pipe's length (Figure 8). Spiral winding is suitable for rehabilitating circular pipes with diameters ranging from 6 to 180 inches. The maximum drive length, which is subject to project specifics, is typically limited to 650 feet. Installation can be carried out in live-flow conditions.

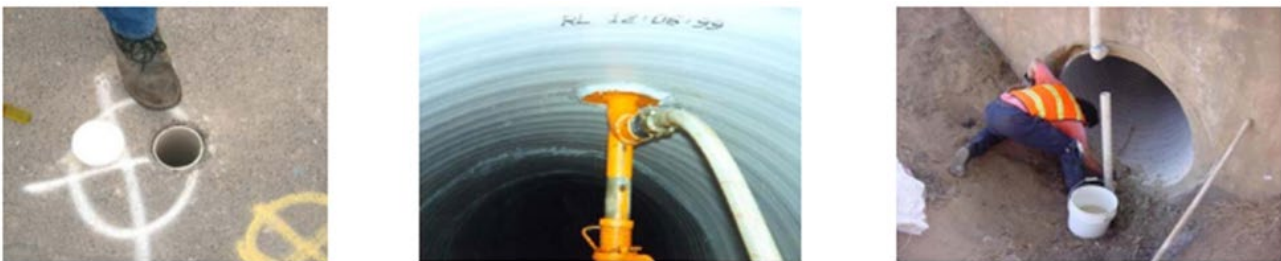
**Figure 9: Spirally Wound Liner: Surface Grouting (left), Grouting Through Liner (middle) and Grouting Through Bulkhead (right)**

Tightly-fitted liners (expandable diameter liners) typically do not require grouting unless specific conditions are met, such as the presence of extensive sections of missing pipe or significant offset of joints in the host culvert pipe. When grouting is required, it can be accomplished through pipes installed from the surface before liner winding, drilled through the installed liner, or via grouting through the bulkhead (Figure 9). According to NCHRP (2010), the standards ASTM F1697 and ASTM F1735 outline the specifications and testing procedures for materials, dimensions, workmanship, stiffness factor, extrusion quality, and a form of marking for extruded PVC profile strips used in the automated production of spirally wound pipe liners. ASTM F1697 provides tables for two different profile strip dimensions showing waterway wall thickness ranging from 0.040 inch to 0.15 inch, representing typical thickness of this type of liner.

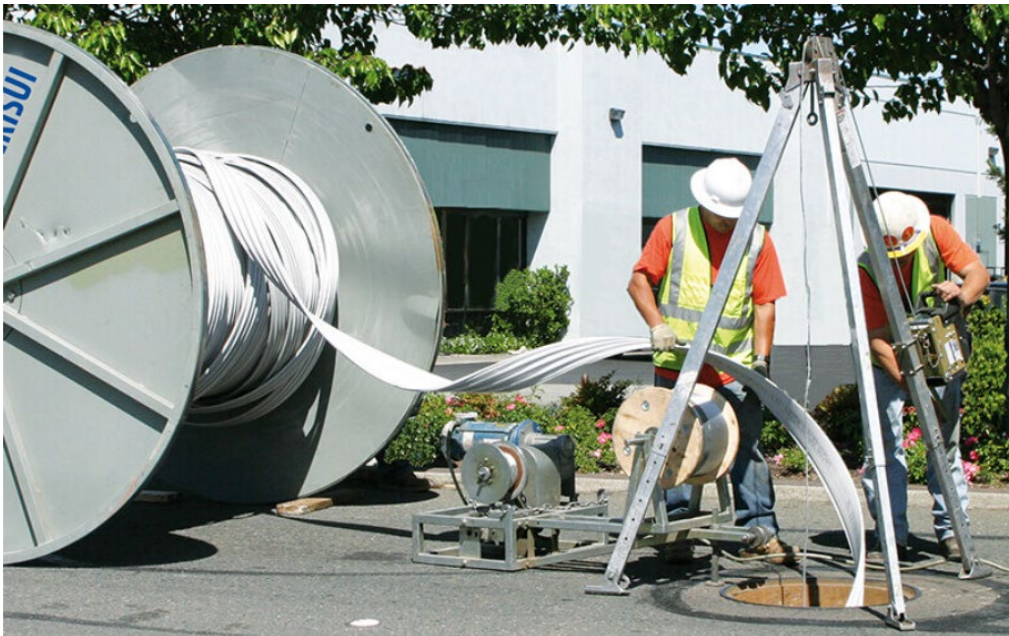
**Figure 10: Spiral-wound Lining**

SCDOT *Best Practices for Assessing Culvert Health and Determining Appropriate Rehabilitation Methods: A Research Project in Support of Operational Requirements for the South Carolina Department of Transportation* (2016) references a spiral-wound lining strategy (Figure 10). In this strategy, the winding machine moves along the culvert, creating a semi-structural or fully structural liner that is leak-tight. This method is particularly well-suited for non-circular host culverts with limited access constraints, and it is applicable for different culvert shapes and tight curves. It does not require access pits.

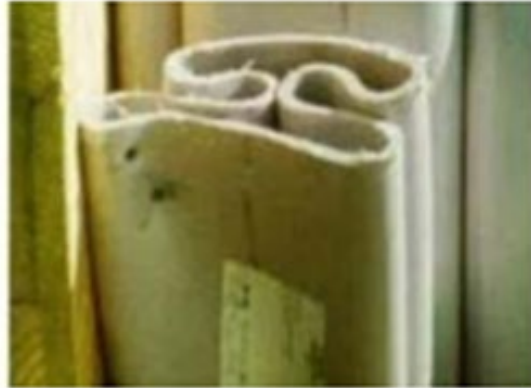
**Figure 11: Fold-and-Form Liner: Common Shapes of Folded PVC Liners - Flat (left) and “H” Shapes (right)**

Liner thickness is determined based on the ASTM F1871 and ASTM F1504 in accordance with the applicable section of Test Method D2122 (Standard Test Method for Determining Dimensions of Thermoplastic Pipe and Fittings). According to NCHRP (2010), the standards ASTM F1871 and ASTM F1504 outline the specifications and testing procedures for materials, dimensions, workmanship, flattening resistance, impact resistance, pipe stiffness, extrusion quality, and a form of marking for folded PVC pipe for existing sewer and conduit rehabilitation. ASTM F1871 provides table for minimum wall thickness of formed pipe, ranging from 0.123 inch to 0.576 inch. ASTM F1504 provides table for minimum wall thickness of rounded pipe, ranging from 0.114 inch to 0.429 inch.

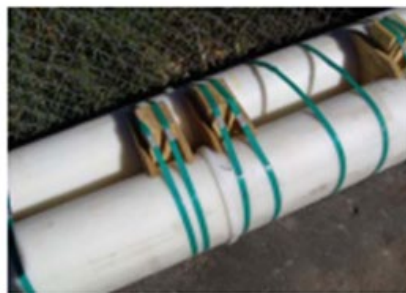
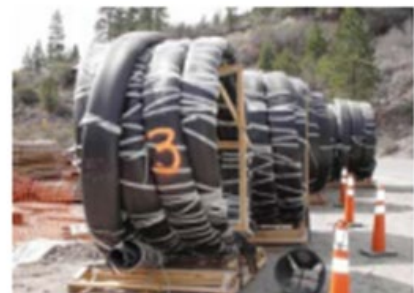
**Figure 14: Deform-Reform Liner: "Heart" Shape of Folded HDPE Liner (left), Plastic Bands to Maintain the Shape (middle), and Coiled Pipe to Transport (right)**

Deform-reform liners are HDPE pipes that are initially manufactured in a round shape with their memory set to remain round through cooling. Then, they undergo reheating with warm water, below the manufacturing temperature, and are deformed into a "U" shape using a former or a "heart" shape (Figure 14, left). This deformed shape is temporarily maintained by a sleeve or plastic bands (Figure 14, middle). Following the folding process, the pipe is coiled on large vertical drums for transportation to the job site (Figure 14, right). The flexible liner is unwound from the coil and pulled into the host pipe using a winching mechanism (Figure 15, left). Once pulled into the culvert, the liner is re-rounded by applying pressure to release the bands, allowing it to revert to its original shape (Figure 15, right). This re-rounding process can use pressurized steam, a combination of steam-generated temperature and pressure, or hot water. The installation cannot be performed in live flow conditions. Liner thickness is determined based on the ASTM F1533, covering requirements and test methods for deformed polyethylene (PE) liner for the rehabilitation of gravity flow and non-pressure pipelines.

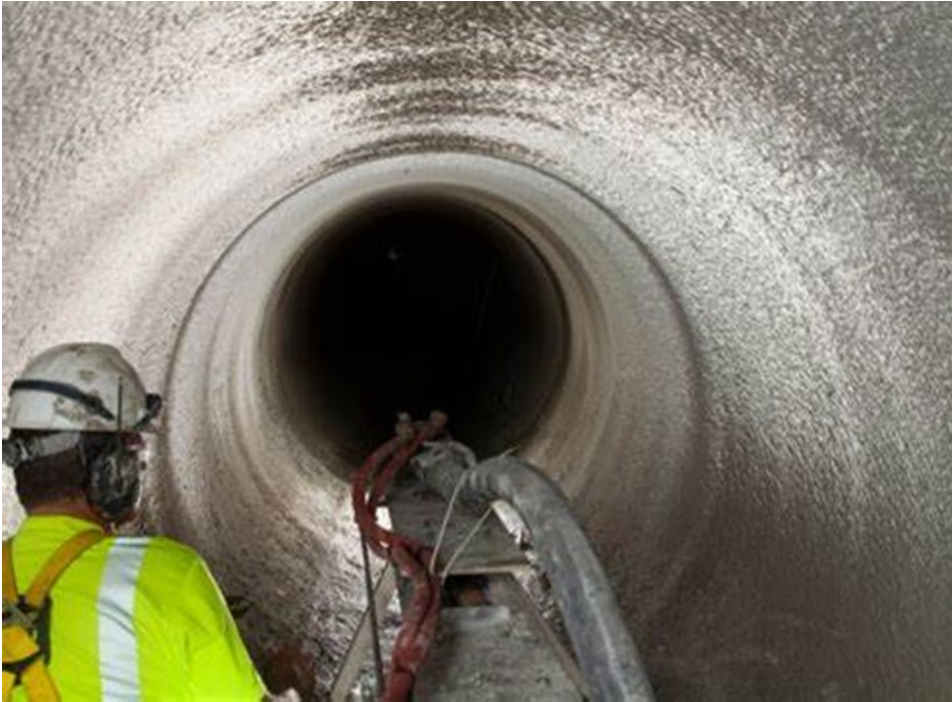
**Figure 17: Centrifugally Cast Concrete Pipe Lining**

The process of CCCP lining, also referred to as a spincast liner, involves the use of a spincaster to apply thin layers of fiber-reinforced cementitious material onto the inner surface of a pipeline (Figure 17). This application creates a waterproof layer that significantly enhances the structural integrity of the pipe, tightly adhering to the original structure. The fiber-reinforced cement mortar, or Permacast mortar, serves the dual purpose of preventing corrosion and minimizing abrasion. The thickness of the coating is typically determined by specific engineering requirements and the need for structural support. CCCP is suitable to be applied to the host culvert with major corrosion, joint in/exfiltration, and invert deterioration. In comparison to the rehabilitation time required for a CIPP lining, this method is known for its shorter time frame and for providing lasting protection. However, it is essential to note that this technique is not suitable for application in temperatures below 45°F.

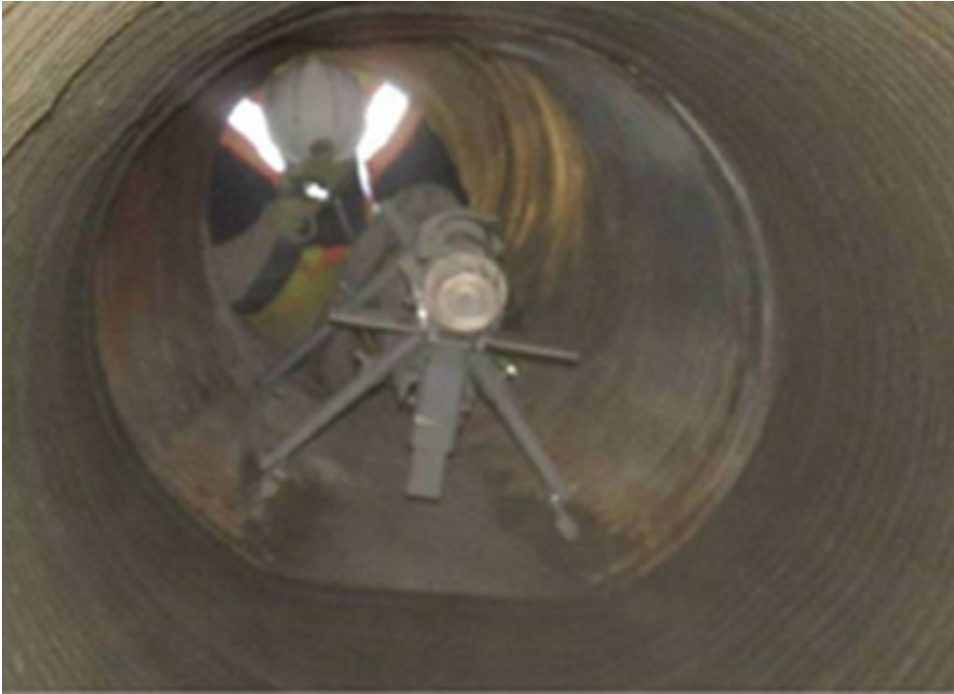
**Figure 18: Installation of Centrifugally Cast Liner**

CCCP liners are applied by a rotating head that is either electric or air-powered (Figure 18). The liner is made of cementitious mortar or other materials as mentioned in other DOT applications. This is suitable for culverts with diameters of 30 up to 120 inches. This type of liner is usually applied to CSP culverts to improve their structural capacity and protect them from corrosion.

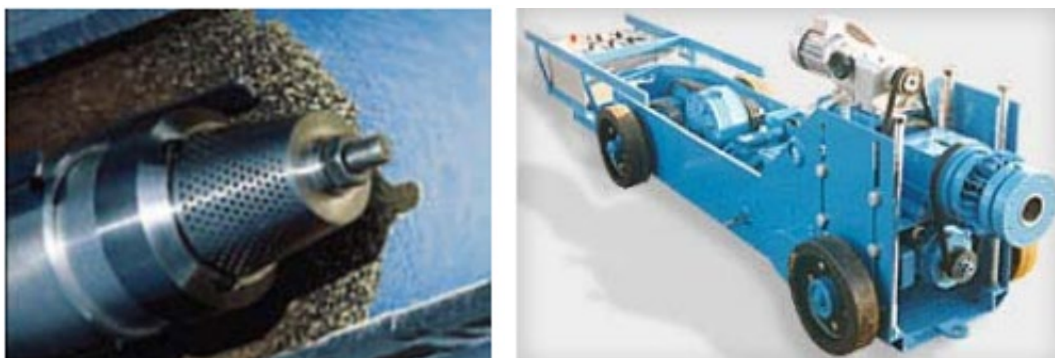
**Figure 19: Spincast System Applies Material to Pipe Walls Using Centrifugal Force for Small Diameter Pipes (left) and for Large Diameter Pipes (right)**

In some centrifugal casting systems, additional trowelling or surfacing may not be necessary. For small diameter pipes, the equipment is remotely operated (Figure 19). For large diameter pipes, an operator can enter the pipe to control the mortar flow, travel speed, and rotation speed of the lining machine head (Figure 19). The centrifugal casting device moving through the pipe evenly applies a continuous, thin layer of cement mortar (typically ranging from 0.25 in. to 0.5 in. thick, and up to 2 in. thick when multiple layers are applied) onto the interior of a deteriorated culvert pipe.

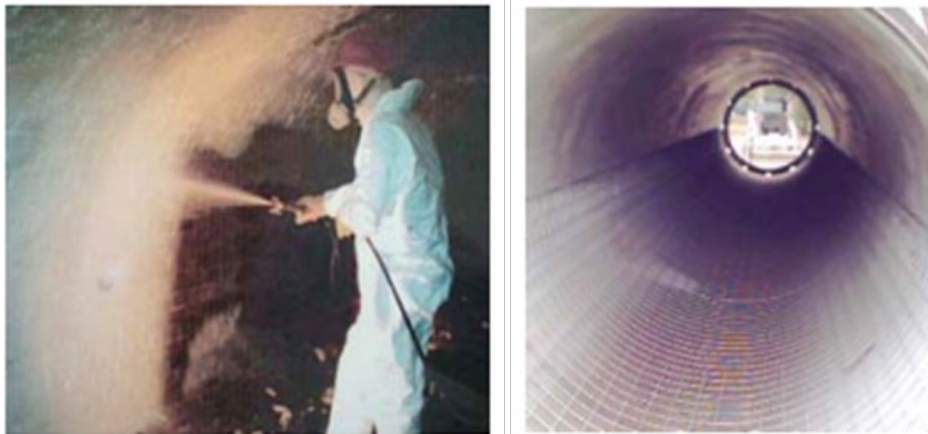
**Figure 20: Sprayed-on Liners: Spray Gun Application (left) and Wire Mesh Installation (right)**

Cement mortar or concrete is pneumatically applied to the structure's surface at a high velocity, also called shotcreting (Figure 20, left). This process can be either wet mix (all ingredients, including water, are pre-mixed before introduction) or dry mix, known as gunite, (ingredients, excluding water, are mixed and fed into the delivery equipment with water added at the nozzle). The choice between the use of wet or dry mix is based on factors like project size, application rate, dust production, rebound, and required pumping length. Another technique, wire mesh reinforced cement mortar lining (Figure 20, right), involves applying two layers of cement mortar that is separated by a wire mesh. The first layer (0.5 inches thick) is conventionally applied using gunite, and the second layer (0.5 inches thick) is applied with a trowel over the wire mesh. The wire mesh helps provide support and prevent chips, cracks, and other problems from happening. This application can be used for culverts with cracks, spalling, and other forms of distress.

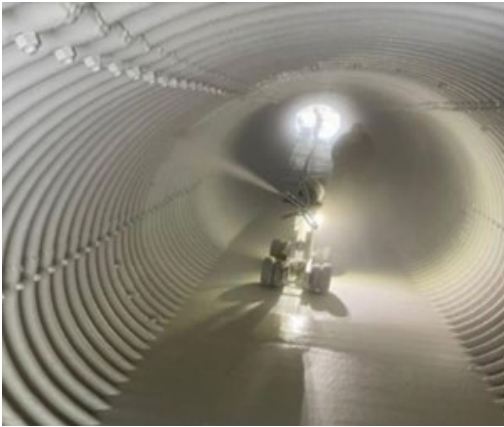
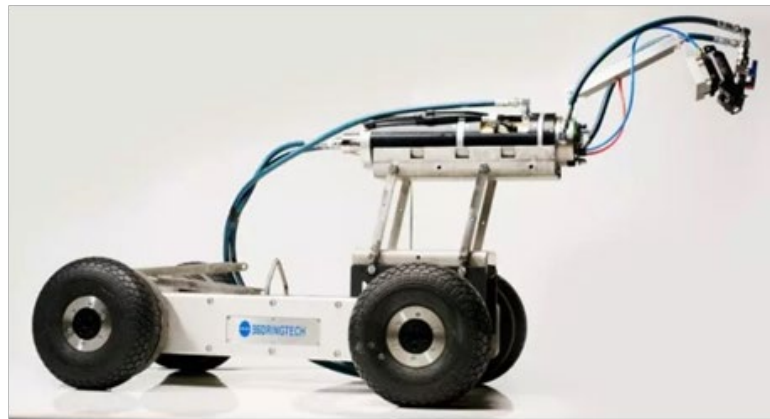
**Figure 21: Sprayed-on Liners: Polyurea Coating Application (left) and Robotic Liner System (right)**

- Virginia Department of Transportation (VDOT) used polyurea lining for highway culverts (12- to 96-inch diameter) in 2005-2006.
- York Region, Canada rehabilitated a fully deteriorated elliptical CSP culvert under a busy road and bridge with minimal traffic disruption (IMC/Nukote Canada, 2023). The project design assumed the existing deteriorated pipe would not contribute to loads; however, all loads applied directly to the structural liner. The spray-applied lining system, a high-performance polyurea/ polyurethane hybrid coating, was selected for its durability, ductility, and load-bearing capabilities. A robotic application ensured precise and efficient coating, contributing to a fully structural and long-lasting outcome (Figure 21).

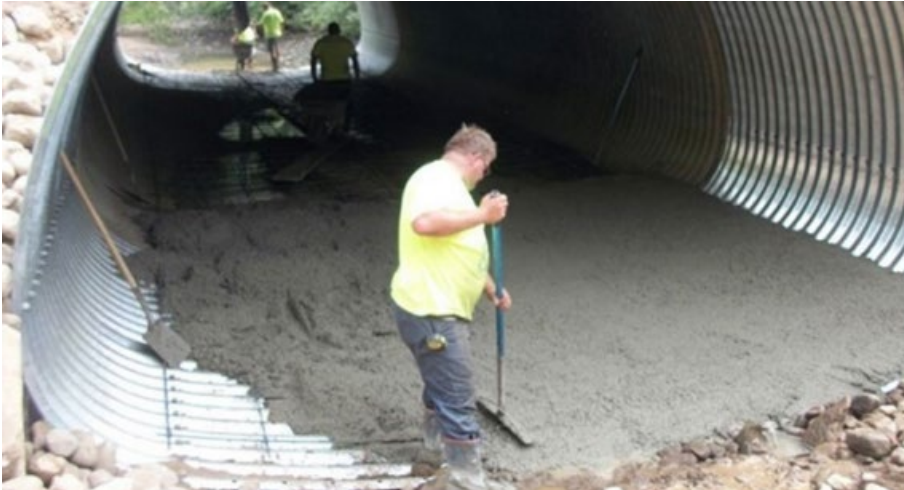
**Figure 22: Invert Paving of a Corrugated Metal Arch Pipe**

Invert paving involves placing reinforced concrete on the invert of the host culvert. The host pipe is not fully deteriorated, and its structural capacity is not compromised. Invert paving can only be done for pipes larger than 36 inches, as personnel entry is required for this type of repair (WisDOT 2018).

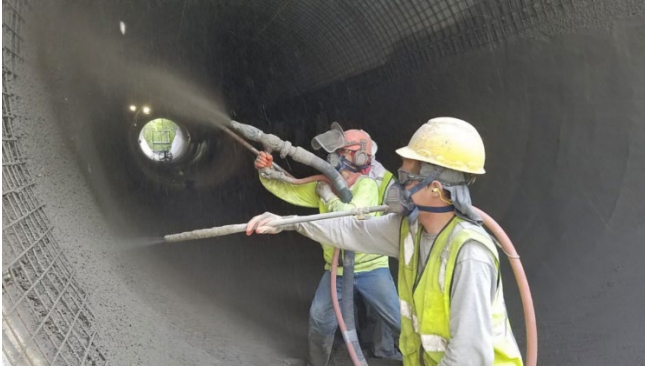
**Figure 25: Shotcrete Lining**

Shotcrete liners use concrete that is pneumatically applied at a high speed. The compaction of the concrete happens due to the force of the application. The liner can be either reinforced or unreinforced. Reinforcement is typically welded wire fabric/fibers or reinforcing bar. This method is most appropriate for culverts with diameters of 60 inches or more as personnel are generally required to enter. Figure 25 shows the rehabilitation of a pipe by shotcrete lining. Shotcrete liners are typically applied within a thickness range of 0.5 inch to 5 inches to ensure a robust lining capable of withstanding environmental elements and the forces of flowing water (Standard Cement 2020; Conteches 2024).
