June 16, 2026 Primary Election

# Access the Vote

VOTING ACCESSIBILITY IN THE DISTRICT OF COLUMBIA  
DURING THE JUNE 16, 2026 PRIMARY ELECTION

DISABILITY RIGHTS DC AT UNIVERSITY LEGAL SERVICES  
220 I STREET NE, SUITE 130, WASHINGTON, DC 20002 | PHONE: 202-547-0198

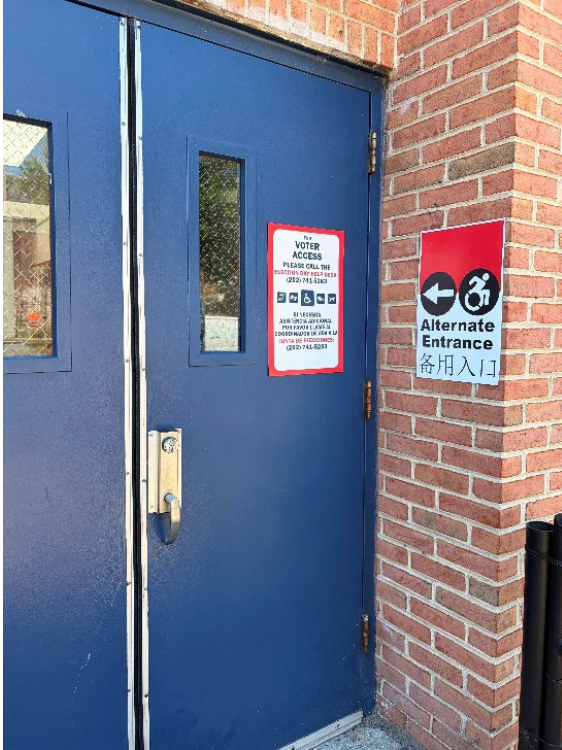
This vote center was both **structurally inaccessible** and **operationally inaccessible**. DRDC’s surveyor noted that several vote center volunteers expressed that they did not believe this site was accessible. Fifteenth Street Presbyterian Church was **structurally inaccessible** due to an abrupt rise of over half an inch caused by uneven pavement.

*This photo, taken June 16, 2026, shows what was designated as the accessible entrance at Fifteenth Street Presbyterian Church. As shown in the picture, the closed, heavy doors had no doorbell or automatic door opener, nor was there a poll worker stationed at the door to open it for voters.*

**Recommendations:** Ensure the route to the vote center entrance is free from abrupt rises and obstacles. Ensure that elevators are accessible to voters with disabilities. Ensure all signage is appropriately placed. Prop open heavy doors. ***Due to the longstanding structural issues at this site, DRDC urges BOE to relocate this vote center.***

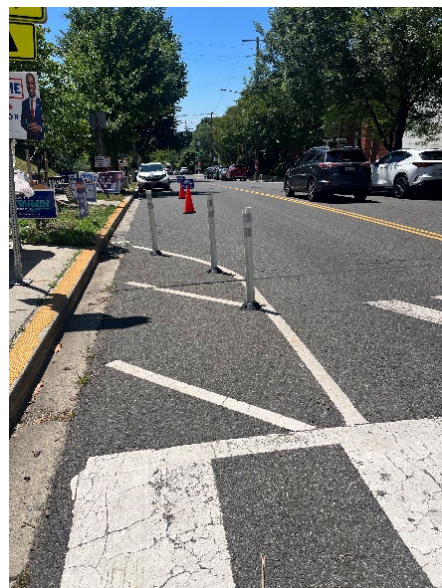
This vote center was **operationally inaccessible** due to a lack of accessible parking and obstructions in the pathway to the vote center entrance. Though BOE had designated accessible street parking, it was far from a curb cut. Additionally, there were permanent barriers surrounding the curb cut which meant that individuals had to enter the lane of traffic to maneuver around the barriers to access the curb cut. Therefore, there was no safe way for individuals to accessibly navigate from the street parking to the entrance. Instead, individuals had to traverse the abrupt rise of the curb to go from the parking area to the vote center entrance. The permanent barriers around the curb cut therefore rendered any designated parking inaccessible, presented an obstruction in the pathway from the parking area to the vote center entrance, resulting in a lack of an accessible route from the parking area to the vote center.

*This photo, taken June 16, 2026, shows the barriers around the curb cut. As demonstrated in the photo, the accessible street parking is designated behind the barriers.*

Recommendations: Remove barriers around the curb cut or provide this vote center with a temporary ramp to allow voters to transfer from the street parking to the sidewalk without an abrupt rise.

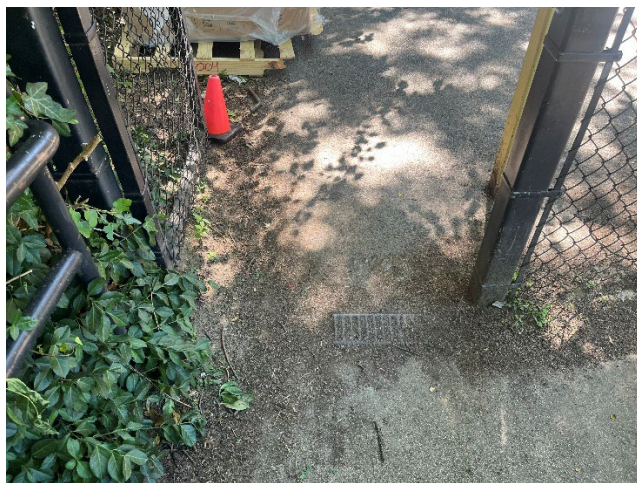
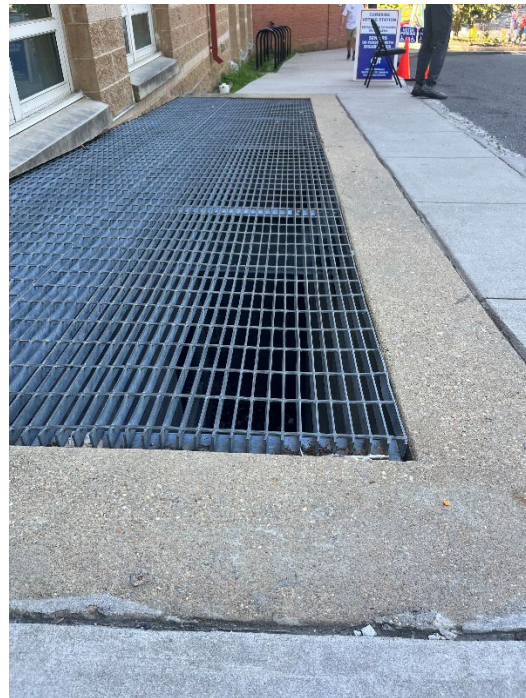
*These photos, taken June 16, 2026, show the dirt path and large metal grate along the route to the accessible entrance at Oyster-Adams Elementary School.*

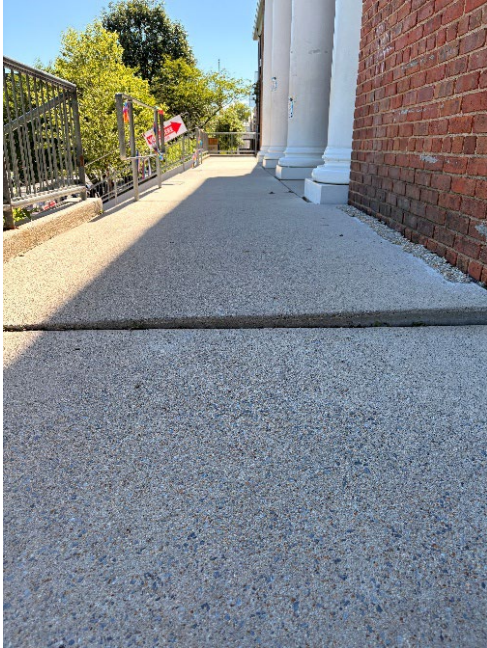
Powell Elementary School was ***operationally inaccessible*** due to a lack of signage. Specifically, there were no signs indicating the location of the accessible parking or the accessible entrance. The main entrance at the front of the vote center has a very large, steep ramp that has an abrupt rise of over half an inch at the top. Therefore, the main entrance is inaccessible. DRDC reported the accessibility issues with the main entrance to BOE on several occasions, and we were pleased to see that the main entrance was not used as the accessible entrance for this election.

*This photo, taken June 16, 2026, shows the abrupt rise at the top of the ramp that serves Powell Elementary's main entrance.*

**Recommendations:** Ensure sufficient signage is clearly posted to make the alternative entrance and accessible parking areas obvious to voters. Ensure that ramps at all vote centers are ADA-compliant. Plug in headphones at ballot marking devices. Prop open heavy doors.

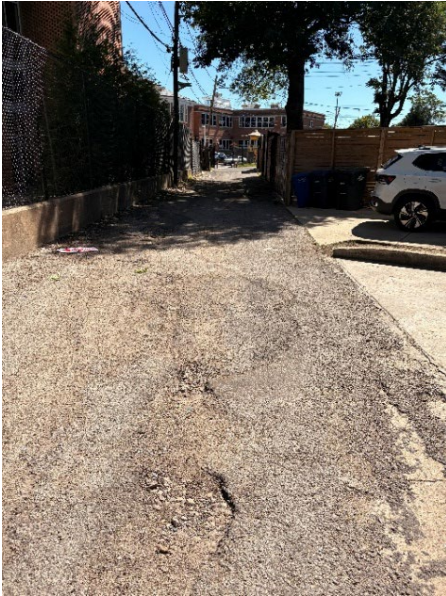
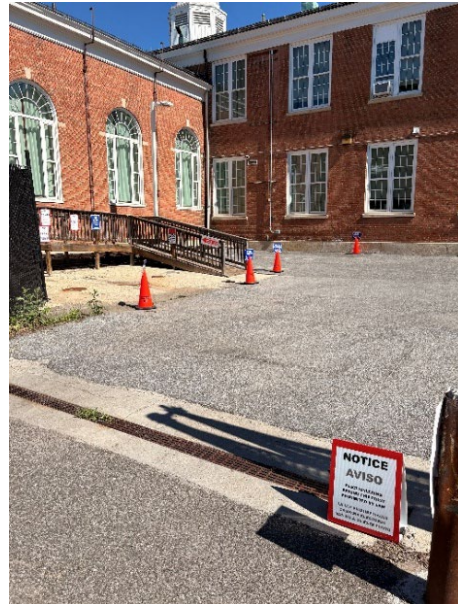
This year, an entrance at the back of the building with a door that led directly into the vote center was used as the accessible entrance. There was a small parking lot right outside the entrance, complete with accessible parking. However, this parking area and entrance were only accessible down a long alley and was not visible from the street or sidewalk.<sup>9</sup> Further, there were no signs indicating where people should go to access the accessible parking and entrance at the front of the vote center where the main entrance and parking area were located. The only signs regarding the accessible entrance were posted behind the building, completely out of sight of the main entrance and parking area. DRDC's surveyor only became aware of this entrance and parking area upon the direction of the site coordinator when she inquired about the lack of designated accessible parking.

<sup>9</sup> Though this entrance and parking area itself were accessible, DRDC notes that it was only accessible by car. The alleyway leading to the parking lot and entrance was very long and had lots of potholes, uneven pavement, and debris that would make it inaccessible to pedestrians with mobility disabilities. Because DRDC's survey only inquires about the route from the parking area to the vote center entrance, we do not consider this as inaccessible for our results. However, we urge BOE to ensure that this vote center is accessible to pedestrians as well.

*The above photos, taken June 16, 2026, show the accessible parking area and accessible entrance, as well as the route to travel to the accessible parking area from the sidewalk. Though the parking area and entrance were accessible themselves, as demonstrated in the picture on the left, the route to the area was replete with potholes and gravel, making it inaccessible for pedestrians with mobility disabilities.*

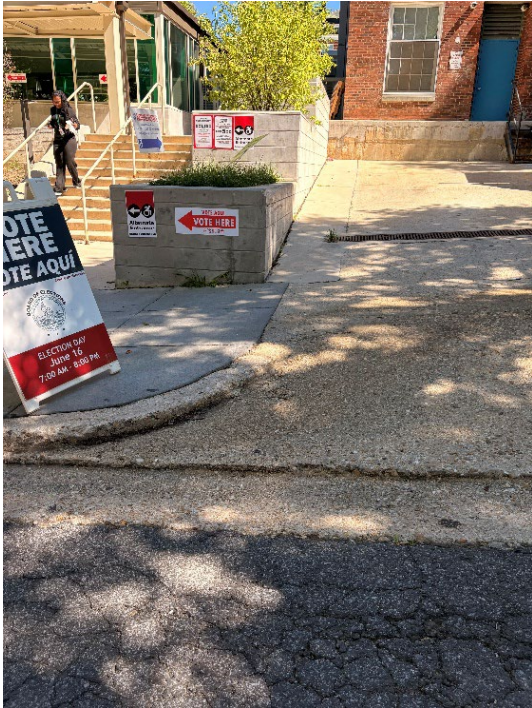
This vote center was both **structurally inaccessible** and **operationally inaccessible**. The vote center was **structurally inaccessible** because the ramp that served as the accessible path from the parking area to the vote

center entrance did not have handrails. Because the ramp was not accessible, there was not an accessible entrance to the vote center.

*This photo, taken on June 16, 2026, shows the driveway that served as the curb cut from the parking area to the route to the vote center entrance at Shepherd Recreation Center. As seen in the photo, there is an abrupt rise at the bottom of the driveway, making the path inaccessible.*

This vote center was **operationally inaccessible** due to inaccessible parking that could have been fixed. The vote center utilized street parking and had designated accessible parking near a driveway, which had a curb cut to serve as the accessible path to the vote center. However, the bottom of the driveway had an abrupt rise of about 1 inch, making this an inaccessible path. There was a temporary ramp located around the corner from the parking area, which DRDC's surveyor suggested to BOE officials be moved to provide an accessible path over the abrupt rise.

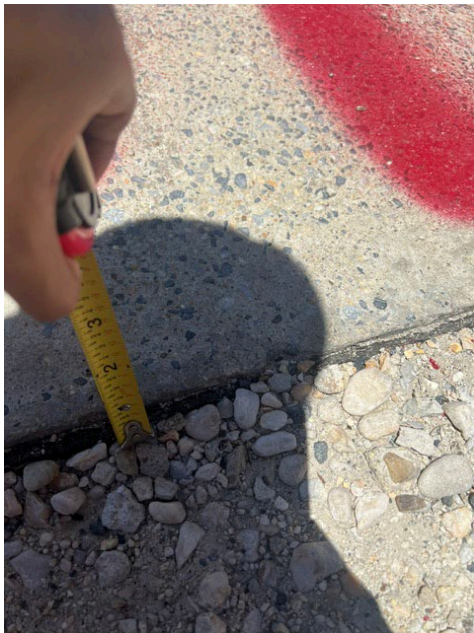
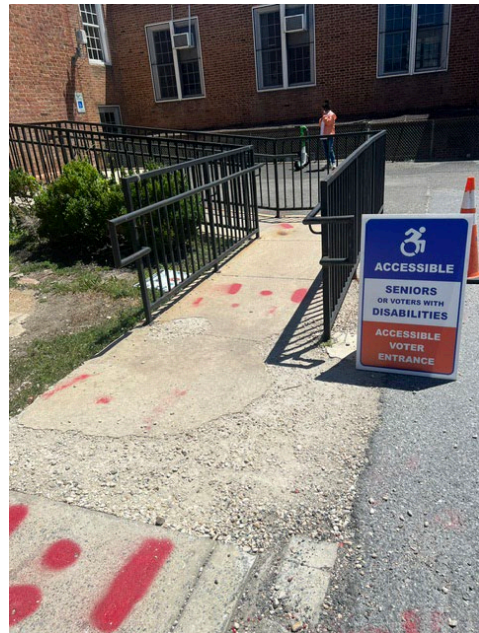
Bunker Hill Elementary School was both **structurally inaccessible** and operationally inaccessible. It was **structurally inaccessible** because the ramp leading into the vote center was inaccessible due to cracked concrete, making it an uneven surface. Second, there was an abrupt rise of over half an inch in the pathway to the entrance.

*These photos, taken June 16, 2026, show the ramp leading to the entrance of Bunker Hill Elementary School's vote center. As shown in the photo on the left, there was an abrupt rise of over 1/2 an inch along the route. As shown in the photo on the right, there was broken concrete and uneven surfaces along the route.*

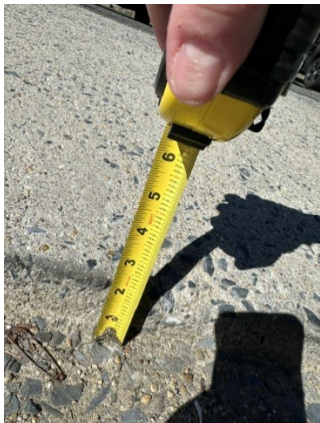
Mt. Horeb Baptist Church was **operationally inaccessible** because there were fewer than 2 accessible parking spots designated for voter use. There was one permanently designated parking space and then the BOE-designated curbside voting area. DRDC's surveyor discussed this with the site coordinator who agreed to separate the accessible parking and curbside voting signage to make it clear that there was a separate accessible parking space. However, the new designated accessible parking space had an abrupt rise of about 2 inches at the curb cut, making the designated space inaccessible.

*This photo, taken June 16, 2026, shows an abrupt rise at the base of the curb cut along the accessible route to Mt. Horeb Baptist Church's vote center entrance. As seen in the photo, the abrupt rise was over 2 inches tall.*

Recommendations: Ensure at least two accessible parking spaces are designated for voter use. Separate accessible parking from curbside voting. Ensure the route from designated parking areas are free from abrupt rises.

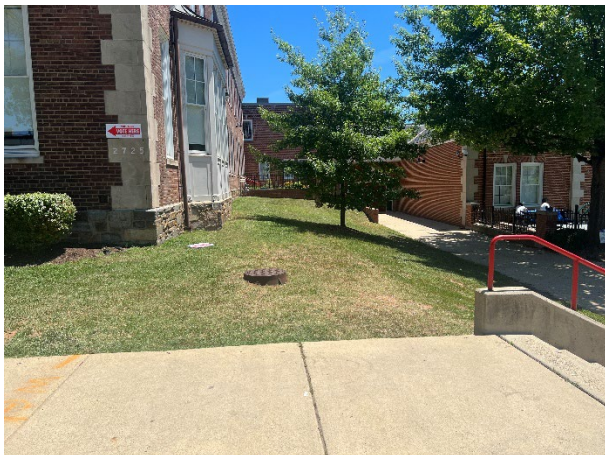
The Noyes Education Campus was ***operationally inaccessible*** for multiple reasons. First, the vote center had misplaced signage from the parking area to the accessible entrance. The vote center utilized a parking lot with permanently designated parking spots that had an accessible path from the main sidewalk to the accessible entrance, but the location of the parking was not clear from the main voter entrance. Nevertheless, BOE’s signage directed voters to the accessible entrance via an inaccessible route – one that required the use of stairs.

*This photo, taken June 16, 2026, shows the pathway indicated by the accessible entrance sign posted on the building. The bottom right corner of the picture shows a flight of stairs voters would traverse should they follow the posted signage.*

**Recommendations:** Ensure all signage is appropriately placed. Remove all obstructions from the path. Educate site coordinators and volunteers regarding the rights of all voters to vote inside the vote center.

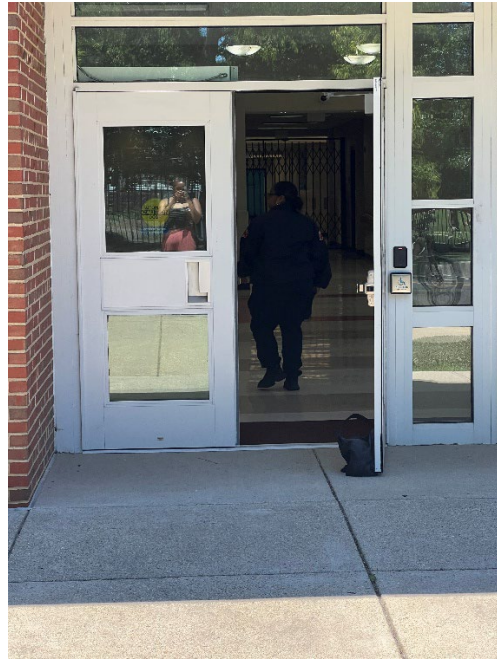
Second, there was an obstruction as the door to the accessible entrance was propped open with a bag, partially blocking the opening. The site coordinator fixed this at the request of DRDC’s surveyor by replacing the bag with a door stopper. When doing this, the site coordinator said the obstruction did not pose an issue to voters in wheelchairs because those voters should vote at the curbside area. The site coordinator further made a

*This photo, taken June 19, 2026, shows the door to the Noyes Education Campus vote center propped open with a large sandbag. Though DRDC applauds BOE for propping open the door, the large sandbag obstructed the doorway.*

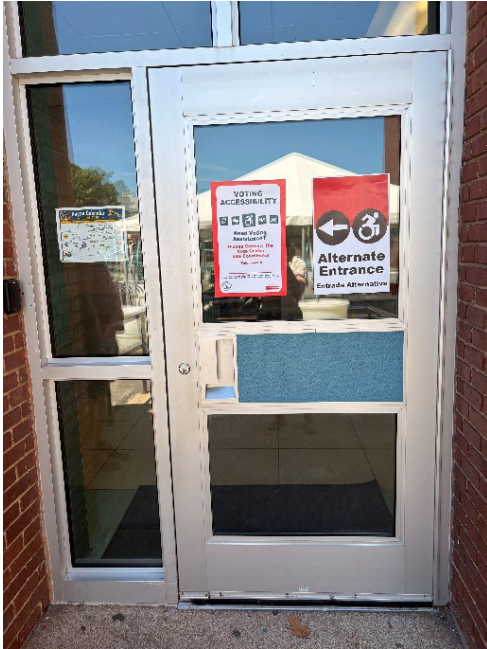
*This photo, taken on June 16, 2026, shows the designated accessible entrance at the Payne Elementary vote center. As demonstrated by the picture, the door was closed, there was no one stationed within line of sight of the door to prop it open, there was no doorbell or automatic door opener, nor was there a phone number on the help sign posted on the door.*

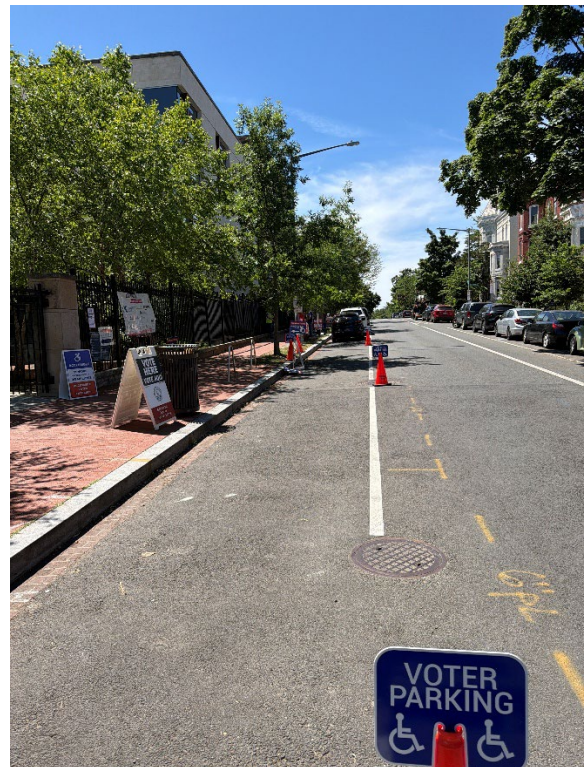
*This photo, taken June 16, 2026, shows the designated accessible street parking at the Stuart-Hobson Elementary School vote center. As shown in the photo, there was no curb cut near the accessible parking area.*

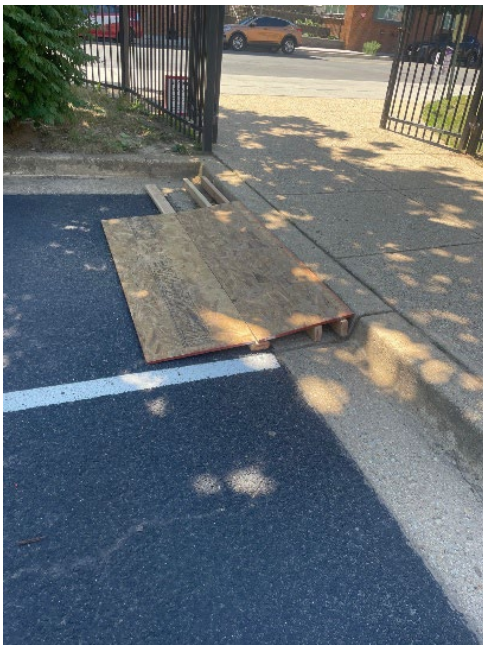
This vote center was **structurally inaccessible** because there was an abrupt rise of over ½ an inch that voters had to traverse. The designated parking area had a curb without a curb cut. The vote center had attempted to place a makeshift ramp using some plywood and 2x4s but this was wholly unsafe for voters.

*This photo, taken on June 16, 2026, shows the makeshift “ramp” erected in the parking lot of the Cesar Chavez Public Charter School vote center.*

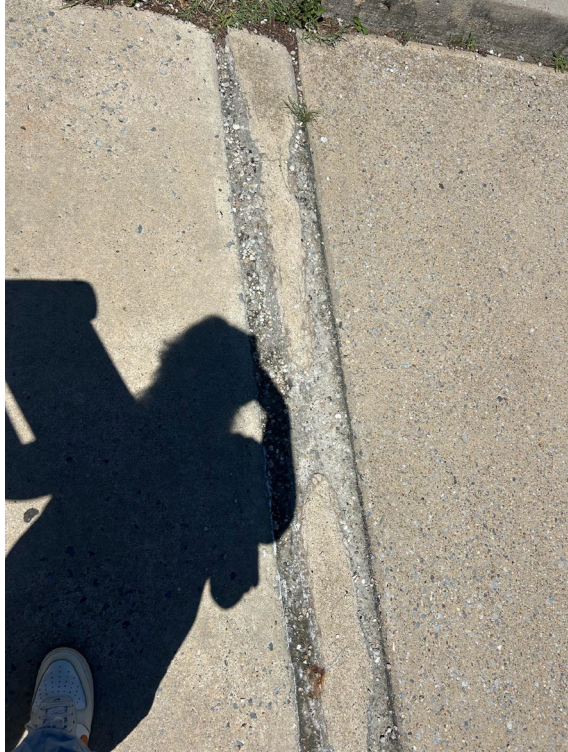
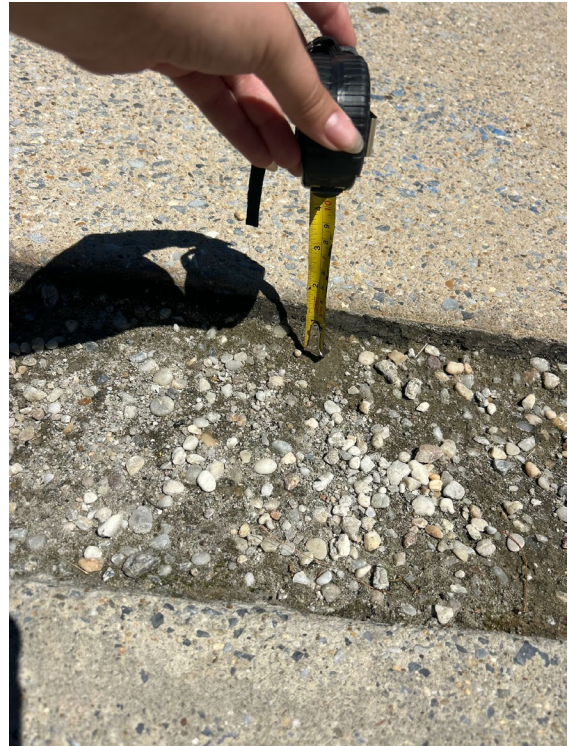
Second, there was a wide crack in the sidewalk about an inch deep, with loose gravel. This created an obstruction for individuals with mobility disabilities.

*The above photos, taken on June 16, 2026, show a large crack in the sidewalk along the route to the Hendley Elementary vote center entrance. As shown in the picture on the right, the crack is over 1 inch deep.*

**Recommendations:** Ensure at least 2 accessible parking spaces are designated for voter use. Ensure pathways are free from obstructions.

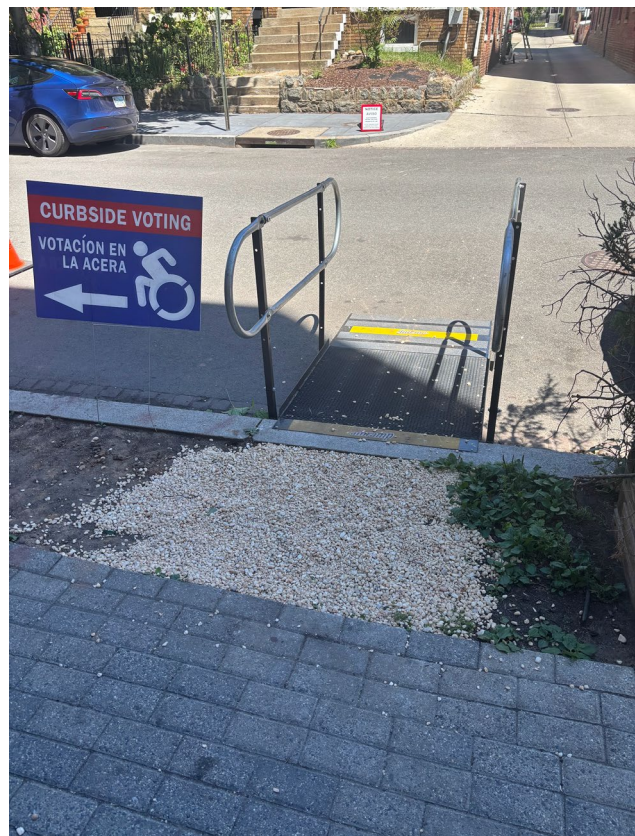
*This photo, taken on June 16, 2026, shows the temporary ramp at Columbia Heights Community Center. As shown in the photo, there was not a solid surface at the top of the ramp, creating an obstruction for voters with disabilities.*

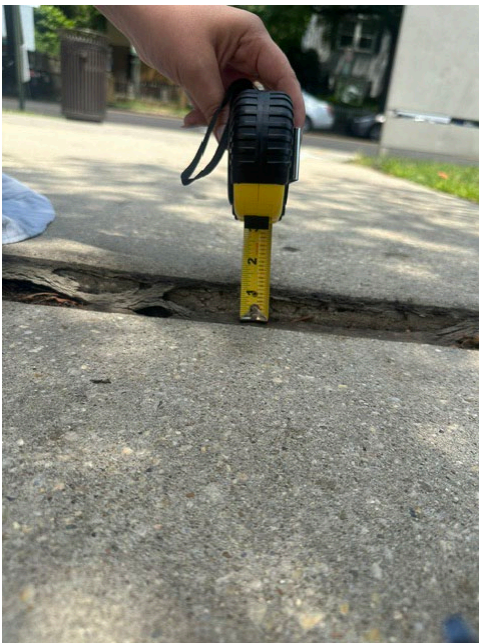
The Deanwood Recreation Center was both **structurally inaccessible** and **operationally inaccessible**. It was **structurally inaccessible** because there was an abrupt rise over ½ and inch along the path from the parking area to the vote center entrance.

*This photo, taken June 10, 2026, shows a large abrupt rise between the parking area and the vote center entrance at Deanwood Recreation Center.*

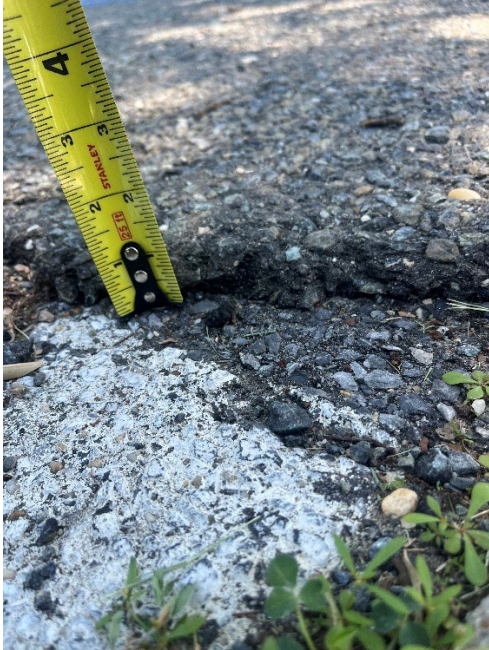
This drop box was **structurally inaccessible** due to an abrupt rise of 1 inch in the pathway from the parking area to the drop box. The abrupt rise was created by broken pavement at the curb cut.

*This photo, taken June 16, 2026, shows an abrupt rise from the parking area to the sidewalk along the route to the ballot drop box.*

Recommendation: Ensure pathways to drop boxes are free of abrupt rises.

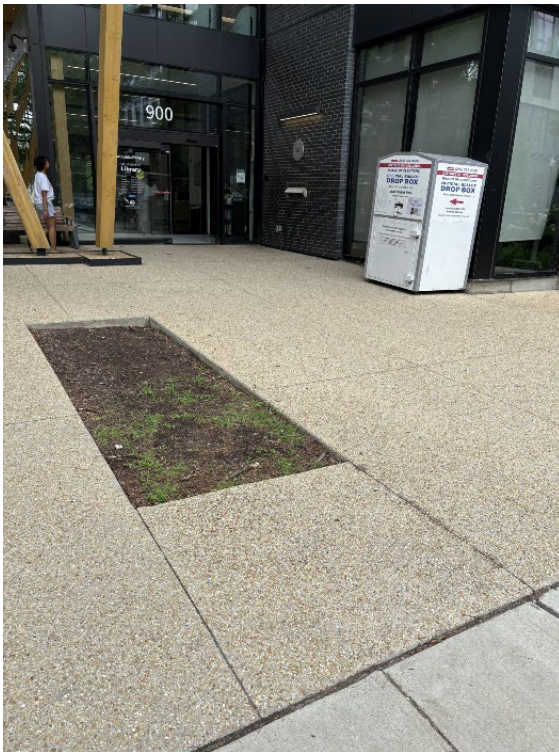
This drop box was **operationally inaccessible** because a large sidewalk paver was missing, creating an obstruction in the pathway.

*This photo, taken June 10, 2026, shows the large gap in the pavement near the Southwest Library ballot drop box.*

Recommendations: Ensure the path to ballot drop boxes are free from obstructions. Relocate this drop box to another part of the Library that is not near the missing paver.
