Assessment of Potential Impacts of Fires at BESS Facilities

LITERATURE REVIEW | August 21, 2025

Prepared by Fire & Risk Alliance, LLC. for:
The American Clean Power Association

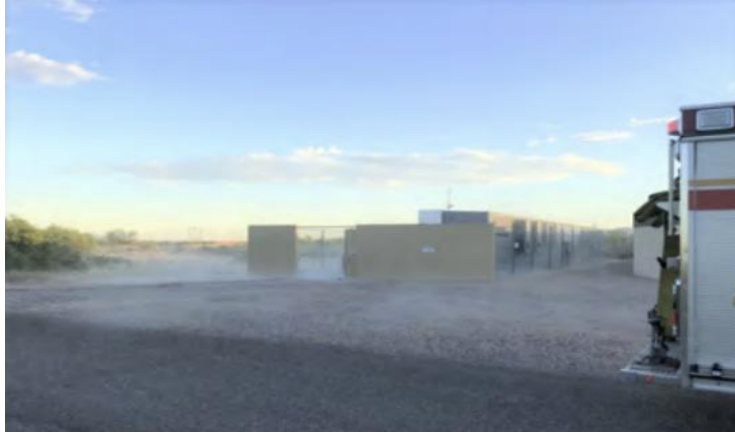
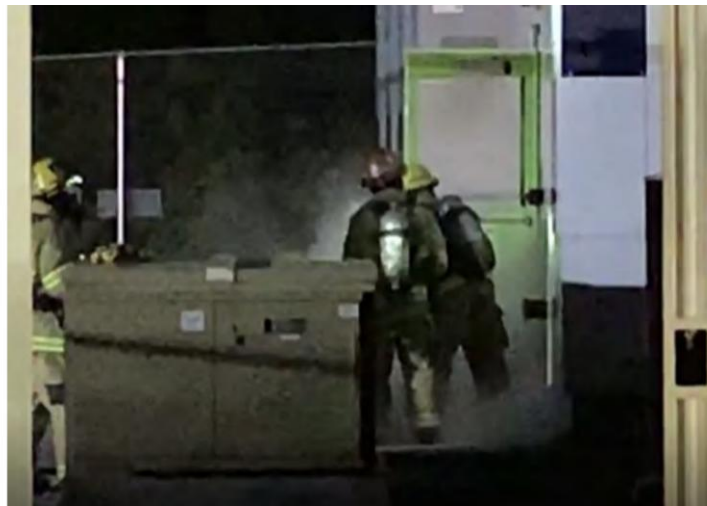
Figure 8: Images of the Surprise, AZ Fire.

- (a) Conditions of the BESS site upon the firefighters' arrival. Venting can clearly be seen coming from the unit [11]
- (b) Approximately 5 seconds after the responding firefighters opened the door to the BESS unit. As noted by UL in the report, high-density gases and vapors can clearly be seen in the photograph [11]

Neither UL or APS’s investigative reports provide pictures of the singular container on fire. Rather, both reports include photos of the damage after the incident, and UL’s report features images of the incident upon arrival and just after firefighters opened the door to the unit during battery venting, which may be seen in Figure 8.

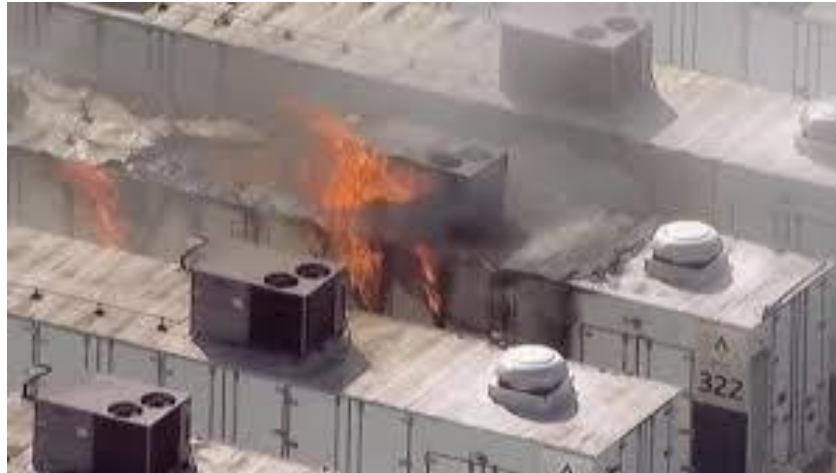
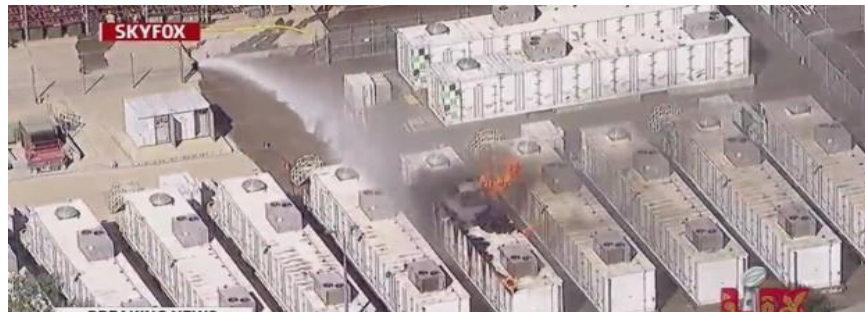
Figure 9: Images of the Escondido BESS Container Fire

Figure 9a shows a clear image of the burning container, including dark smoke and flames [15]. Figure 9b shows a clear image of the burning container as part of the larger BESS facility [16]. It can be seen that firefighters are applying water from a distance to surrounding containers to avoid fire spread and are letting the involved container burn out [16].

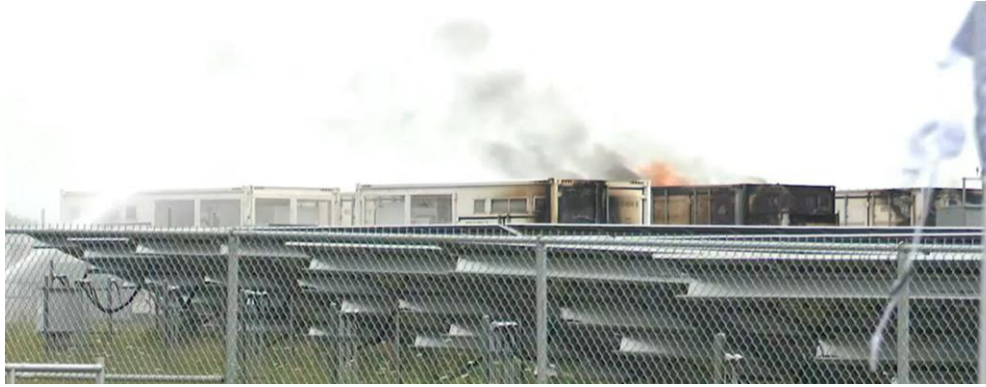
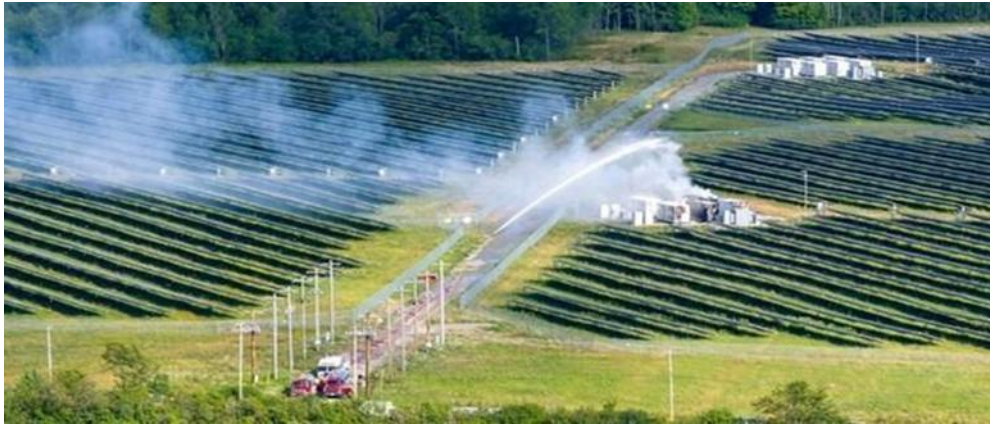
Figure 10: Images of the Chaumont (Lyme) BESS Fire Incident

- (a) An image showing burned containers emitting smoke and flames. The solar panels can also be seen in front of the BESS [19].
- (b) A remote image showing the smoking BESS containers in the context of the whole site. Firefighters can be seen spraying water onto the adjacent containers from a great distance. [20]

On July 27, 2023, a multi container fire occurred at a utility-scale facility in Lyme, New York (see Figure 10). The system was 4-5 months old and was operational and in use during the incident. An investigative report showed that the cause of the incident had to do with “the controls” [17, 18, 19]. There is minimal information regarding the specific design impairments and controls issue that led to this incident.

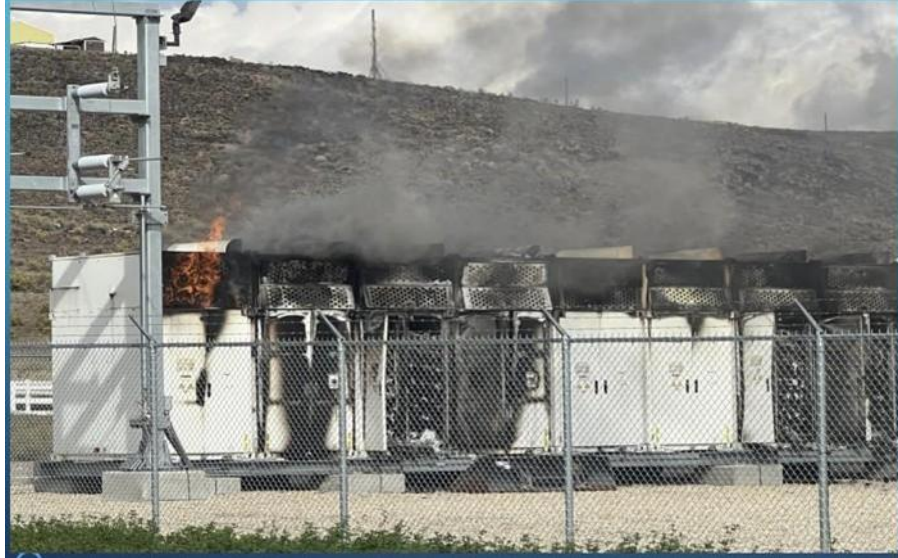
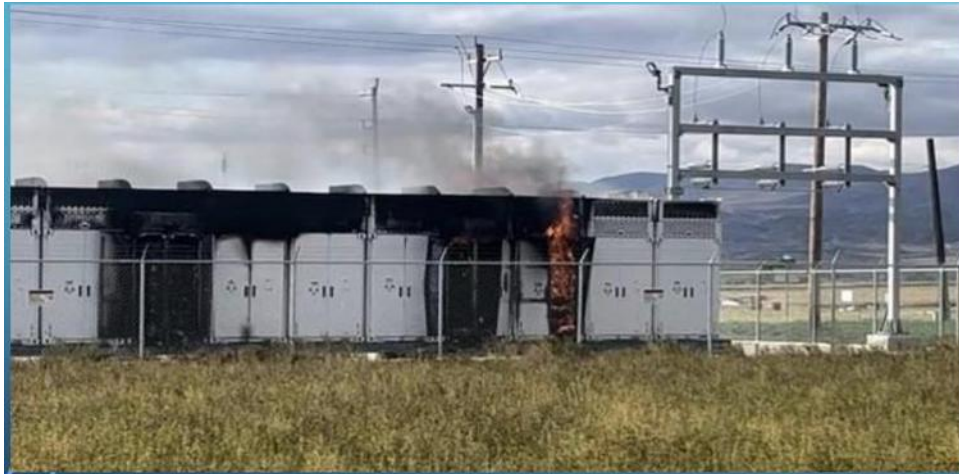
Figure 12: Images of the Melba, ID BESS Fire

- (a) An image showing one side of the burning enclosure at the substation [24].
- (b) Another angle of the burning BESS enclosure showing the other side burning [24]

A fire at a BESS unit installed at a substation for distribution report occurred in Melba, Idaho on October 2, 2023. At the time of the incident, the system was in the pre-commissioning stage (not yet operational) [5]. The unit capacity was 8 MWh [5]. It was suspected that water intrusion led to a short-circuit, which caused excess heat production that eventually lead to ignition of the battery cells, with the fire spreading among battery segments until burning out [23]. 48 hours after the event, the temperature of the batteries was reported to be approximately 650 °F [24]. The fire burned out after three days, and the substation remained operational through the fire event with external road closures [23, 24]. Images of this incident may be found in Figure 12.

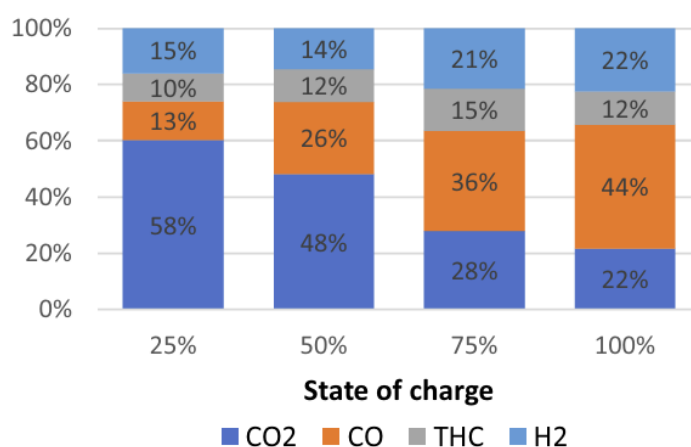
Figure 14: Impact of SOC on Proportion of CO₂, CO, Total Hydrocarbons (THC) and H₂ [36]

The list and proportions of gases generated from batteries undergoing TR is influenced by the State of Charge (SOC). At 0% SOC, more CO₂ is produced than CO, and only a few solvents are produced. The impact of SOC on the production of CO₂, CO, total hydrocarbons (THC) and H₂ on a prismatic NMC cell experiencing TR is presented in Figure 14 [36].

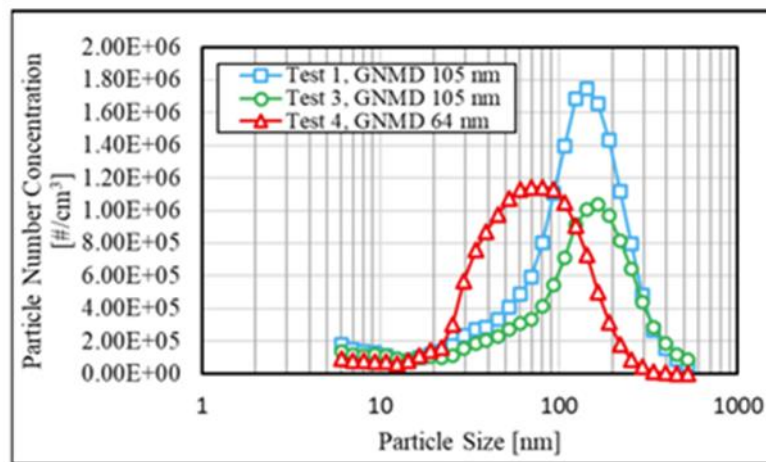
Figure 16: Airborne Particle Sizes [47]

A distribution of airborne particle sizes as a function of particle count in repeated tests of NMC battery cells is presented in Figure 16 [47]. The mean particle size ranges from about 70 to 130 nm, which is also the size range noted for the greatest mass. These are smaller than those shown in Figure 16 as the data reported in Figure 15 was done downstream of the source and hence had settled out of the airstream.
