VILEX Reconstruction & Arthrodesis

ALPHALOK™ RECON MINI-FRAG

CASE STUDY

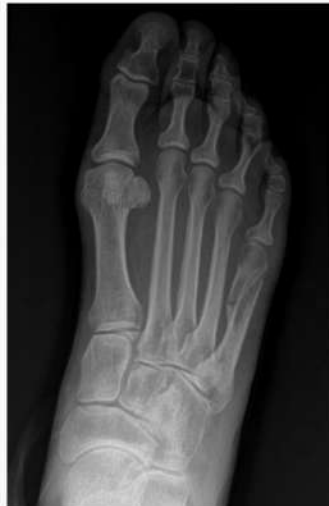
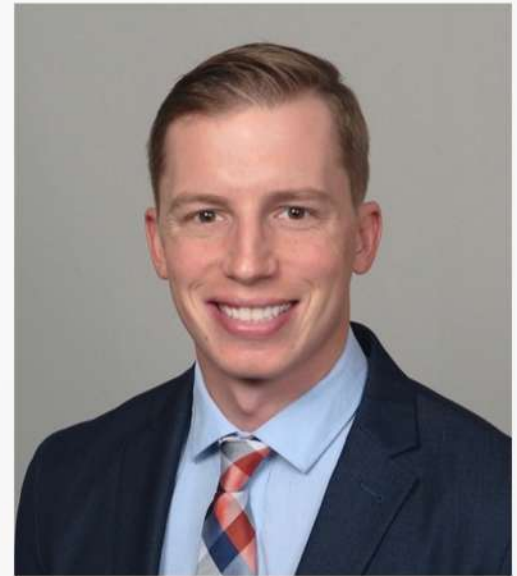
Pre-Op

- 72 YO F sustained twisting injury to right foot causing a comminuted, displaced 5th metatarsal shaft fracture.
 - Skin intact, no fracture blisters.
- PMH: GERD
PSH: L 5th metatarsal ORIF.

Due to comminution and displacement, surgical and nonsurgical options were discussed, and I recommended open reduction internal fixation of her 5th metatarsal.

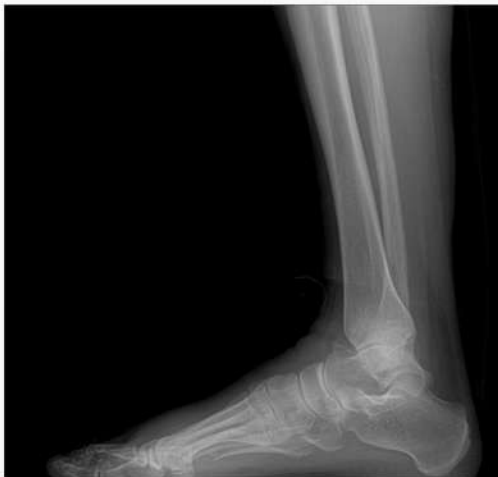
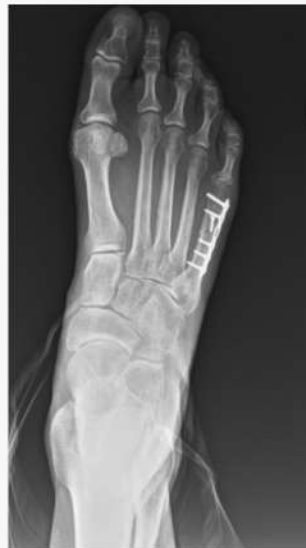
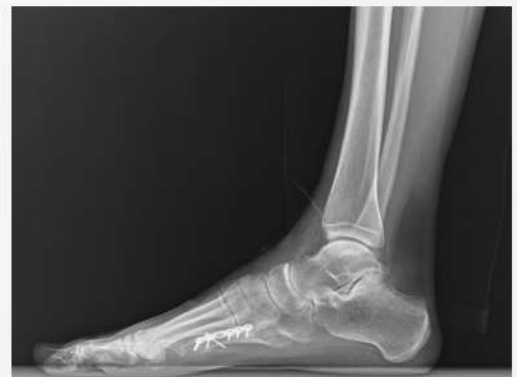
Post-Op

- 2.0 mm fully-threaded interfragmentary screw
- Mini-frag 6-hole straight plate
- 1.5 and 2.0 mm locking screws
