# ODC Daily Coaling Plan

23/07/2025

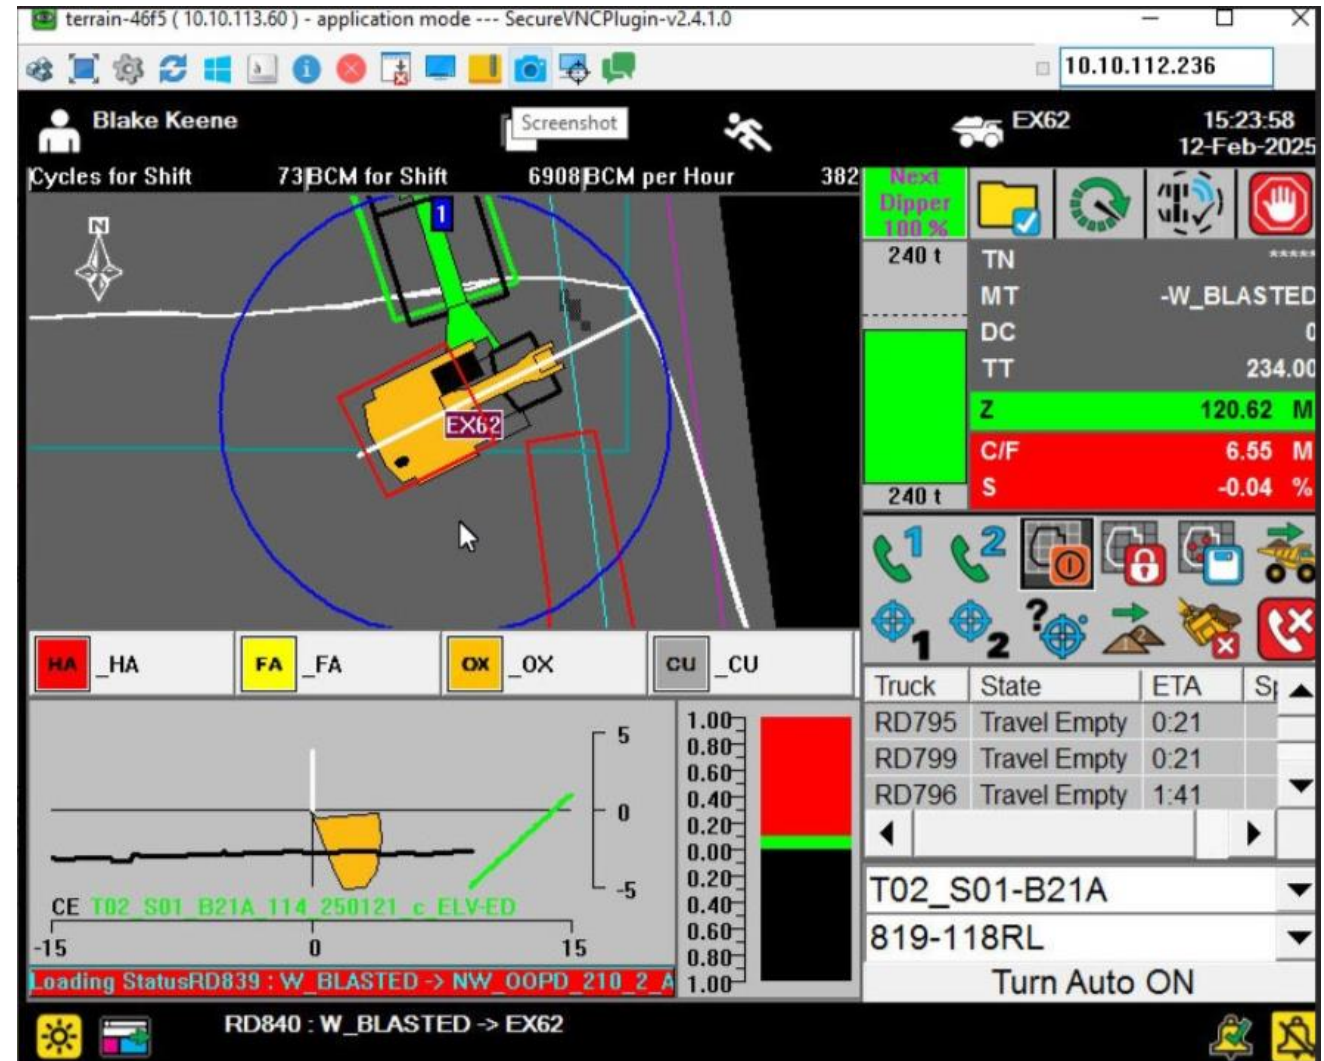
- New modifier coal types are being introduced into Minestar.
- Each load that is not “Fresh” coal needs to have the corresponding button pressed for the type of coal it is. Toggle on / off.
- Coal type modifiers included in the update will be
  - FA- Fault affected coal
  - HA- For heat affected coal
  - OX- For oxidised coal
  - CU- For clean-up coal

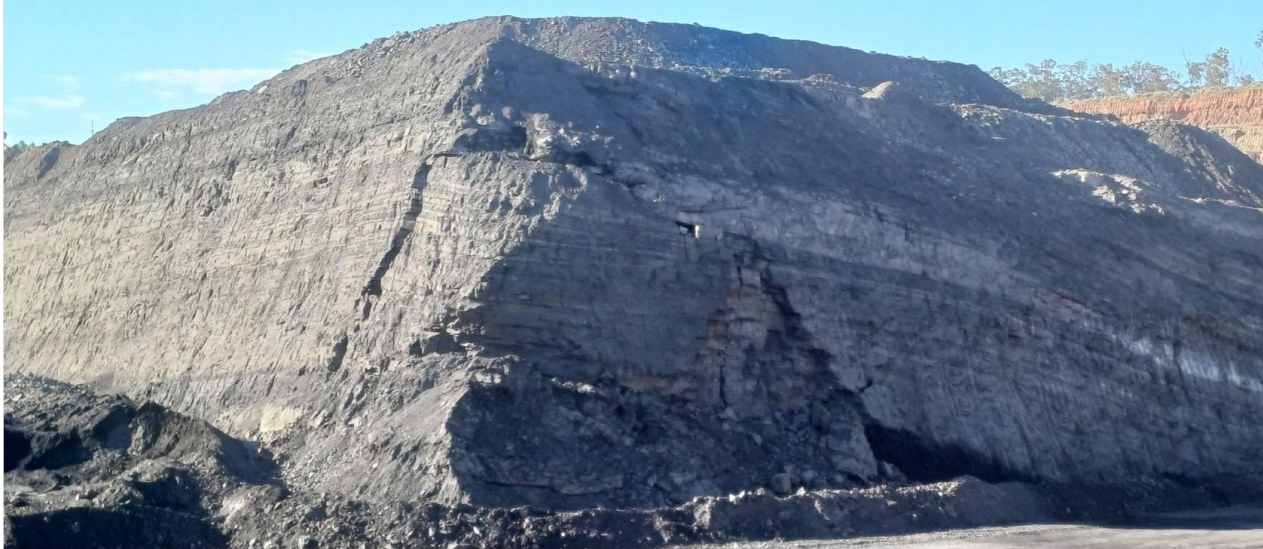
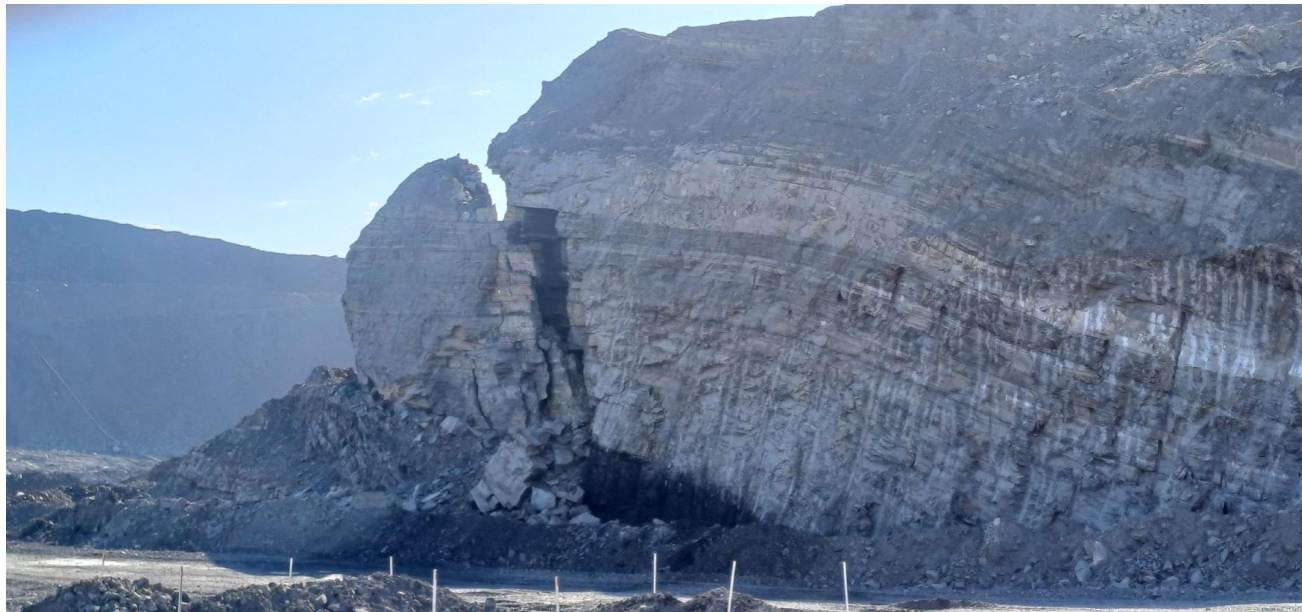
# GH021 Toppling Failure

A large-scale toppling failure has occurred at GH021 (Terrace 2 Strip 2 Burnt zone). Continued development of cracking has also been observed in the surrounding area, indicating ongoing ground movement.

Current RED TARP Controls as following

- **20m Crest Standoff**
- **35m exclusion zone from the toe**
- **Inspections as per RED TARP requirements**
- **3m high risk bunding outside of the 35m exclusion zone.**

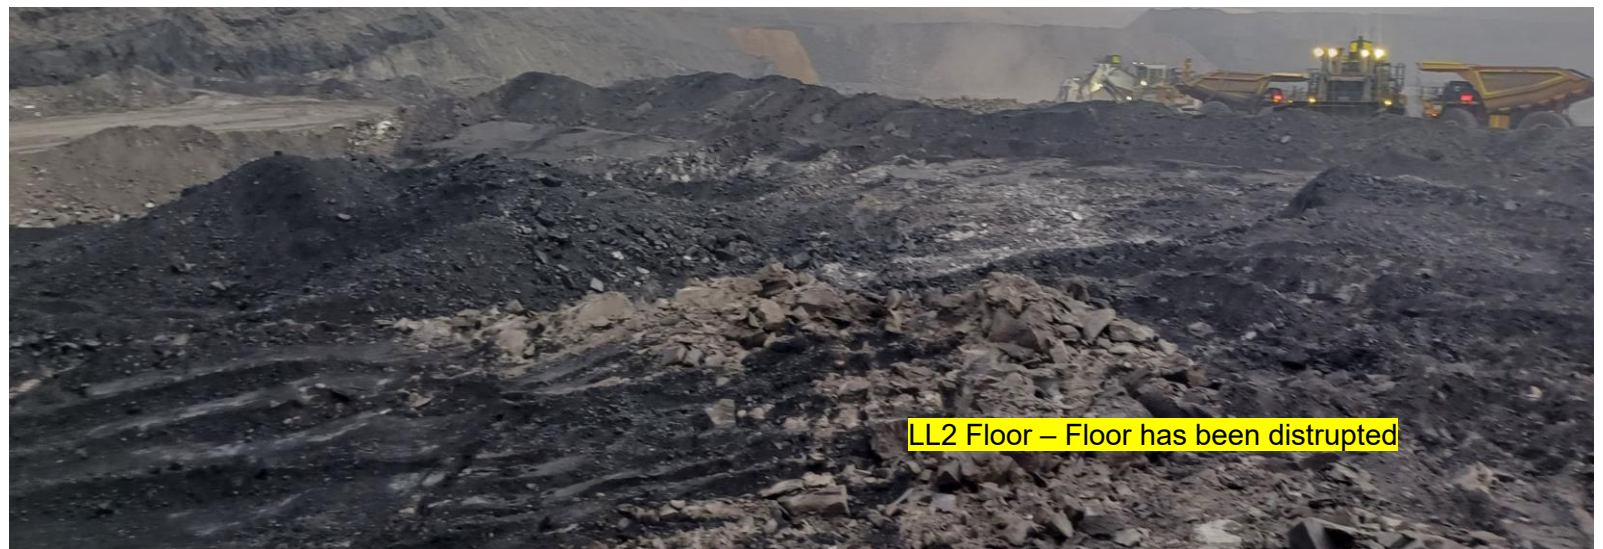
LL1 Roof – Leave no dirt on roof

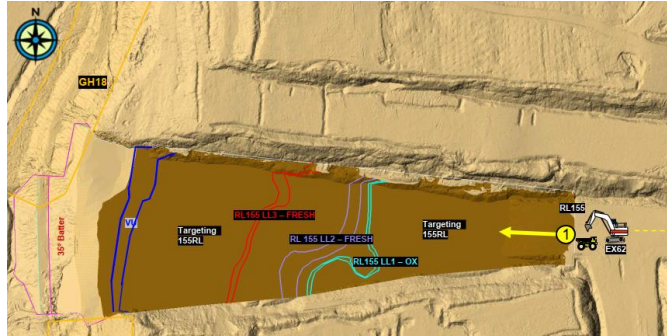
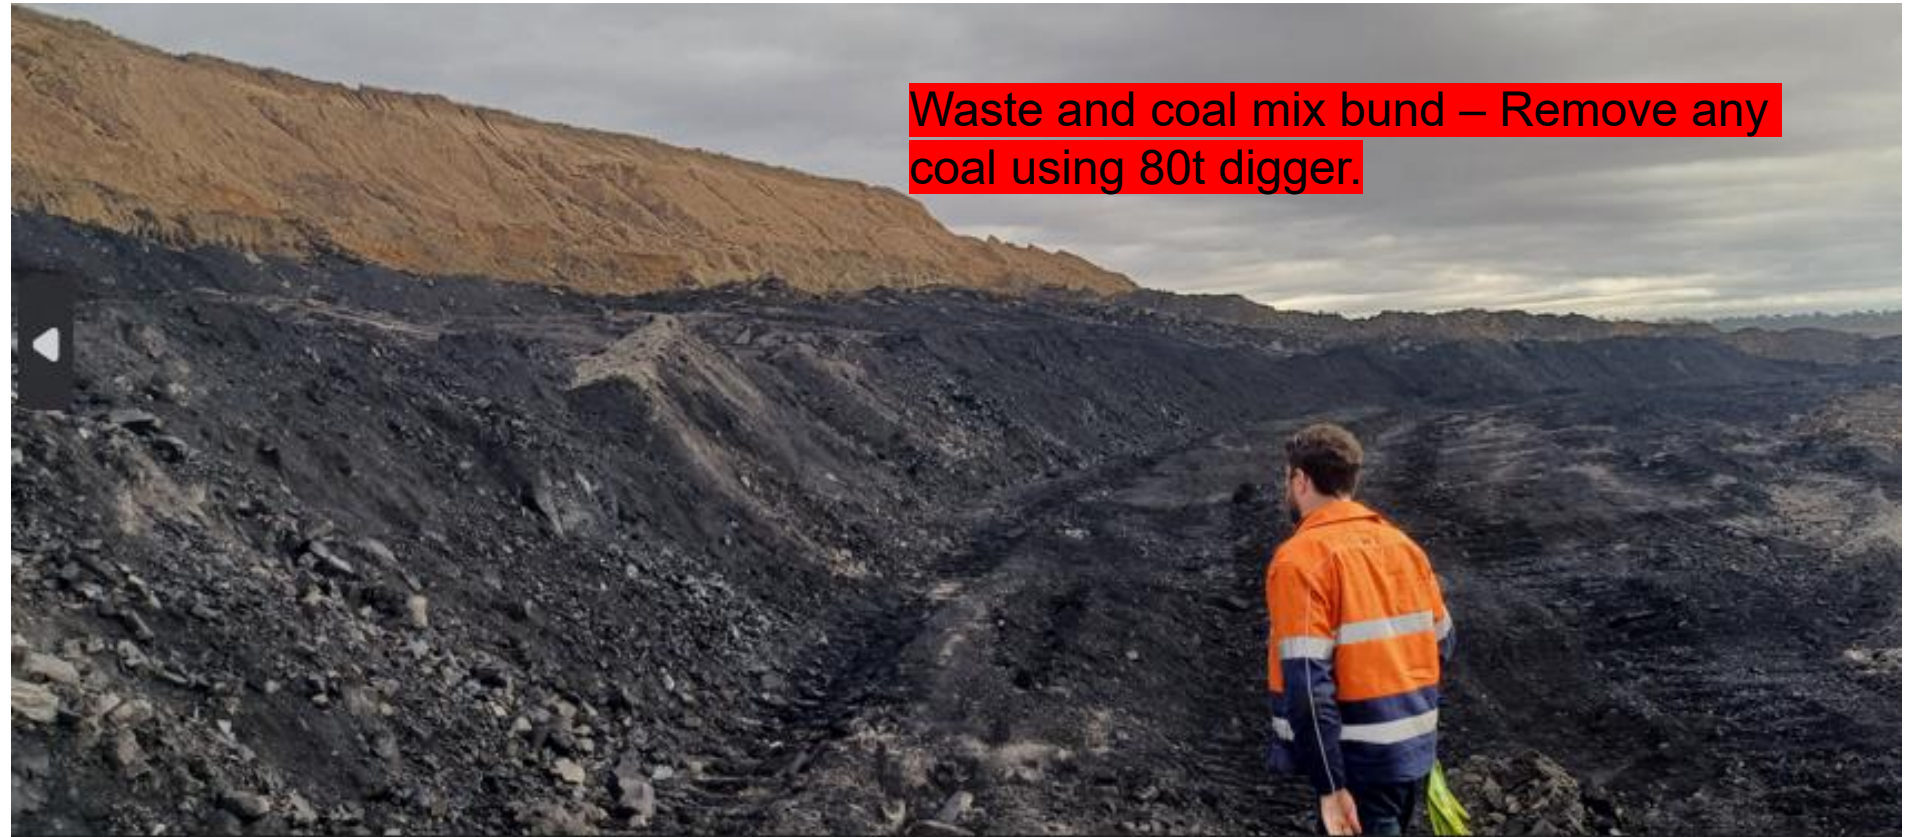
# T05/S01 Ramp 6 De-Stack

Send final clean up to SP-A and stockpile separated

Waste and coal mix bund – Remove any coal using 80t digger.

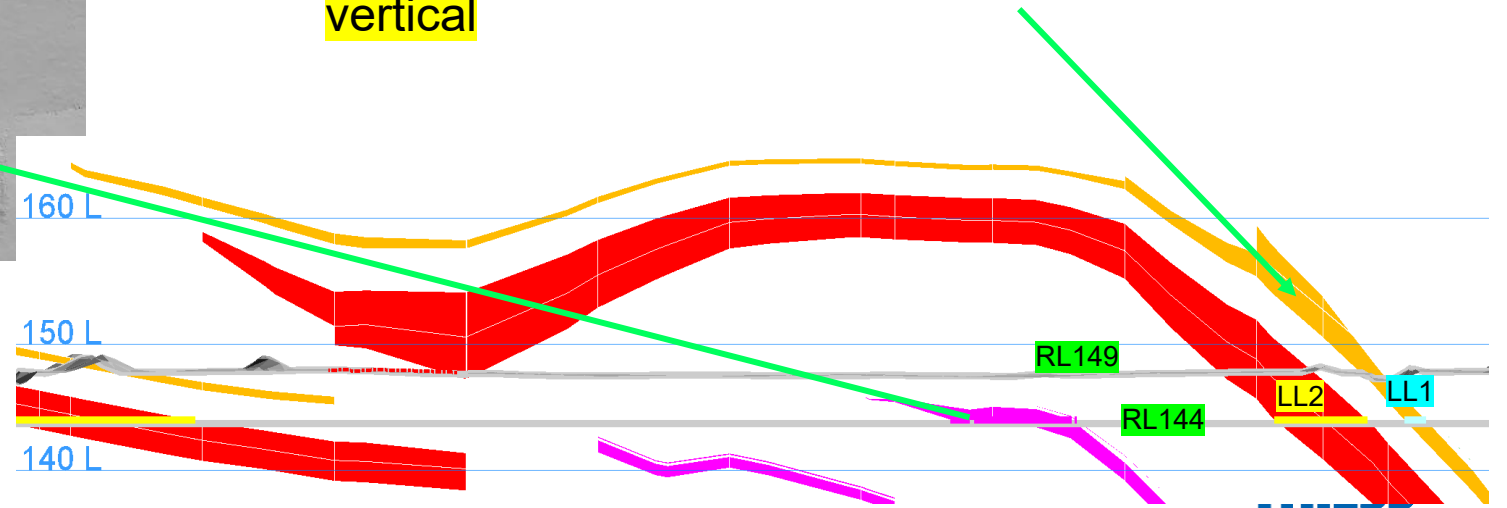
Expose LL1 and LL2 coal. LL1 and LL2 is near  
vertical
