## **Performance Testing of a Novel Dry-Fog Mold Remediation and Prevention Process**

Final Report

Under ITTP, "Performance Testing of a Novel Dry-Fog Mold Remediation and  
Prevention Process"

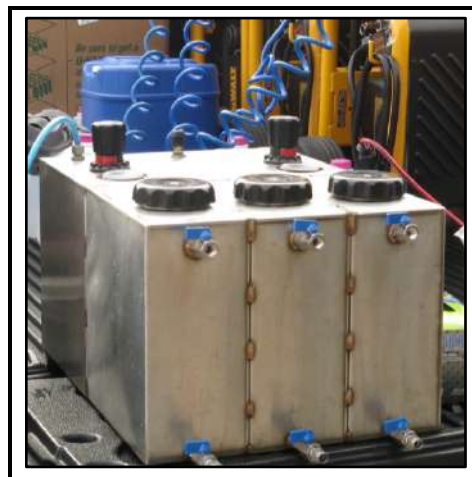
Figure 1. Dry-fog application system.

1. Demonstrate the dry-fog process via the 2<sup>nd</sup> generation application system (Figure 1) in two buildings at Fort Campbell, KY.
2. Determine the efficacy and performance (via sampling and analysis) of the dry-fog process.
3. Verify initial remediation impact(s) and non-reoccurrence of mold/mildew over a test period of 6 months (via sampling and analysis).

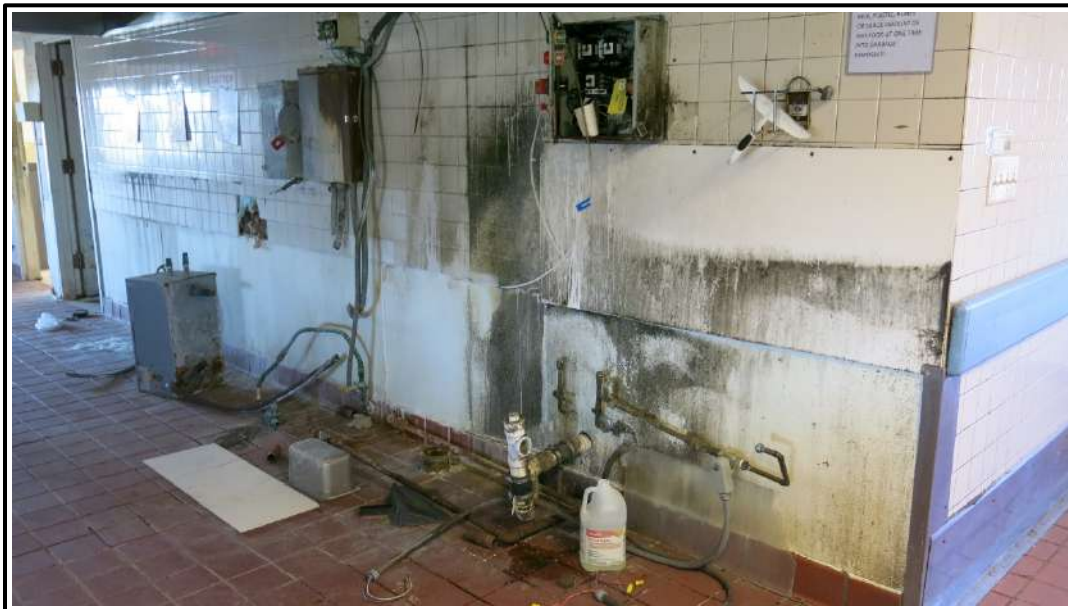
Figure 4. Kitchen area inside Bldg. 2261.

Bldg. 2261 (Figure 3) is a vacant dining facility with an interior area of 4000 sq ft, of which approximately 3700 sq ft were treated. Figures 4 and 5 show the existing conditions inside the facility. Mold was visible on most all surfaces to varying degrees.

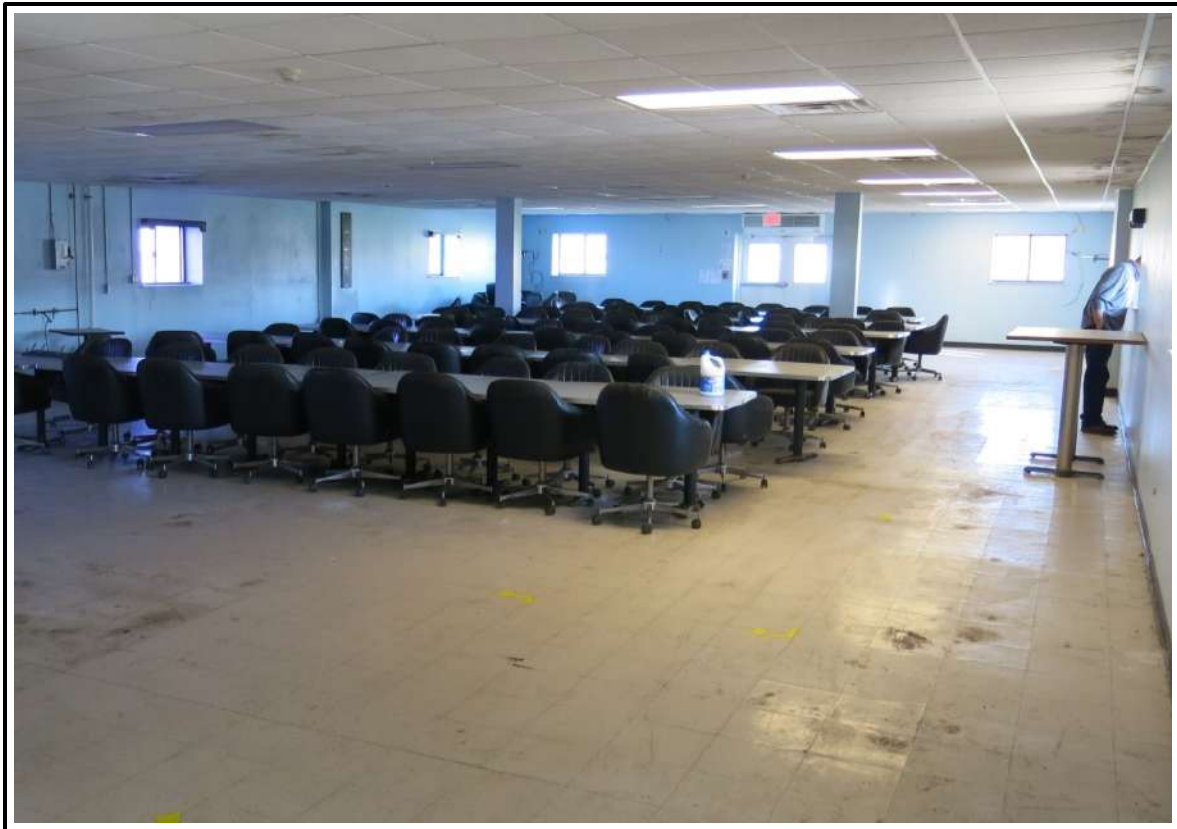
Figure 5. Dining area inside Bldg. 2261.

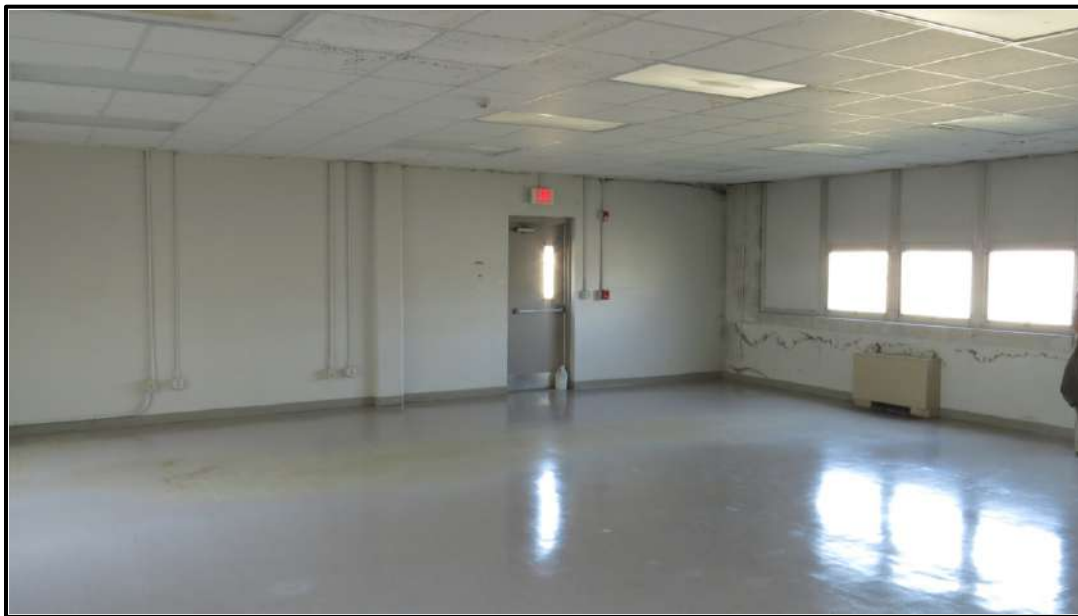
Figure 7. Classroom area inside Bldg. 6733.

Bldg. 6733 (Figure 6) is a vacant hammerhead style barracks facility with interior area of 38,000 sq ft, of which approximately 2800 sq ft were treated. Only the administrative area of the first floor (i.e., classroom, offices, and restrooms) were included in this demonstration. Figures 7 and 8 show the amounts of mold visible on the wall surfaces.

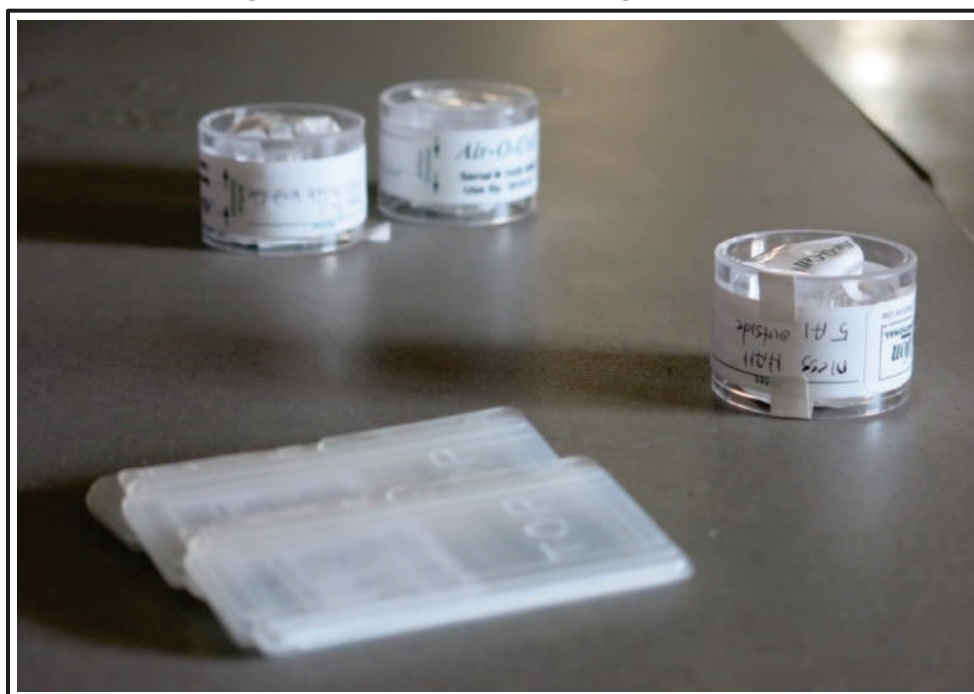
Figure 10. Air and surface sampling equipment.

Sampling Pump P/Z-Lite-IAQ (Figure 20). Sampling protocol for normal office space requires an air flow rate of 15 liters per minute (lpm) for a 5-minute period (EMLab 2012, pp 22-23, 29). Zefon Air-O-Cell™ sample containers were used to capture the air samples. Surface samples were taken using the tape pull method (EMLab 2012, pp 37-38, 29).

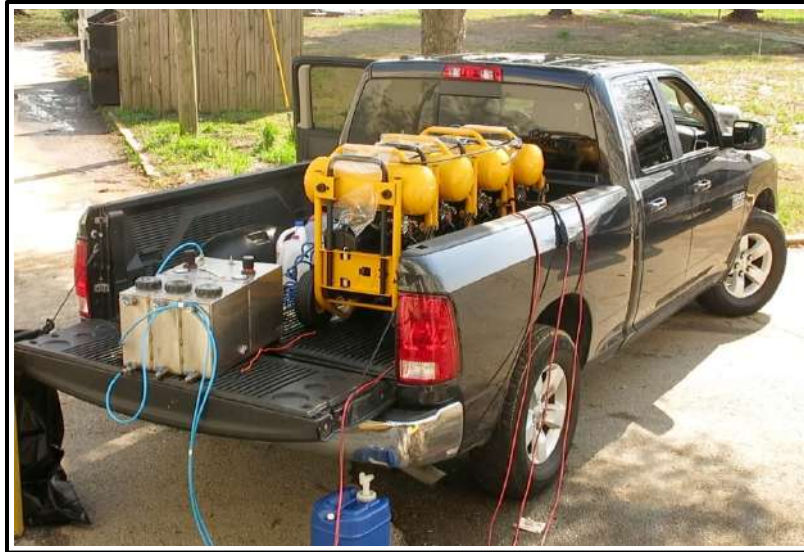
Figure 11. Equipment to apply the dry-fog treatment.

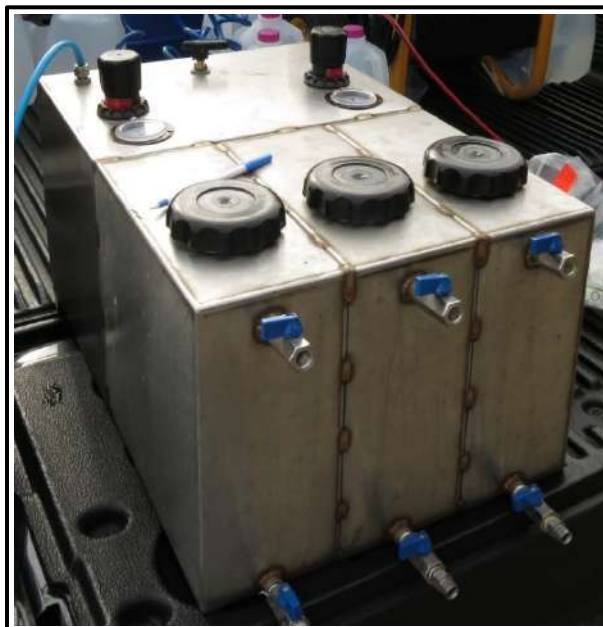
The dry-fog technology is housed inside the metal box (Figure 12). Independent control of the flow rates and pressures for the liquid and air provides the patented ability to generate the dry-fog. The dry fog is made up of particles ranging from 6-8 microns in diameter. Mold spores generally vary from 10-30 microns in diameter (Peacock Enterprises 2017). The dry fog's small particle size (much smaller than the mold spores) provides a mechanism to treat areas inaccessible to liquid treatments, and ensures that the fog can physically infiltrate all spaces and porous materials available to mold spores.

Figure 12. Dry-fog technology apparatus.

Air compressors provide pressure to quickly distribute the dry fog. The dry fog disseminates rather readily covering 1000 sq ft having 8- to 10-ft ceiling heights in approximately 1 hour (i.e., 10,000 cu ft per hour [cu ft/hr]). This is accomplished with minimal manpower requirements. A single individual can completely treat, including mobilizing and demobilization, a 2000 sq ft single-story facility/space in approximately 3 hours. Larger treatment volumes take correspondingly longer treatment times for a given number of air compressors and spray nozzles.

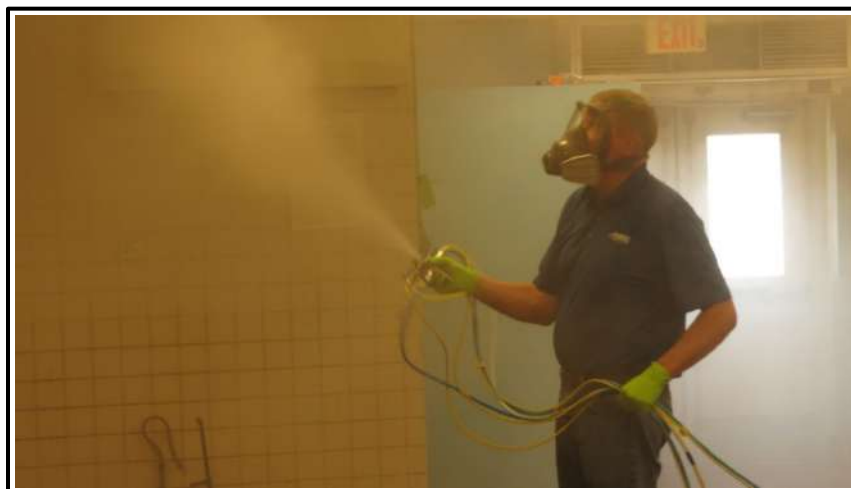
Figure 14. Dry-fog being applied to intake of HVAC ducting Bldg. 2261.

The treatment is performed by introducing the dry-fog via spray nozzles (Figures 13-15).

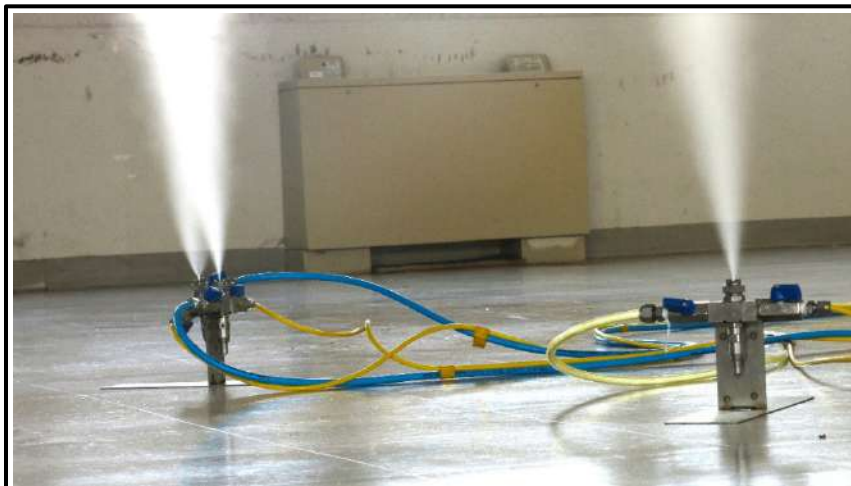
Figure 15. Dry-fog being applied via spray nozzles in Bldg. 6733.

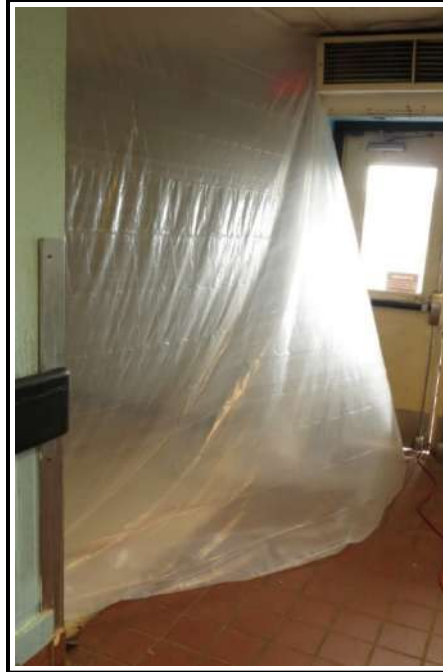
Figure 16 shows an example of minimalistic plastic barriers put in place to generate enough back pressure to provide positive pressure and to ensure coverage when doing smaller areas within larger, more spacious rooms. Although these barriers do not completely contain the dry-fog, they do allow the dry fog to accumulate sufficiently to provide treatment (Figure 17).

Figure 16. Positive pressure at various points within Bldg. 2261.

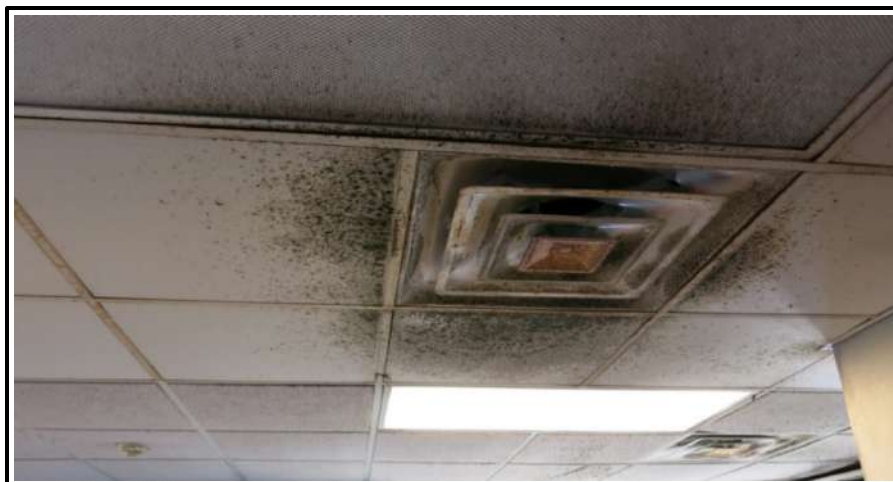
Note that the treatment does not remove the black appearance of mold (Figure 19). Even though the treatment has eliminated the mold spores, treated surfaces will still appear “moldy” so it is essential that air and surface sampling be performed (before and after treatment) to provide quantitative measurements of the treatment’s removal effectiveness. An additional advantage of the dry-fog treatment is that surfaces can be cleaned with typical household cleaning products rather than with the more hazardous chemicals used for traditional mold treatment and cleaning.

Figure 19. Mold growing near duct vents in Bldg. 2261.

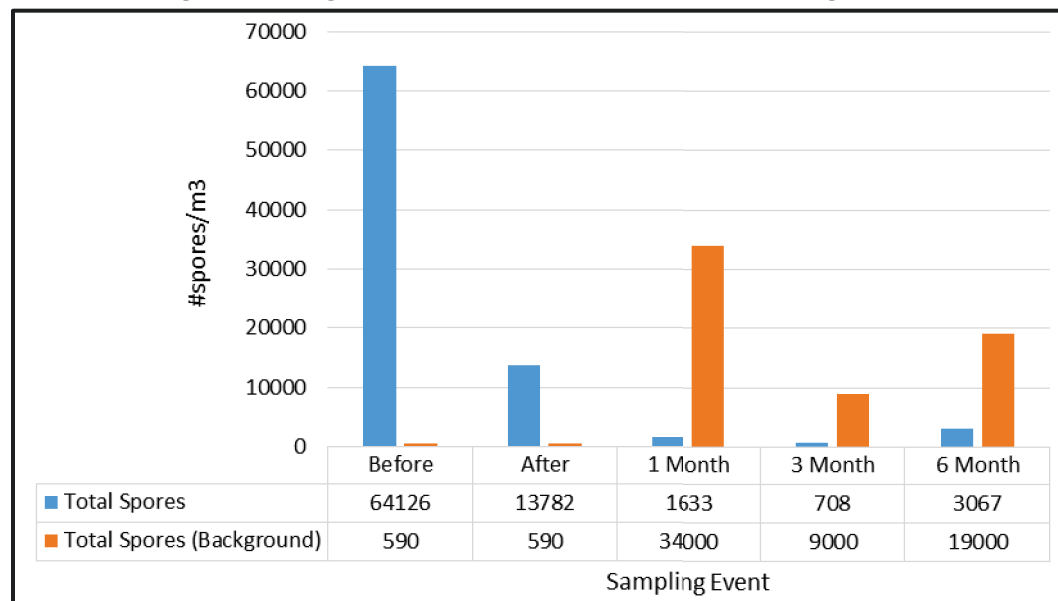
Figure 22. Bldg. 2261—Total Spores vs. Total Spores (background).

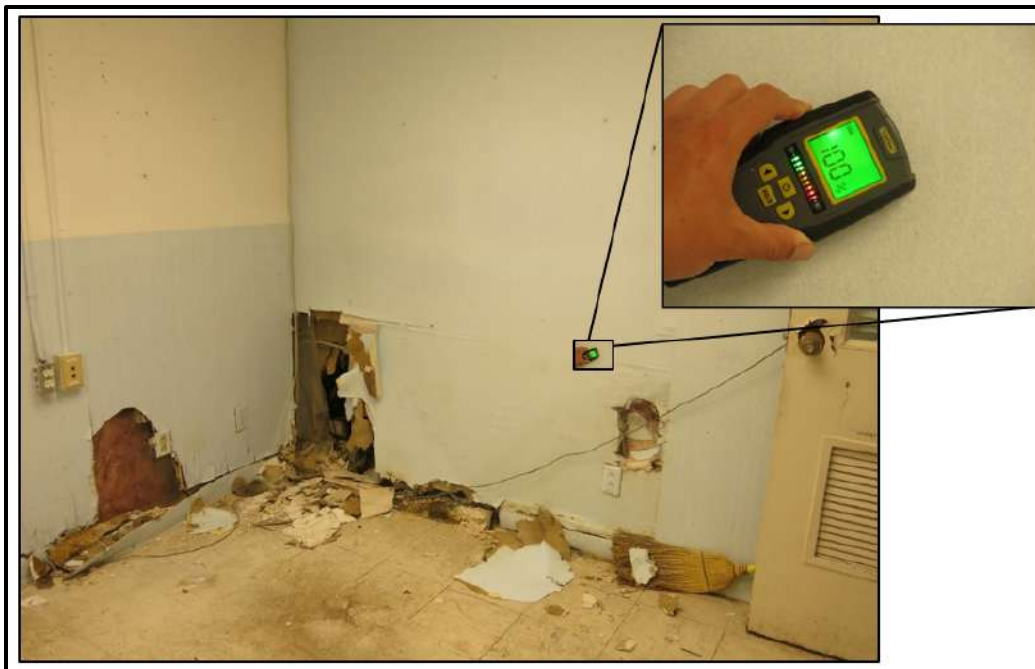
While performing the 3-month sampling event, team members encountered demolition activities in the room represented by Sample #4. Figure 27 shows the debris and the meter reading showing 100% moisture content on the wall surface. The wall was damp to the touch and clearly saturated with water. The adjacent room, represented by Sample #3, had recently begun to leak from the ceiling (Figure 28). It is believed that these changes to the interior environmental/structural conditions played a role in the increased total spore count. However, it should be noted that the background total spore count continued to increase beginning with the 1-month sampling event through the 6-month sampling event, where background was between four and seven times greater than the indoor sample results.

Figure 27. Wall surface moisture content of 100% near Sample Location #4.
